SLOPE STABILITY HAZARD ASSESSMENT
3064 - 3070 ALLENBY ROAD

COWICHAN VALLEY REGIONAL DISTRICT

March 1, 1982
File: 17-971-1

Thurber Consultants Ltd.
Victoria, B.C.

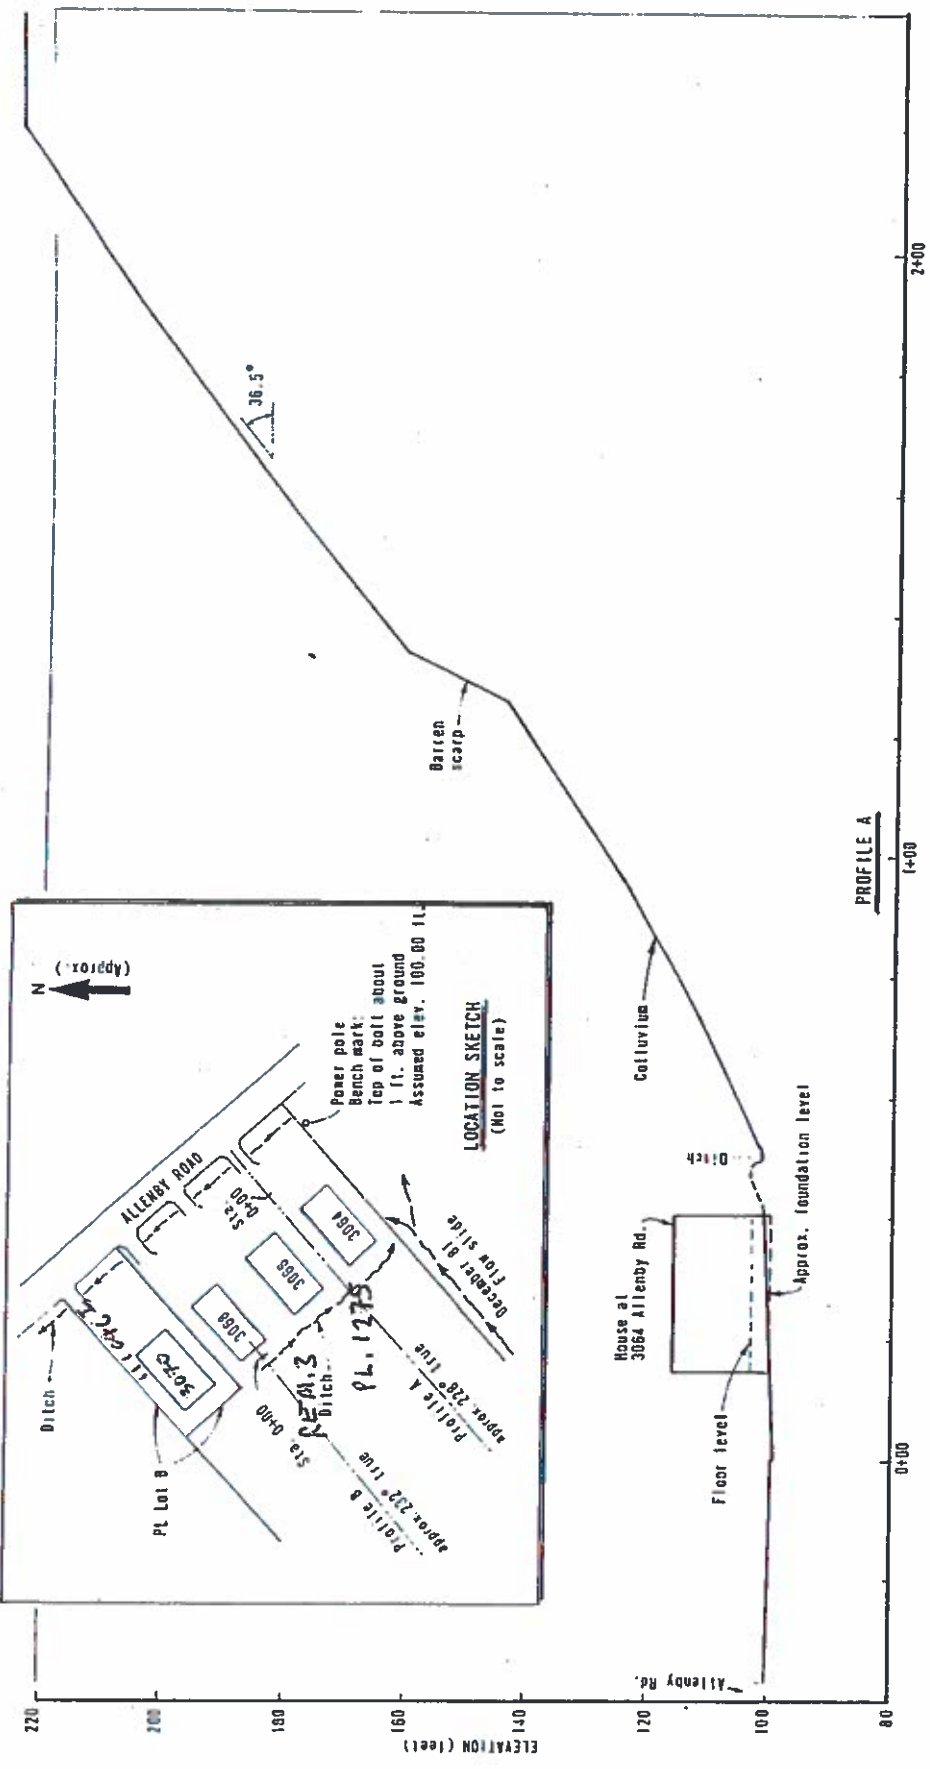
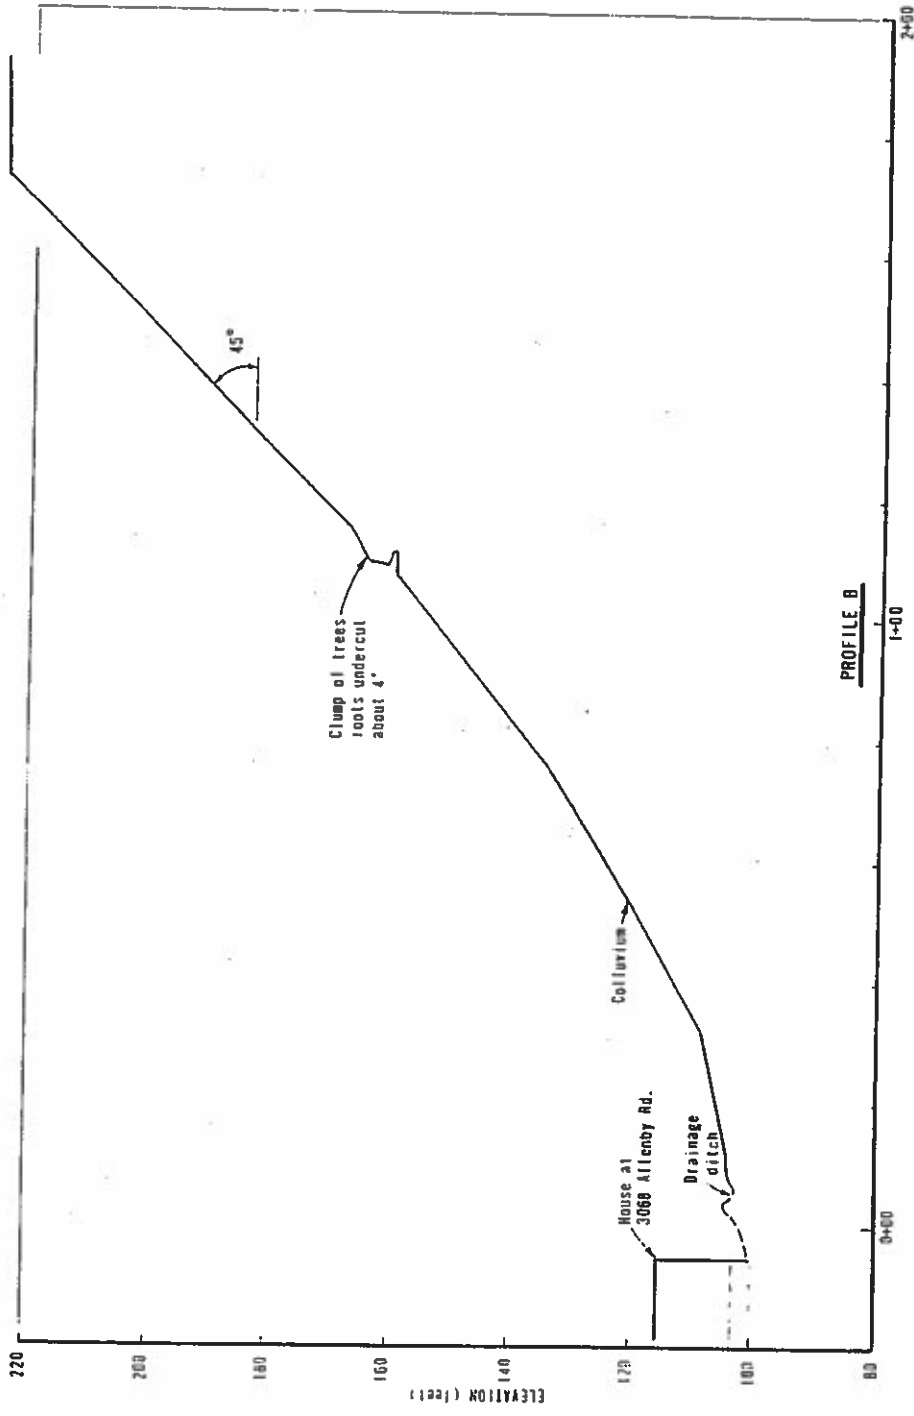
Conichan Valley Regional District	
		SLOPE PROFILES	
3068 Allenby Rd.		Duncan, B.C.	
DATE	D.R.S.	DRAWN BY	
Jan. 11, 1982		THURBER CONSULTANTS LTD., Geotechnical Engineers	
SCALE	1" = 20'

The slope has been oversteepened by toe erosion by the ancestral Cowichan River. Average slope angles in the upper part of the slope were measured at 36 to 45°. A number of barren scarps were noted; the one shown on profile A on Dwg. 17-971-1-1 is 16 ft high and has a slope of 63°. The ground surface is less steep near the base of the slope because of a build-up of colluvium at the toe.
