2020 Corporate Strategic Asset Management Plan

Appendix E Condition Assessment Framework Part 3 - Public Safety

A – 12
Sahtlam Fire Hall

**Cowichan Valley Regional District
Facility Condition Assessment and Capital Plan
Sahtlam Fire Hall, 4384 Cowichan Lake Road, Duncan, BC V9L 6J7**

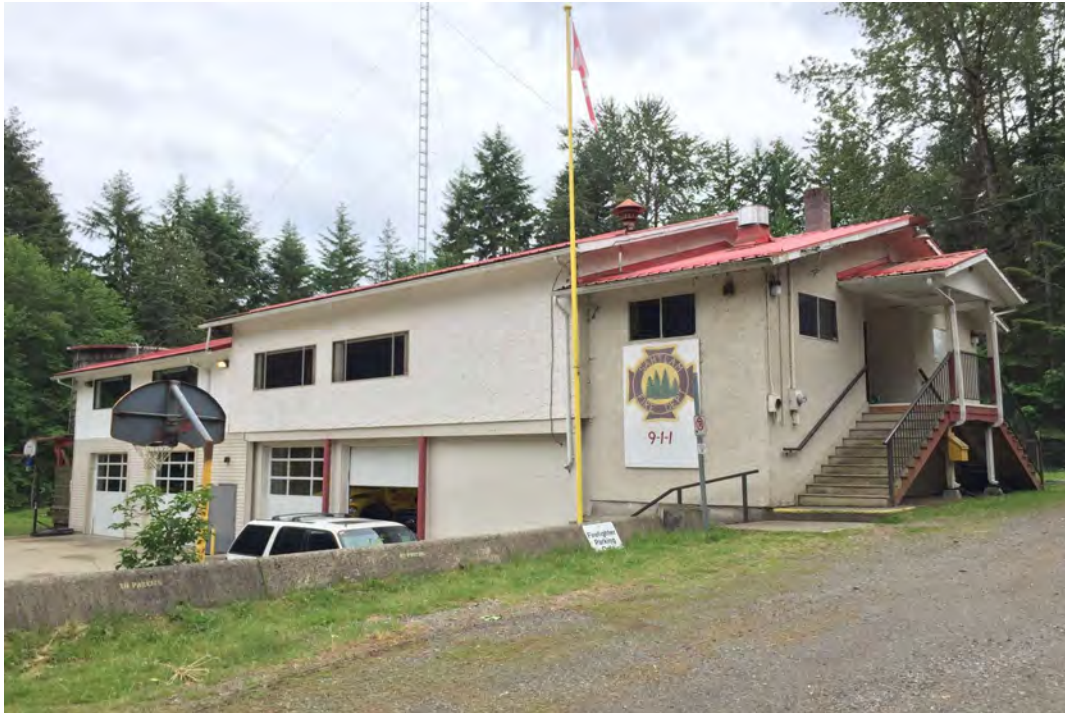
Sahtlam Fire Hall was initially constructed in 1971. An addition was constructed between 1982 and 1988.

Refer to Photo 01 for an overview of the building.

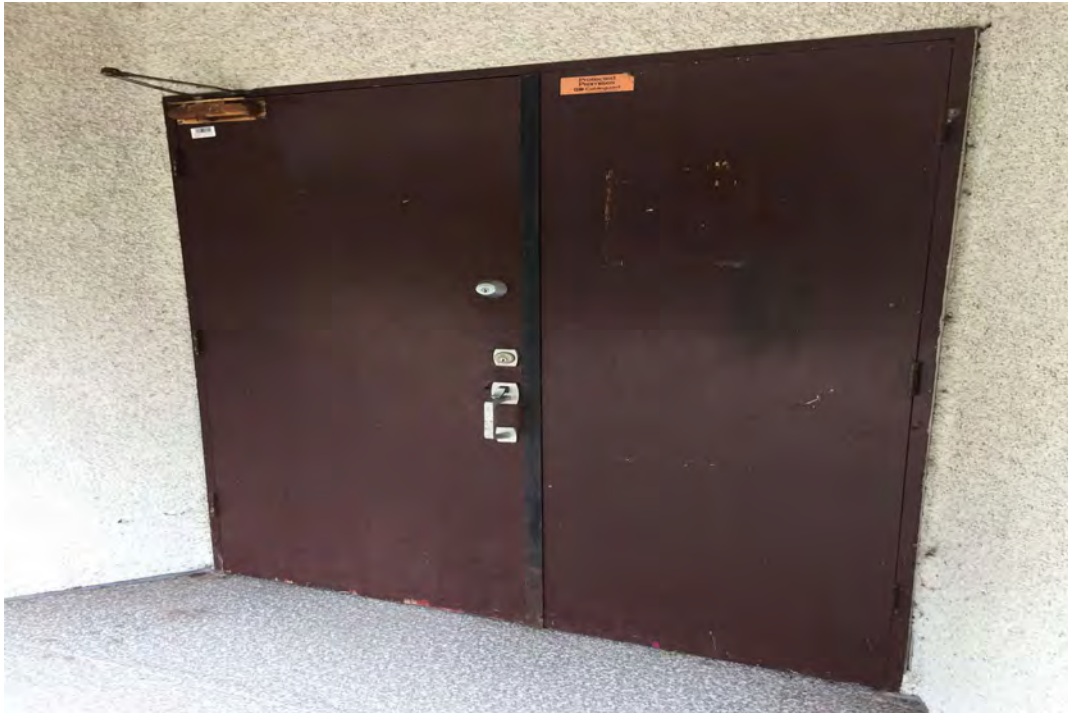
Photo 25

17	Sahtlam Fire Hall	4384 Cowichan Lake Road, Duncan, BC	B Shell	B20 Exterior Enclosure	B2030 Exterior Doors	B203001 Exterior Wood Doors	Front Entrance Doors	25	Double outwing wood doors are present at the front entrance to the building.	3	5	1971	31-May-17	MH	46	30	5	Replace doors at end of service life. The cost to replace the front entrance doors is expected to arrive at less than the threshold value of the report and has not been carried into the cash flow tables.	Replacement	3 - Future Renewal	No	Yes	No	Yes								
18	Sahtlam Fire Hall	4384 Cowichan Lake Road, Duncan, BC	B Shell	B20 Exterior Enclosure	B2030 Exterior Doors	B203002 Glazed Doors	Sliding Patio Door	26	An aluminum sliding glass door with double paned IGU gives access to the lounge's exterior deck.	4	5	1985	31-May-17	MH	32	35	10	Replace sliding glass doors at the end of service life. The cost to replace the sliding glass door is expected to arrive at less than the threshold value of the report and has not been carried into the cash flow tables.	Replacement	3 - Future Renewal	No	Yes	No	No

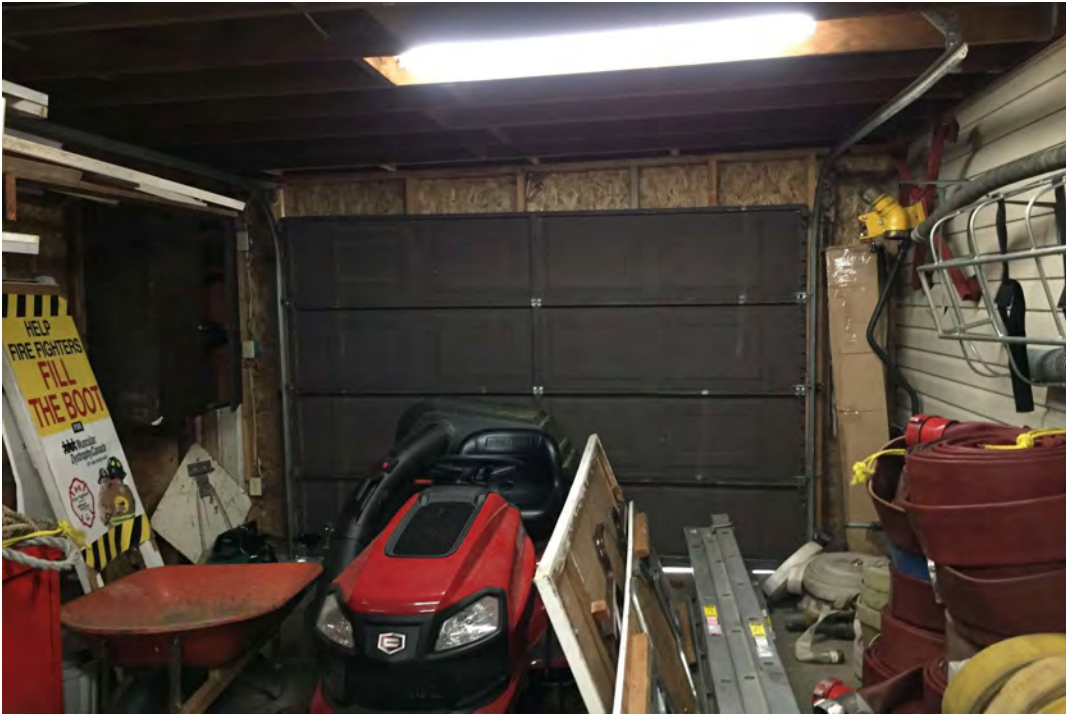
Photo 27

19	Sahtlam Fire Hall	4384 Cowichan Lake Road, Duncan, BC	B Shell	B20 Exterior Enclosure	B2030 Exterior Doors	B203004 Overhead Garage Doors	Storage Garage Door	27	A single steel overhead door (manually operated) provides access through the garage below the lounge's exterior deck.	4	5	1985	31-May-17	MH	32	35	3	Replace overhead garage door on the storage garage at end of service life. The cost to replace the overhead door is expected to arrive at less than the threshold value of the report and has not been carried into the cash flow tables.	Replacement	3 - Future Renewal	No	Yes	No	No								
20	Sahtlam Fire Hall	4384 Cowichan Lake Road, Duncan, BC	B Shell	B20 Exterior Enclosure	B2030 Exterior Doors	B203004 Overhead Garage Doors	Apparatus Bay Doors	28/29	Four vinyl-coated steel overhead doors with single glazing for natural lighting. Two of the doors have been provided with automatic openers. The age of the doors and openers has been approximated.	4	5	2015	31-May-17	MH	2	25	23	Replace apparatus bay doors and automatic openers at end of service life. This item falls outside the ten year plan, costs associated with this item have not been carried into the cash flow tables.	Replacement	3 - Future Renewal	Yes	Yes	Yes	No

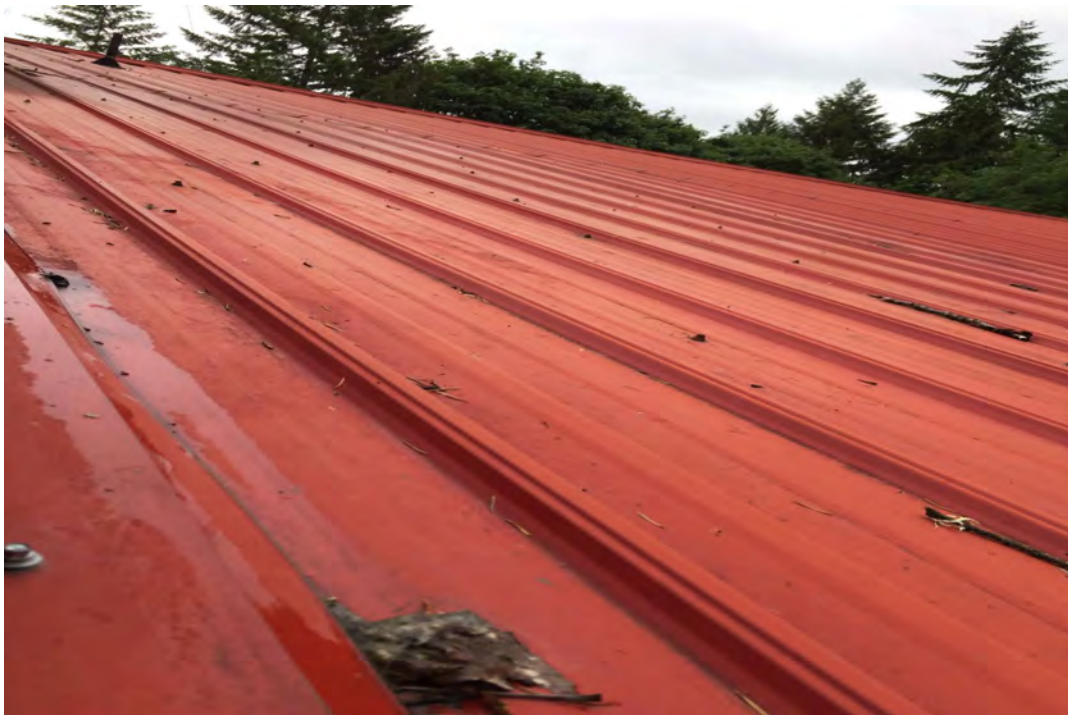
Photo 30

21	Sahtlam Fire Hall	4384 Cowichan Lake Road, Duncan, BC	B Shell	B30 Roofing	B3010 Roof Coverings	B301002 Slope Roof	Metal Panels - Original	30	The sloped roofs are clad with prefinished, corrugated metal roofing panels.	4	5	1990	31-May-17	MH	27	50	23	Replace metal roofing panels and accessories at end of service life. This item falls outside the ten year plan, costs associated with this item have not been carried into the cash flow tables.	Replacement	3 - Future Renewal	No	Yes	No	No								
22	Sahtlam Fire Hall	4384 Cowichan Lake Road, Duncan, BC	B Shell	B30 Roofing	B3010 Roof Coverings	B301002 Slope Roof	Metal Panels - Addition	x	The sloped roofs are clad with prefinished, corrugated metal roofing panels.	4	5	1998	31-May-17	MH	19	50	31	Replace metal roofing panels and accessories at end of service life. This item falls outside the ten year plan, costs associated with this item have not been carried into the cash flow tables.	Replacement	3 - Future Renewal	No	Yes	No	No

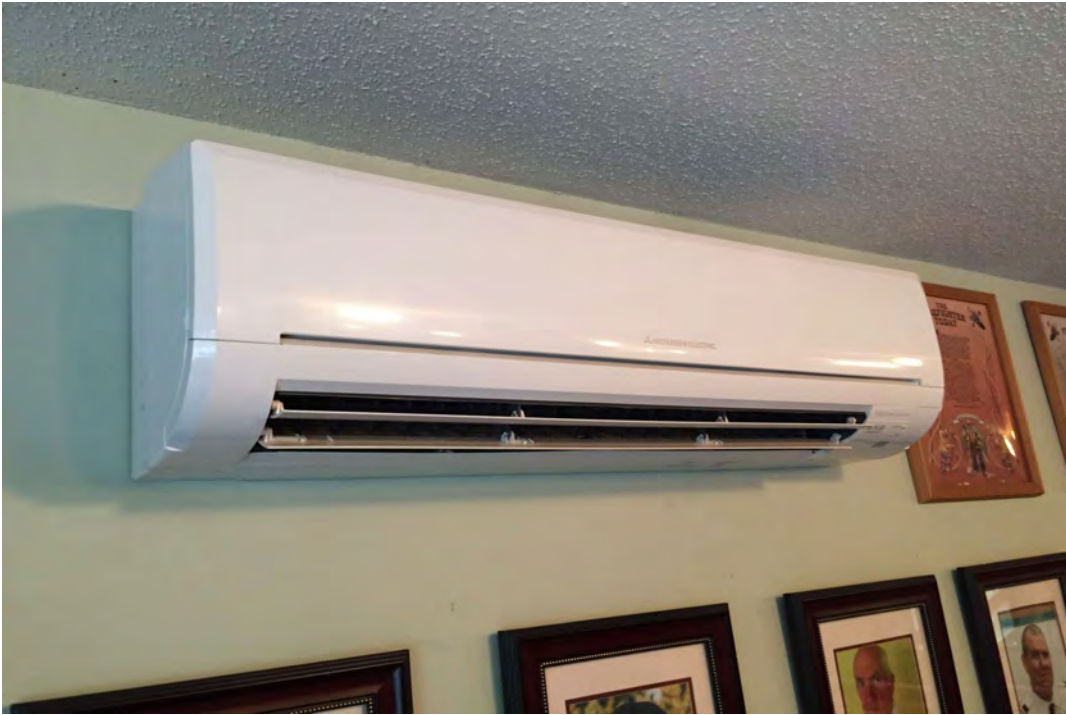
Photo 51

33	Sahtlam Fire Hall	4384 Cowichan Lake Road, Duncan, BC	D Services	D30 HVAC	D3040 Distribution Systems	D304001 Air Distribution, Heating and Cooling	Heat Pumps	50-52	Three 24k BTU Mitsubishi heat pumps with dedicated digital thermostats condition the interior spaces (community hall and lounge). The age of the heat pumps has been approximated.	4	5	2010	31-May-17	MH	7	25	18	Replace compressors as they fail. Replace the heat pumps once it is no longer economical to maintain the units. This item falls outside the ten year plan, costs associated with this item have not been carried into the cash flow tables.	Replacement	3 - Future Renewal	Yes	No	No	No									
34	Sahtlam Fire Hall	4384 Cowichan Lake Road, Duncan, BC	D Services	D30 HVAC	D3050 Terminal and Package Units	D305002 Unit Heaters	Electric Forced Air	53/54	Electric fan heaters provide heating in the crawspace, apparatus bay and some interior spaces (where the heat pumps do not service). The age of the heaters varies and has been approximated.	3	5	2010	31-May-17	MH	7	35	28	Replace heaters as unit failure occurs. This item falls outside the ten year plan, costs associated with this item have not been carried into the cash flow tables.	Replacement	3 - Future Renewal	Yes	No	No	No

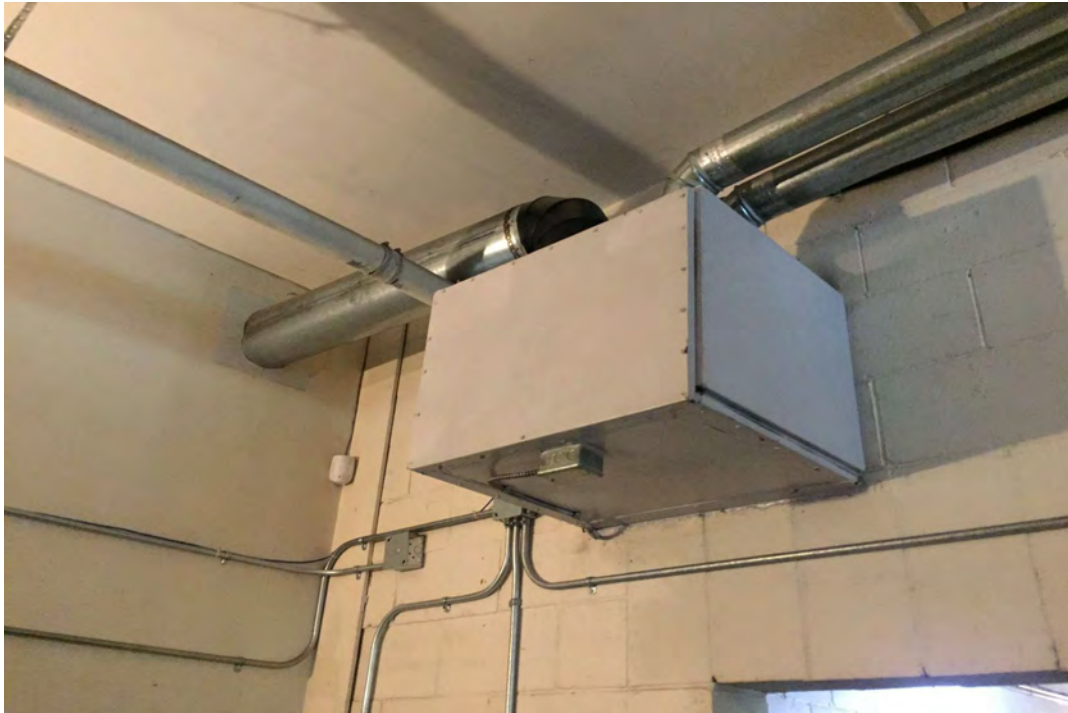
Photo 57

37	Sahtlam Fire Hall	4384 Cowichan Lake Road, Duncan, BC	D Services	D30 HVAC	D3050 Terminal and Package Units	D304007 Exhaust Systems - Apparatus Bay	Apparatus Bay	57	The truck exhaust pipes connect to ducting that is exhausted from the building by a furnace fan, which is understood to have been installed in approximately 1990 and approved for use by WorkSafe BC.	3	5	1990	31-May-17	MH	27	30	3	Replace or overhaul the exhaust fan at end of service life. The cost to replace the exhaust fan is expected to arrive at less than the threshold value of the report and has not been carried into the cash flow tables.	Replacement	3 - Future Renewal	No	No	No	Yes									
38	Sahtlam Fire Hall	4384 Cowichan Lake Road, Duncan, BC	D Services	D20 Plumbing	D2020 Domestic Water Distribution	D202003 Domestic Water Equipment	Pump	58	The building's water supply originates from a well. The water is pumped into the building, treated and stored for domestic use.	3	5	2006	31-May-17	MH	11	20	9	Replace the pump at end of service life. The cost to replace the water pump is expected to arrive at less than the threshold value of the report and has not been carried into the cash flow tables.	Replacement	3 - Future Renewal	No	No	Yes	No

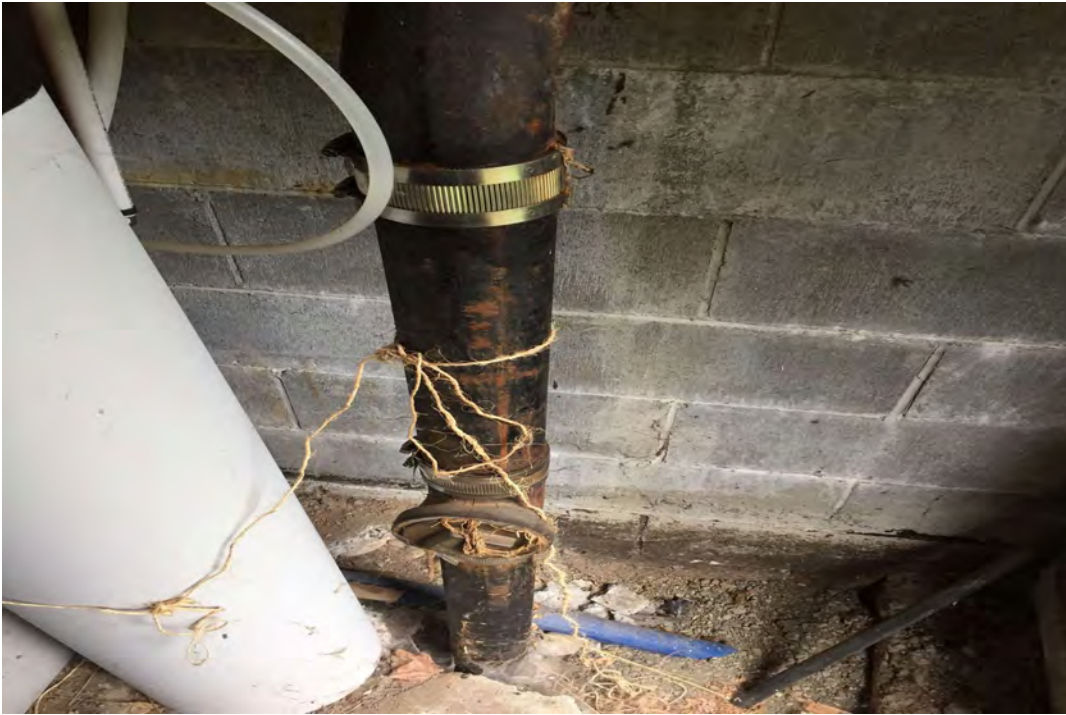
Photo 59

39	Sahtlam Fire Hall	4384 Cowichan Lake Road, Duncan, BC	D Services	D20 Plumbing	D2030 Sanitary Waste	D2030 Sanitary Waste	Piping	59/60	Sanitary and storm water collection piping was largely cast iron or ABS, where visible. The average year of installation was taken to be 1977.	3	5	1977	31-May-17	MH	40	60	20	Complete localized repairs as may be necessary as the building ages. This item falls outside the ten year plan, costs associated with this item have not been carried into the cash flow tables.	Replacement	3 - Future Renewal	Yes	No	No	No									
40	Sahtlam Fire Hall	4384 Cowichan Lake Road, Duncan, BC	D Services	D20 Plumbing	D2020 Domestic Water Distribution	D202003 Domestic Water Equipment	Treatment	61-63	The well water is treated with UV light, water softening and stored in a pressurized well-water tank.	3	5	2006	31-May-17	MH	11	20	9	Install new water treatment and storage equipment at the end of service life. A larger capacity and brand new storage tank is located in the crawspace and is ready for installation as the new well is activated (estimated 2017-2018).	Replacement	3 - Future Renewal	Yes	No	No	No	1	\$3,000	EA	\$3,000	0%	0%	5%	\$4,000

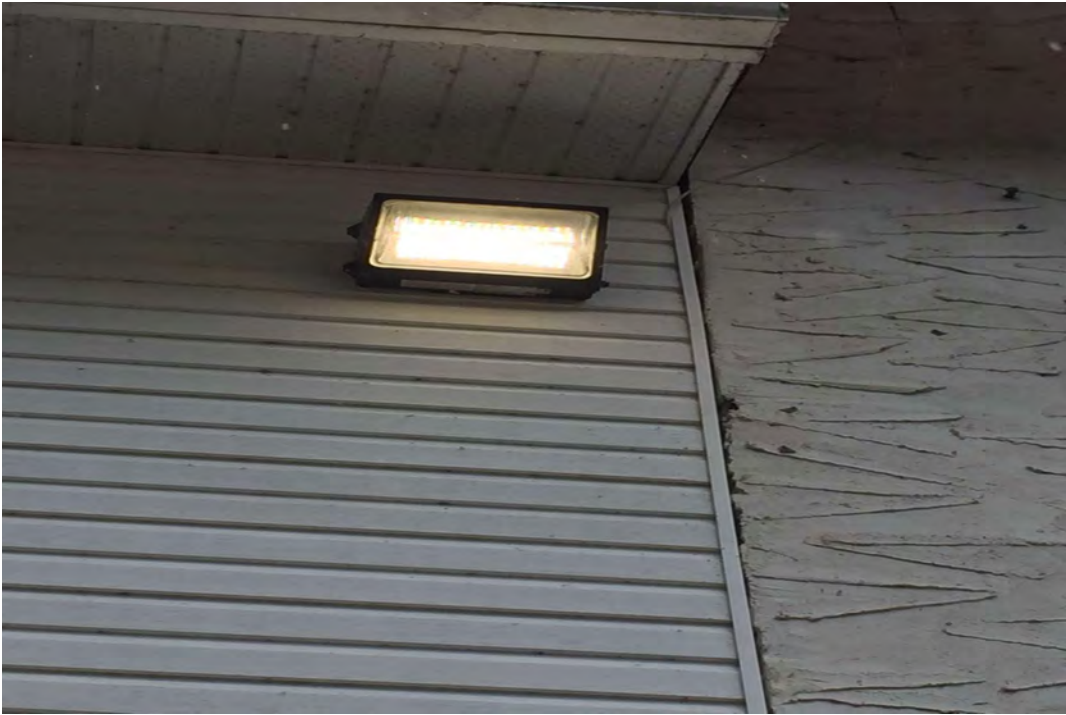
Photo 73

46	Sahtlam Fire Hall	4384 Cowichan Lake Road, Duncan, BC	D Services	D50 Electrical	D5020 Lighting and Branch Wiring	D502002 Lighting Equipment	Outdoor Fixtures	73/74	The exterior lighting is a combination of high-intensity discharge and LED replacement fixtures. The age of the fixtures has been approximated.	4	5	2010	31-May-17	MH	7	25	18	Replace the HID fixtures with LED as ballasts fail. The cost to replace the remaining HID lights is expected to arrive at less than the threshold value of the report and has not been carried into the cash flow tables.	Replacement	3 - Future Renewal	Yes	Yes	No	No								
47	Sahtlam Fire Hall	4384 Cowichan Lake Road, Duncan, BC	D Services	D50 Electrical	D5030 Communication and Security	D503008 LAN, TV, Telephone	Infrastructure Cabling	75	The facility is served by LAN, telephone, and TV cabling with boxes above the apparatus bay and within the crawl space. Upgrades have been performed over the years as technology has advanced. The age of the cabling infrastructure varies and the year of installation has been taken as 2005.	4	5	2005	31-May-17	MH	12	25	18	Upgrade low-voltage cable infrastructure as required. This item falls outside the ten year plan, costs associated with this item have not been carried into the cash flow tables.	Replacement	3 - Future Renewal	Yes	No	Partial	No
