# **2020 Corporate Strategic Asset Management Plan**

### **Condition Assessment Framework Part 6 - Sewer Systems**

## 800 - Cowichan Bay Sewer

Infrastructure Condition Assessment and Capital Plan  
1825 Cowichan Bay Road., Cowichan Bay, BC

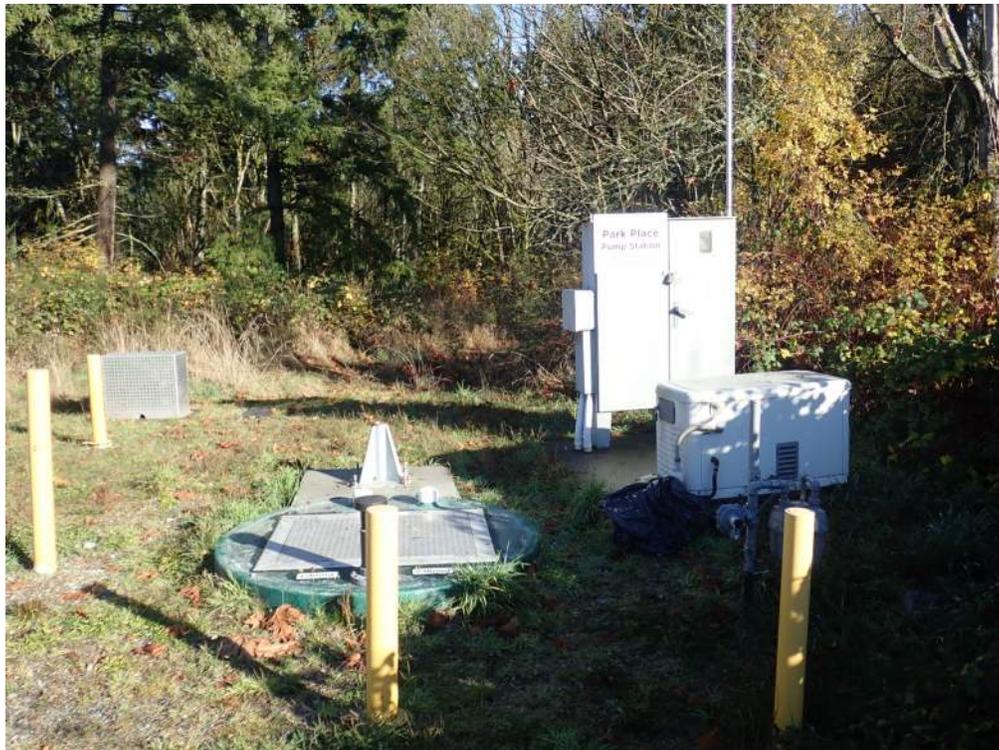
800 (1)

3) Condition of wet well:  
Visible Deterioration of structure and hatch:

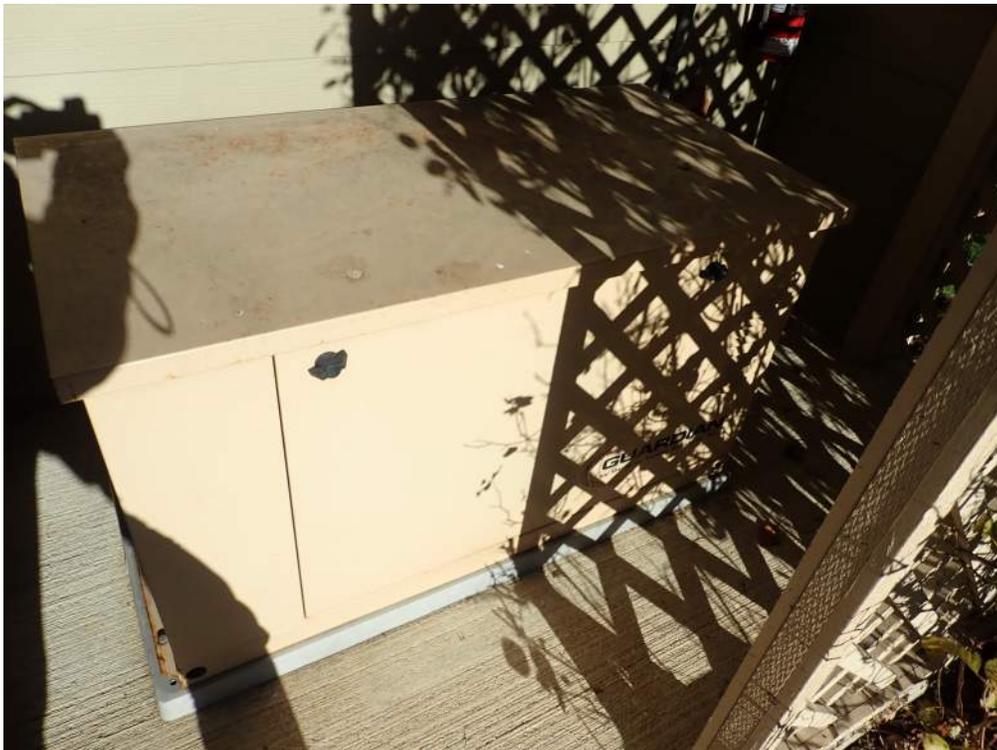
801 (1)

3) Condition of Structure:

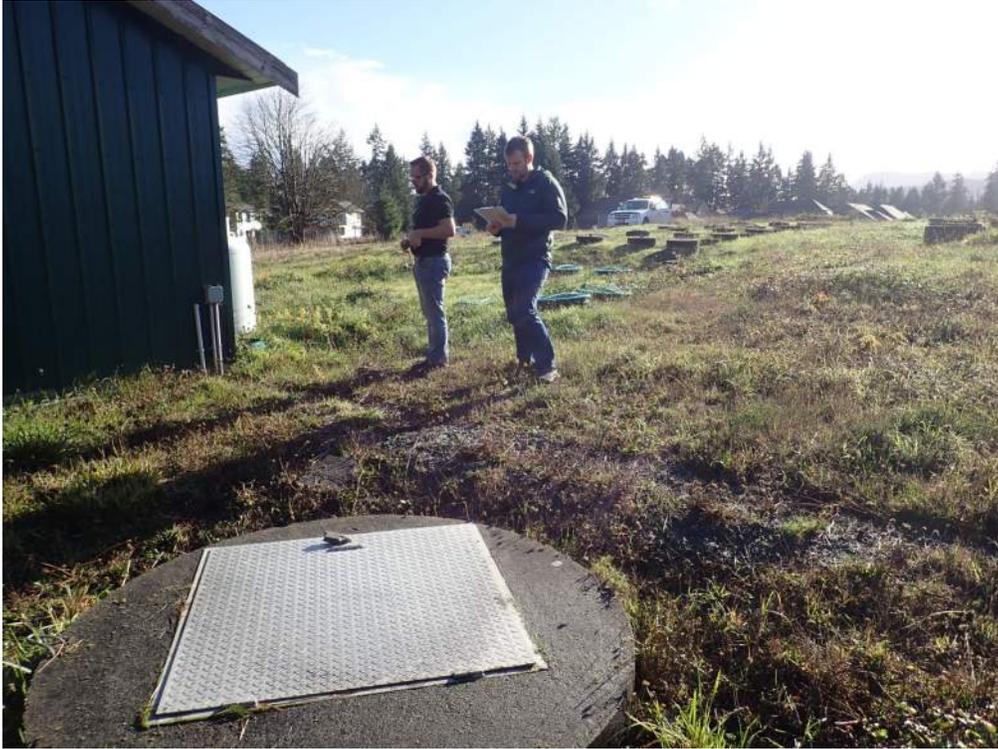
801 (28)

801 Brulette Place Sewer-See Infrastructure Condition Assessment table with corresponding photo ID's

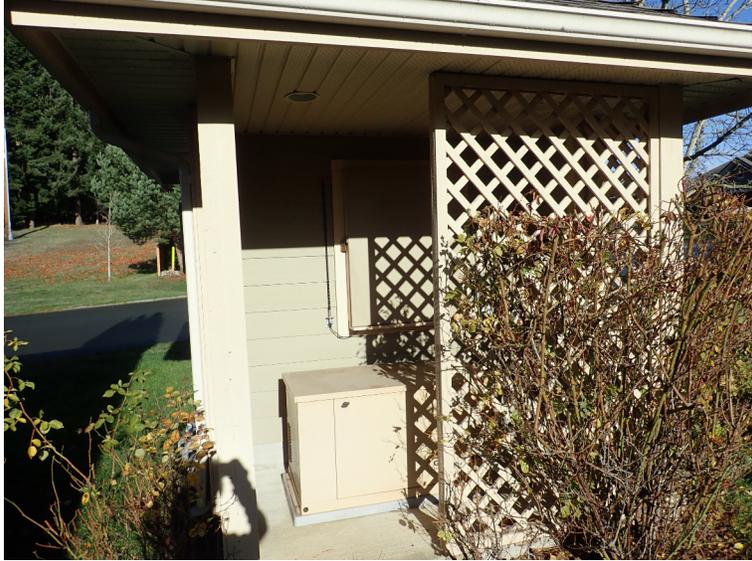
Photo 1

Bruletter Place Sewer - Com. Kiosk - Functional Code 801

Brulette Place Sewer - Com. Kiosk	Sewer Service Building	801	A Substructure	A10 Foundations	A1030 Slab on Grade	A103001 Standard Slab on Grade	Interior of Building At-Grade/ Slab-on-Grade		1	The floor is concrete slab-on-grade. Isolated hairline cracking was observed. No evidence of major settlement or heaving was reported or observed.	5	5	2010	21-Nov-17	MH	8	50	42	The concrete slab-on-grade is expected to remain serviceable for the life of the building, with isolated repairs, if needed. No capital expenses associated with this item are expected.	Not Applicable	Not Applicable	Yes	Yes	Yes	No	120	\$10	SF	\$1,200	0%	5%	5%	\$2,000
Brulette Place Sewer - Com. Kiosk	Sewer Service Building	801	B Shell	B10 Superstructure	B10 Superstructure	B10 Superstructure	Interior of Building/ General Superstructure		1	The superstructure is comprised of wood framing on all four walls and roof trusses, supported on a cast-in-place concrete foundation.  No settlement or other evidence of structural distress was observed or reported. There was no evidence or reports of long-term leakage that would allude to concealed structural damage.	5	5	2010	21-Nov-17	MH	8	50	42	Interior protected structural components are expected to last the life of the building. No major capital expenditures are expected to be required.	Not Applicable	Not Applicable	Yes	Yes	Yes	No	120	\$40	SF	\$4,800	0%	5%	5%	\$6,000

Brulette Place Sewer - Com. Kiosk	Sewer Service Building	801	B Shell	CB20 Exterior Enclosure	B2010 Exterior Walls	B201001 Exterior Enclosure	Exterior Walls/ Cementitious Siding		1	Painted cementitious siding and wood trim are present on the exterior walls.	4	4	2010	21-Nov-17	MH	8	12	4	Repaint siding and trim.  At the time of painting, replace sealant joints and wood trim as required.	Repair Allowance	3 - Future Renewal	Yes	Yes	No	No	200	\$8	SF	\$1,600	0%	15%	5%	\$2,000
Brulette Place Sewer - Com. Kiosk	Sewer Service Building	801	B Shell	CB20 Exterior Enclosure	B2010 Exterior Walls	B201001 Exterior Enclosure	Exterior Walls/ Cementitious Siding		1	Painted cementitious siding and wood trim are present on the exterior walls.	5	5	2010	21-Nov-17	MH	8	50	42	The cementitious siding is expected to last the life of the building.  Note: isolated sealant and wood trim replacement should be completed as part of the ongoing painting.	Replacement	3 - Future Renewal	Yes	Yes	No	No	200	\$35	SF	\$7,000	0%	5%	5%	\$8,000

Brulette Place Sewer - Com. Kiosk	Sewer Service Building	801	B Shell	CB20 Exterior Enclosure	B2010 Exterior Walls	B201001 Exterior Enclosure	Exterior Walls/ Soffit		1	Perforated metal soffit is present at the roof overhangs.	5	5	2010	21-Nov-17	MH	8	50	42	The perforated metal soffit is expected to last the life of the building. No capital expenses associated with this item are expected.	Replacement	3 - Future Renewal	Yes	Yes	No	No	60	\$20	SF	\$1,200	0%	10%	5%	\$2,000
Brulette Place Sewer - Com. Kiosk	Sewer Service Building	801	B Shell	B20 Enclosure	E2030 Exterior Doors	B203001 Solid Doors	Exterior Walls/ Door		1	Two painted metal doors are present on the building.	5	5	2010	21-Nov-17	MH	8	30	22	Replace doors at the end of their service life.	Replacement	3 - Future Renewal	Yes	Yes	No	No	1	\$500	EA	\$500	0%	5%	5%	\$1,000
Brulette Place Sewer - Com. Kiosk	Sewer Service Building	801	B Shell	D30 Roofing	B3010 Roof Coverings	B301001 High Slope Roof Coverings	Roof/Sloped Roof Assembly		1	The roof is sloped roof assembly with asphalt shingles.  The roof drains via aluminum gutters to rain water leaders which drain to grade.	5	5	2010	21-Nov-17	MH	8	25	17	Replace the roof at the end of its service life.  Ongoing maintenance of the roof should include review of all exposed fasteners and resealing of penetrations.	Replacement	3 - Future Renewal	No	Yes	No	No	150	\$30	SF	\$4,500	0%	5%	5%	\$5,000

Brulette Place Sewer - Com. Kiosk	Sewer Service Building	801	B Shell	D30 Roofing	B3010 Roof Coverings	B301001 High Slope Roof Coverings	Roof/Sloped Roof Assembly		1	The roof is sloped roof assembly with asphalt shingles.  The roof drains via aluminum gutters to rain water leaders which drain to grade.	5	5	2010	21-Nov-17	MH	8	25	17	Replace gutters at the end of their service life.	Replacement	3 - Future Renewal	Yes	Yes	No	No	40	\$10	SF	\$400	0%	10%	5%	\$1,000
Brulette Place Sewer - Com. Kiosk	Sewer Service Building	801	C Interiors	C30 Interior Finishes	C3010 Wall Finishes	C301003 Gypsum Wallboard Finishes	Interior/Interior Finishes			The interior gypsum and plywood walls and ceilings are painted.	5	5	2010	21-Nov-17	MH	8	20	12	Repaint interiors as required.  Note: a long service life has been included to reflect to building usage.	Repair Allowance	3 - Future Renewal	Yes	Yes	No	No	1	\$500	LS	\$500	0%	0%	5%	\$1,000

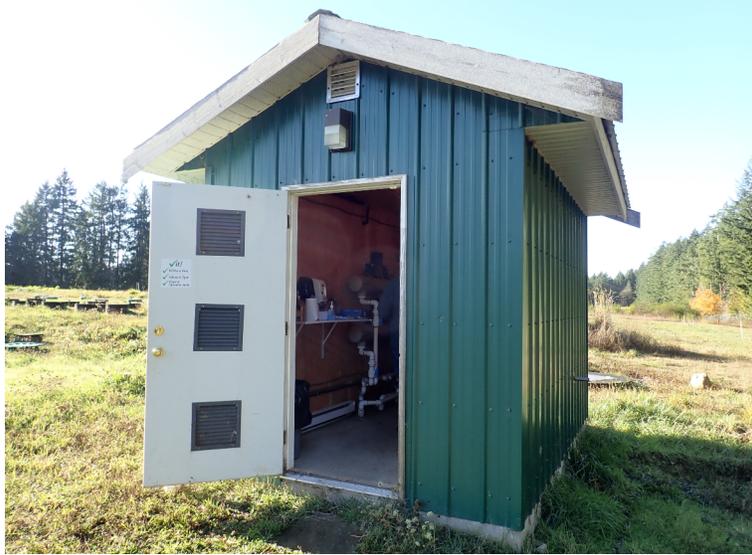
Photo 1

Bruletter Place Sewer - Lift Station- Functional Code 801

Brulette Place Sewer - Lift Station	Sewer Service Building	801	A Substructure	A10 Foundations	A1030 Slab on Grade	A103001 Standard Slab on Grade	Interior of Building At-Grade/ Slab-on-Grade	1	The floor is concrete slab-on-grade (polished concrete throughout). Isolated hairline cracking was observed. No evidence of major settlement or heaving was reported or observed.	5	5	2010	21-Nov-17	MH	8	50	42	The concrete slab-on-grade is expected to remain serviceable for the life of the building, with isolated repairs, if needed. No capital expenses associated with this item are expected.	Not Applicable	Not Applicable	Yes	Yes	Yes	No	50	\$10	SF	\$500	0%	5%	5%	\$1,000
Brulette Place Sewer - Lift Station	Sewer Service Building	801	B Shell	B10 Superstructure	B10 Superstructure	B10 Superstructure	Interior of Building/ General Superstructure	1	The superstructure is comprised of wood framing on all four walls and roof trusses, supported on a cast-in-place concrete foundation.  No settlement or other evidence of structural distress was observed or reported. There was no evidence or reports of long-term leakage that would allude to concealed structural damage.	5	5	2010	21-Nov-17	MH	8	50	42	Interior protected structural components are expected to last the life of the building. No major capital expenditures are expected to be required.	Not Applicable	Not Applicable	Yes	Yes	Yes	No	50	\$40	SF	\$2,000	0%	5%	5%	\$3,000

Brulette Place Sewer - Lift Station	Sewer Service Building	801	B Shell	CB20 Exterior Enclosure	B2010 Exterior Walls	B201001 Exterior Enclosure	Exterior Walls/ Metal Siding	1	Painted metal siding (with exposed fasteners) is present on the exterior walls.	4	4	2010	21-Nov-17	MH	8	12	4	Complete fastener and sealant replacement as required.	Repair Allowance	3 - Future Renewal	Yes	Yes	No	No	1	\$500	LS	\$500	0%	15%	5%	\$1,000
Brulette Place Sewer - Lift Station	Sewer Service Building	801	B Shell	CB20 Exterior Enclosure	B2010 Exterior Walls	B201001 Exterior Enclosure	Exterior Walls/ Cementitious Siding	1	Painted metal siding (with exposed fasteners) is present on the exterior walls.	5	5	2010	21-Nov-17	MH	8	50	42	The metal siding is expected to last the life of the building.	Replacement	3 - Future Renewal	Yes	Yes	No	No	180	\$35	SF	\$6,300	0%	5%	5%	\$7,000
Brulette Place Sewer - Lift Station	Sewer Service Building	801	B Shell	CB20 Exterior Enclosure	B2010 Exterior Walls	B201001 Exterior Enclosure	Exterior Walls/ Soffit	1	Perforated metal soffit is present at the roof overhangs.	5	5	2010	21-Nov-17	MH	8	50	42	The perforated metal soffit is expected to last the life of the building. No capital expenses associated with this item are expected.	Replacement	3 - Future Renewal	Yes	Yes	No	No	16	\$20	SF	\$320	0%	10%	5%	\$1,000

Brulette Place Sewer - Lift Station	Sewer Service Building	801	B Shell	B20 Enclosure	E2030 Exterior Doors	B203001 Solid Doors	Exterior Walls/ Door	1	Two painted metal doors are present on the building.	5	5	2010	21-Nov-17	MH	8	30	22	Replace doors at the end of their service life.	Replacement	3 - Future Renewal	Yes	Yes	No	No	1	\$500	EA	\$500	0%	5%	5%	\$1,000
Brulette Place Sewer - Lift Station	Sewer Service Building	801	B Shell	D30 Roofing	B3010 Roof Coverings	B301001 High Slope Roof Coverings	Roof/Sloped Roof Assembly	1	The roof is standing seam metal roof.  The roof is edge drained.	5	5	2010	21-Nov-17	MH	8	40	32	Replace the metal roof at the end of its service life.  Ongoing maintenance of the roof should include review of all exposed fasteners and resealing of penetrations. It is assumed that this work would be completed with the siding remedial work.	Replacement	3 - Future Renewal	No	Yes	No	No	60	\$30	SF	\$1,800	0%	5%	5%	\$2,000

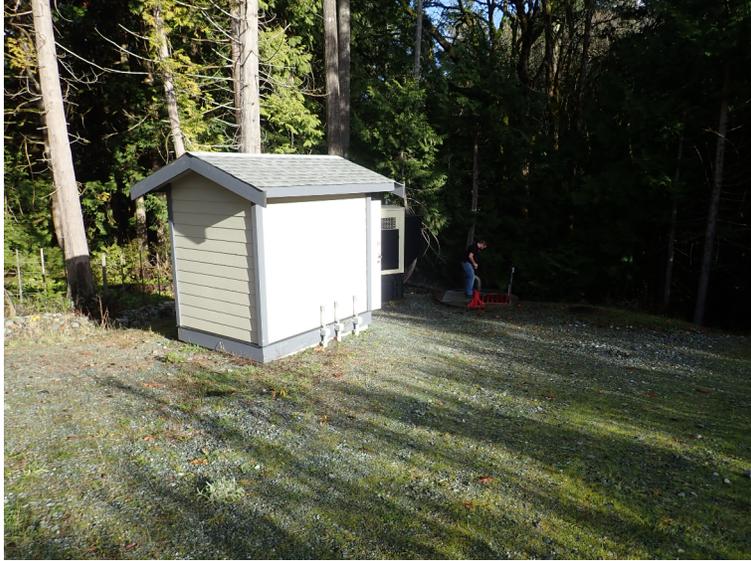
Photo 1

Sentinel Ridge Sewer - Lift Station 2	Sewer Building	802	A Substructure	A10 Foundations	A1030 Slab on Grade	A103001 Standard Slab on Grade	Interior of Building At-Grade/ Slab-on-Grade		1	The floor is concrete slab-on-grade (polished concrete throughout). Isolated hairline cracking was observed. No evidence of major settlement or heaving was reported or observed.	5	5	2010	21-Nov-17	MH	8	50	42	The concrete slab-on-grade is expected to remain serviceable for the life of the building, with isolated repairs, if needed. No capital expenses associated with this item are expected.	Not Applicable	Not Applicable	Yes	Yes	Yes	No	70	\$10	SF	\$700	0%	5%	5%	\$1,000
Sentinel Ridge Sewer - Lift Station 2	Sewer Building	802	B Shell	B10 Superstructure	B10 Superstructure	B10 Superstructure	Interior of Building/ General Superstructure		1	The superstructure is comprised of wood framing on all four walls and roof trusses, supported on a cast-in-place concrete foundation.  No settlement or other evidence of structural distress was observed or reported. There was no evidence or reports of long-term leakage that would allude to concealed structural damage.	5	5	2010	21-Nov-17	MH	8	50	42	Interior protected structural components are expected to last the life of the building. No major capital expenditures are expected to be required.	Not Applicable	Not Applicable	Yes	Yes	Yes	No	70	\$40	SF	\$2,800	0%	5%	5%	\$4,000

Sentinel Ridge Sewer - Lift Station 2	Sewer Building	802	B Shell	B20 Exterior Enclosure	B2010 Exterior Walls	B201001 Exterior Enclosure	Exterior Walls/ Cementitious Siding		1	Painted cementitious siding and wood trim are present on the exterior walls.	4	4	2010	21-Nov-17	MH	8	12	5	Repaint siding and trim.  At the time of painting, replace sealant joints and wood trim as required.	Repair Allowance	3 - Future Renewal	Yes	Yes	No	No	200	\$8	SF	\$1,600	0%	15%	5%	\$2,000
Sentinel Ridge Sewer - Lift Station 2	Sewer Building	802	B Shell	B20 Exterior Enclosure	B2010 Exterior Walls	B201001 Exterior Enclosure	Exterior Walls/ Cementitious Siding		1	Painted cementitious siding and wood trim are present on the exterior walls.	5	5	2010	21-Nov-17	MH	8	50	42	The cementitious siding is expected to last the life of the building.  Note: isolated sealant and wood trim replacement should be completed as part of the ongoing painting.	Replacement	3 - Future Renewal	Yes	Yes	No	No	200	\$35	SF	\$7,000	0%	5%	5%	\$8,000

Sentinel Ridge Sewer - Lift Station 2	Sewer Building	802	B Shell	B20 Exterior Enclosure	B2010 Exterior Walls	B201001 Exterior Enclosure	Exterior Walls/ Soffit		1	Perforated metal soffit is present at the roof overhangs.	5	5	2010	21-Nov-17	MH	8	50	42	The perforated metal soffit is expected to last the life of the building. No capital expenses associated with this item are expected.	Replacement	3 - Future Renewal	Yes	Yes	No	No	20	\$20	SF	\$400	0%	10%	5%	\$1,000
Sentinel Ridge Sewer - Lift Station 2	Sewer Building	802	B Shell	B20 Enclosure	B2030 Exterior Doors	B203001 Solid Doors	Exterior Walls/ Door		1	Two painted metal doors are present on the building.	5	5	2010	21-Nov-17	MH	8	30	22	Replace doors at the end of their service life.	Replacement	3 - Future Renewal	Yes	Yes	No	No	1	\$500	EA	\$500	0%	5%	5%	\$1,000
Sentinel Ridge Sewer - Lift Station 2	Sewer Building	802	B Shell	B30 Roofing	B3010 Roof Coverings	B301001 High Slope Roof Coverings	Roof/Sloped Roof Assembly		1	The roof is sloped assembly which has been waterproofed with asphalt shingles.	5	5	2010	21-Nov-17	MH	8	25	17	Replace the asphalt shingle assembly at the end of its service life.  Ongoing maintenance of the roof should include review of all exposed fasteners and resealing of penetrations.	Replacement	3 - Future Renewal	No	Yes	No	No	80	\$30	SF	\$2,400	0%	5%	5%	\$3,000

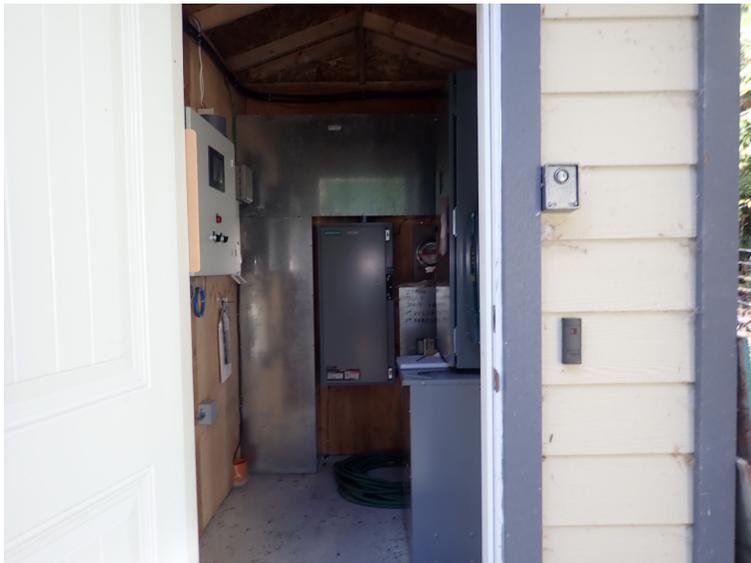
Photo 2

Sentinel Ridge Sewer - Lift Station 2	Sewer Building	802	C Interiors	C30 Interior Finishes	C3010 Wall Finishes	C301003 Gypsum Wallboard Finishes	Interior/Interior Finishes		2	The interior gypsum and plywood walls and ceilings are painted.	5	5	2010	21-Nov-17	MH	8	20	12	Repaint interiors as required.  Note: a long service life has been included to reflect building usage.	Repair Allowance	3 - Future Renewal	Yes	Yes	No	No	1	\$500	LS	\$500	0%	0%	5%	\$1,000
Sentinel Ridge Sewer - Lift Station 2	Sewer Building	802	C Interiors	D50 Electrical	D5020 Lighting and Branch Wiring	Exterior Lighting Equipment	Exterior Lighting Equipment			An exterior light is present on the building near the entrance.	5	5	2010	21-Nov-17	MH	8	20	13	Repalce lights at the end of their service life.	Replacement	3 - Future Renewal	Yes	Yes	No	No	1	\$200	LS	\$200	0%	0%	5%	\$1,000

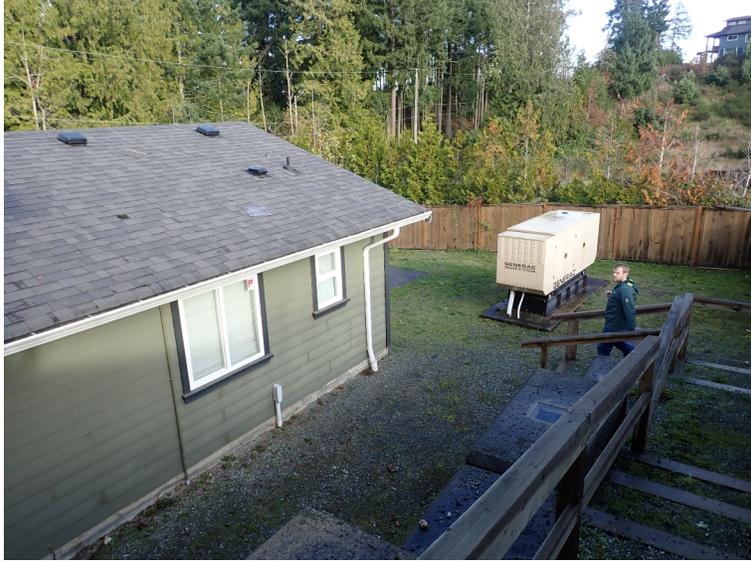
Photo 1

Sentinel Ridge Sewer - Sewer Treatment Plant	Sewer Building	802	A Substructure	A10 Foundations	A1030 Slab on Grade	A103001 Standard Slab on Grade	Interior of Building At-Grade/ Slab-on-Grade	1	The floor is concrete slab-on-grade (polished concrete throughout). Isolated hairline cracking was observed. No evidence of major settlement or heaving was reported or observed.	5	5	2013	21-Nov-17	MH	5	50	45	The concrete slab-on-grade is expected to remain serviceable for the life of the building, with isolated repairs, if needed. No capital expenses associated with this item are expected.	Not Applicable	Not Applicable	Yes	Yes	Yes	No	800	\$30	SF	\$24,000	0%	5%	5%	\$27,000
Sentinel Ridge Sewer - Sewer Treatment Plant	Sewer Building	802	A Substructure	A10 Foundations	A1030 Slab on Grade	A103006 Foundation Drainage	Underground/ Perimeter Drains	1	Perimeter drain pipes are assumed to be installed at the footing level. No issues related to foundation drainage were noted by facility staff. No information was available regarding the scoping of the system to review for continuity.	5	5	2013	21-Nov-17	MH	5	10	5	Periodic camera inspection and isolated repairs as required.	Study	Not Applicable	No	N/A	No	N/A	1	\$500	LS	\$500	0%	0%	5%	\$1,000

Sentinel Ridge Sewer - Sewer Treatment Plant	Sewer Building	802	A Substructure	A10 Foundations	A1030 Slab on Grade	A103006 Foundation Drainage	Underground/ Perimeter Drains	1	Perimeter drain pipes are assumed to be installed at the footing level. No issues related to foundation drainage were noted by facility staff. No information was available regarding the scoping of the system to review for continuity.	5	5	2013	21-Nov-17	MH	5	50	45	The foundation drainage is expected to last the life of the building. No major capital expenditures are expected to be required.  Note: this should be updated with the results of the foundation drainage review recommended in A103006 Foundation Drainage (above).	Contingency	3 - Future Renewal	N/A	N/A	No	No								
Sentinel Ridge Sewer - Sewer Treatment Plant	Sewer Building	802	B Shell	B10 Superstructure	B10 Superstructure	B10 Superstructure	Interior of Building/ General Superstructure	1	The superstructure is comprised of wood framing on all four walls and roof trusses, supported on a cast-in-place concrete foundation.  No settlement or other evidence of structural distress was observed or reported. There was no evidence or reports of long-term leakage that would allude to concealed structural damage.	5	5	2013	21-Nov-17	MH	5	50	45	Interior protected structural components are expected to last the life of the building. No major capital expenditures are expected to be required.	Not Applicable	Not Applicable	Yes	Yes	Yes	No	800	\$30	SF	\$24,000	0%	5%	5%	\$27,000

Sentinel Ridge Sewer - Sewer Treatment Plant	Sewer Building	802	B Shell	C820 Exterior Enclosure	B2010 Exterior Walls	B201001 Exterior Enclosure	Exterior Walls/ Cementitious Siding	1	Painted cementitious siding and wood trim are present on the exterior walls.	4	4	2013	21-Nov-17	MH	5	12	7	Repaint siding and trim.  At the time of painting, replace sealant joints and wood trim as required.	Repair Allowance	3 - Future Renewal	Yes	Yes	No	No	800	\$8	SF	\$6,400	0%	15%	5%	\$8,000
Sentinel Ridge Sewer - Sewer Treatment Plant	Sewer Building	802	B Shell	C820 Exterior Enclosure	B2010 Exterior Walls	B201001 Exterior Enclosure	Exterior Walls/ Cementitious Siding	1	Painted cementitious siding and wood trim are present on the exterior walls.	5	5	2013	21-Nov-17	MH	5	50	45	The cementitious siding is expected to last the life of the building.  Note: isolated sealant and wood trim replacement should be completed as part of the ongoing painting.	Replacement	3 - Future Renewal	Yes	Yes	No	No	800	\$35	SF	\$28,000	0%	5%	5%	\$31,000

Sentinel Ridge Sewer - Sewer Treatment Plant	Sewer Building	802	B Shell	C820 Exterior Enclosure	B2010 Exterior Walls	B201001 Exterior Enclosure	Exterior Walls/ Soffit	1	Perforated metal soffit is present at the roof overhangs.	5	5	2013	21-Nov-17	MH	5	50	43	The perforated metal soffit is expected to last the life of the building. No capital expenses associated with this item are expected.	Replacement	3 - Future Renewal	Yes	Yes	No	No	100	\$20	SF	\$2,000	0%	10%	5%	\$3,000
Sentinel Ridge Sewer - Sewer Treatment Plant	Sewer Building	802	B Shell	C820 Exterior Enclosure	B2020 Exterior Windows	B202001 Windows	Exterior Walls/Windows	1	Two vinyl framed windows are present on the building.	5	5	2013	21-Nov-17	MH	5	25	20	Replace windows at the end of their service life.	Replacement	3 - Future Renewal	Yes	Yes	No	No	2	\$200	EA	\$400	0%	10%	5%	\$1,000
Sentinel Ridge Sewer - Sewer Treatment Plant	Sewer Building	802	B Shell	B20 Enclosure	E2030 Exterior Doors	B203001 Solid Doors	Exterior Walls/ Door	1	One painted metal door is present on the building.	5	5	2013	21-Nov-17	MH	5	30	25	Replace door at the end of its service life.	Replacement	3 - Future Renewal	Yes	Yes	No	No	1	\$1,500	EA	\$1,500	0%	5%	5%	\$2,000

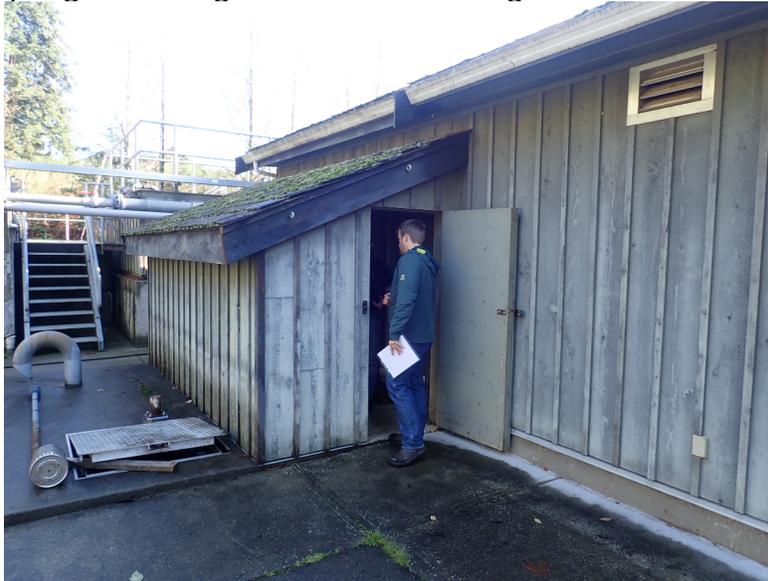
Photo 1

Mill Springs - Sewage Treatment Building	Sewage Treatment Building	813	A Substructure	A10 Foundations	A1030 Slab on Grade	A103001 Standard Slab on Grade	Interior of Building At-Grade/ Slab-on-Grade	1	The floor is concrete slab-on-grade (polished concrete throughout). Isolated hairline cracking was observed. No evidence of major settlement or heaving was reported or observed.	4	4	2013	21-Nov-17	MH	5	50	45	The concrete slab-on-grade is expected to remain serviceable for the life of the building. No capital expenses associated with this item are expected.	Not Applicable	Not Applicable	Yes	Yes	Yes	No	1300	\$10	SF	\$13,000	0%	5%	5%	\$15,000
Mill Springs - Sewage Treatment Building	Sewage Treatment Building	813	A Substructure	A10 Foundations	A1030 Slab on Grade	A103006 Foundation Drainage	Underground/ Perimeter Drains	1	Perimeter drain pipes are assumed to be installed at the footing level. No issues related to foundation drainage were noted by facility staff. No information was available regarding the scoping of the system to review for continuity.	4	4	2013	21-Nov-17	MH	5	10	5	Periodic camera inspection and isolated repairs as required.	Study	Not Applicable	No	N/A	No	N/A	1	\$500	LS	\$500	0%	0%	5%	\$1,000

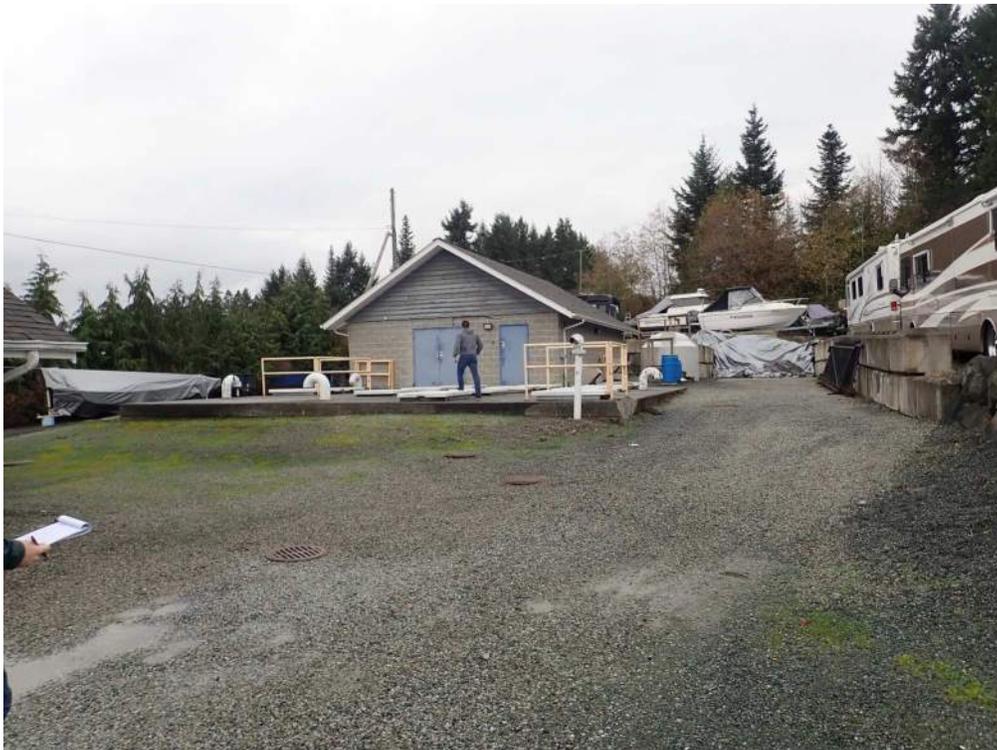
815 (26)  
13 of 20

1) Type of Treatment System (Schematic) Disposal Field  
old RBL never wanted (to be replaced)  
↳ bio film was accumulating ↳ in runs backfilled w/ 1/2 drain rock.  
↳ cleaned out ↳ closing drain pipe

2) Site Conditions/Security  
↳ had issues w/ break-out due to no drain rock under pipes.

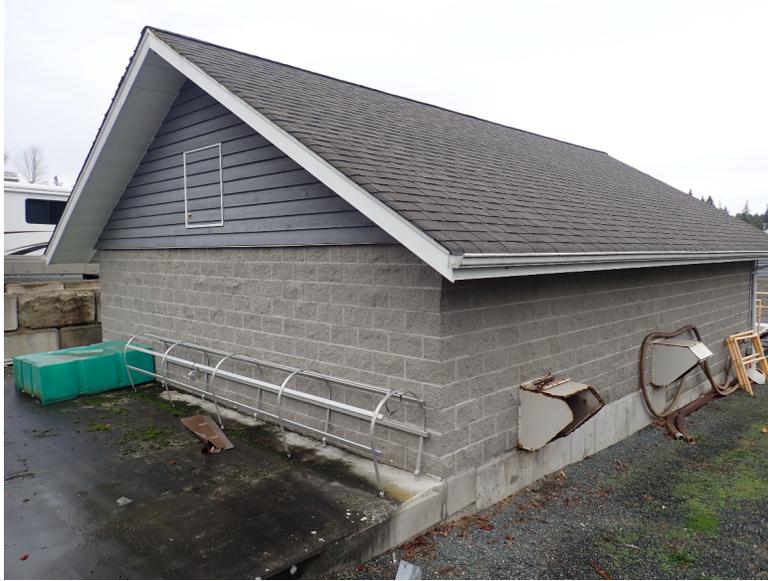
Photo 1

Arbutus Ridge -Sewer - Functional Code 815

Arbutus Ridge - Sewage Treatment Building (1 & 2)	Sewage Treatment Building	815	A Substructure	A10 Foundations	A1030 Slab on Grade	A103001 Standard Slab on Grade	Interior of Building At-Grade/ Slab-on-Grade	1	The floor is concrete slab-on-grade. Isolated hairline cracking was observed. No evidence of major settlement or heaving was reported or observed.	4	4	2008	21-Nov-17	MH	10	50	40	The concrete slab-on-grade is expected to remain serviceable for the life of the building, with isolated repairs, if needed. No capital expenses associated with this item are expected.	Not Applicable	Not Applicable	Yes	Yes	Yes	No	1600	\$8	SF	\$12,800	0%	5%	5%	\$15,000
Arbutus Ridge - Sewage Treatment Building (1 & 2)	Sewage Treatment Building	815	A Substructure	A10 Foundations	A1030 Slab on Grade	A103006 Foundation Drainage	Underground/ Perimeter Drains	1	Perimeter drain pipes are assumed to be installed at the footing level. No issues related to foundation drainage were noted by facility staff. No information was available regarding the scoping of the system to review for continuity.	4	4	2008	21-Nov-17	MH	10	10	2	Periodic camera inspection and isolated repairs as required.	Study	Not Applicable	No	N/A	No	N/A	2	\$500	LS	\$1,000	0%	0%	5%	\$2,000

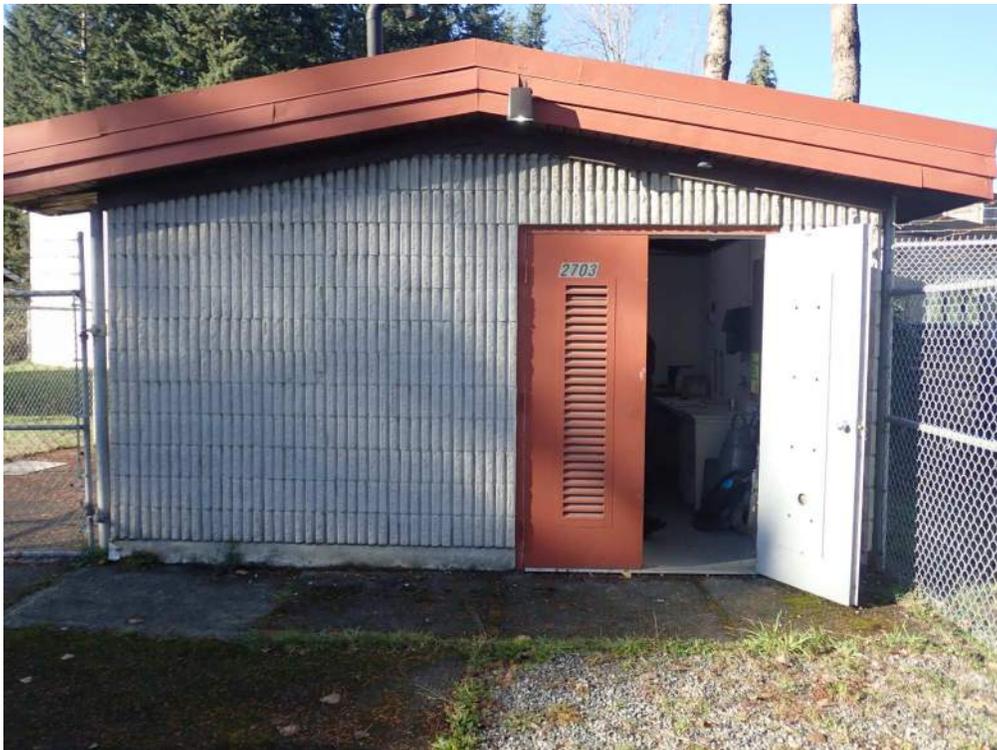
820 (1)

1) Site Conditions  
- 20' above from neighbouring fenced area

2) Building Conditions  
- site security

3) Condition of wet well:  
visible Deterioration of structure and hatch:

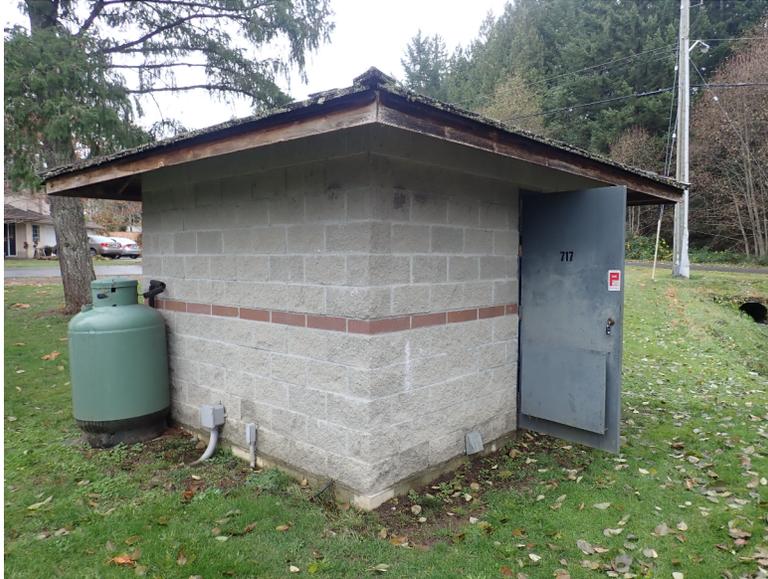
Photo 1

Maple Hill -Lift Station	Sewage Treatment Building	830	C Interiors	D50 Electrical	D5020 Lighting and Branch Wiring	D502002 Lighting Equipment	Exterior Lighting Equipment		An exterior light is present on the building near the entrance.	4	4	2000	21-Nov-17	MH	18	20	10	Replace lights at the end of their service life.	Replacement	3 - Future Renewal	Yes	Yes	No	No	1	\$200	LS	\$200	0%	0%	5%	\$1,000

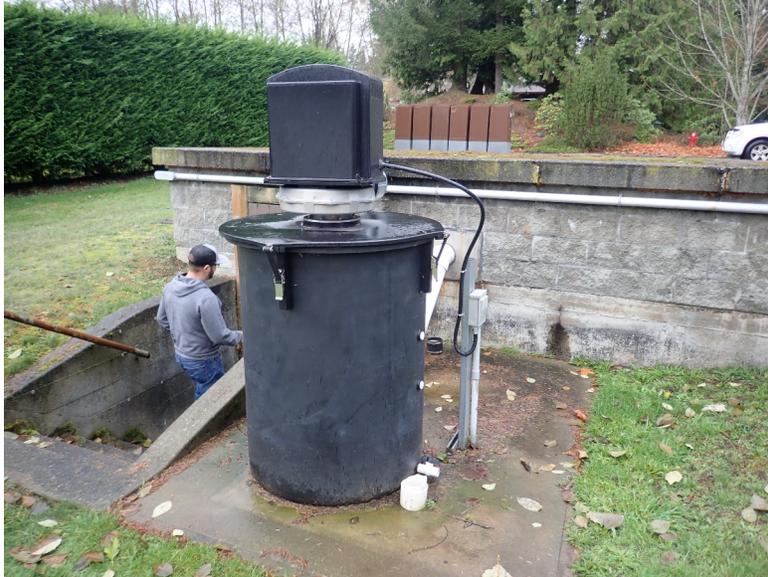
Photo 1

Maple Hill - Sewage Treatment Building	Sewage Treatment Building	830	A Substructure	A10 Foundations	A1030 Slab on Grade	A103001 Standard Slab on Grade	Interior of Building At-Grade/ Slab-on-Grade	1	The floor is concrete slab-on-grade. Isolated hairline cracking was observed. No evidence of major settlement or heaving was reported or observed.	4	4	1990	21-Nov-17	MH	28	50	22	The concrete slab-on-grade is expected to remain serviceable for the life of the building, with isolated repairs, if needed. No capital expenses associated with this item are expected.	Not Applicable	Not Applicable	Yes	Yes	Yes	No	150	\$10	SF	\$1,500	0%	5%	5%	\$2,000
Maple Hill - Sewage Treatment Building	Sewage Treatment Building	830	B Shell	B10 Superstructure	B10 Superstructure	B10 Superstructure	Interior of Building/ General Superstructure	1	The superstructure is comprised of masonry blocks. Some efflorescence was noted on the interior; however, MH understands that active leaks are present. No settlement or other evidence of structural distress was observed or reported. There was no evidence or reports of long-term leakage that would allude to concealed structural damage.	4	4	1990	21-Nov-17	MH	28	50	22	Masonry structural components are expected to last the life of the building. A contingency budget has been included for isolated mortar joint replacement and sealant replacement throughout the cinder block assemblies.	Repair Allowance	3 - Future Renewal	Yes	Yes	Yes	No	1	\$2,000	EA	\$2,000	0%	10%	5%	\$3,000

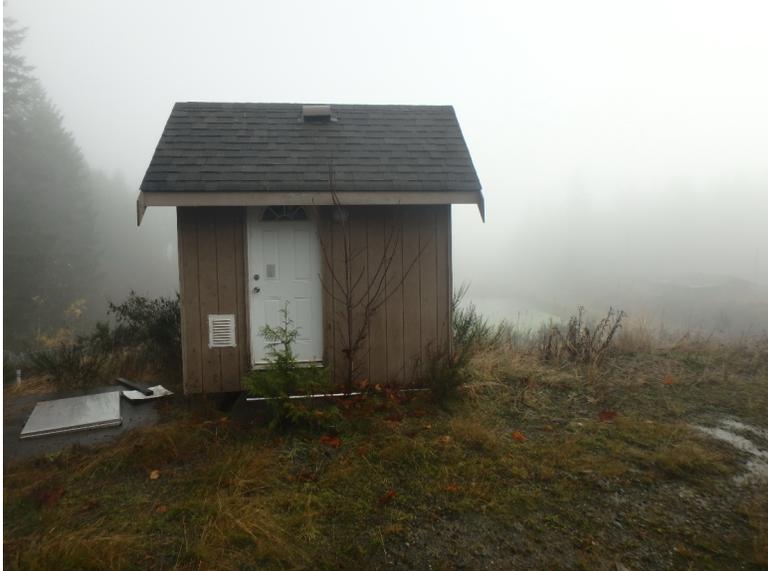
Photo 1

Shawnigan Beach - Lift Station - Functional Code 840

Shawinigan Beach - Lift Station	Sewage Building	840	A Substructure	A10 Foundations	A1030 Slab on Grade	A103001 Standard Slab on Grade	Interior of Building At-Grade/ Slab-on-Grade	1	The floor is concrete slab-on-grade (polished concrete throughout). Isolated hairline cracking was observed. No evidence of major settlement or heaving was reported or observed.	4	4	2010	21-Nov-17	MH	8	50	42	The concrete slab-on-grade is expected to remain serviceable for the life of the building. No capital expenses associated with this item are expected.	Not Applicable	Not Applicable	Yes	Yes	Yes	No	50	\$10	SF	\$500	0%	5%	5%	\$1,000
Shawinigan Beach - Lift Station	Sewage Building	840	B Shell	B10 Superstructure	B10 Superstructure	B10 Superstructure	Interior of Building/ General Superstructure	1	The superstructure is comprised of wood framing on all four walls and roof trusses, supported on a cast-in-place concrete foundation.  No settlement or other evidence of structural distress was observed or reported. There was no evidence or reports of long-term leakage that would allude to concealed structural damage.	4	4	2010	21-Nov-17	MH	8	50	42	Interior protected structural components are expected to last the life of the building. No major capital expenditures are expected to be required.	Not Applicable	Not Applicable	Yes	Yes	Yes	No	50	\$40	SF	\$2,000	0%	5%	5%	\$3,000

Shawinigan Beach - Lift Station	Sewage Building	840	B Shell	CB20 Exterior Enclosure	B2010 Exterior Walls	B201001 Exterior Enclosure	Exterior Walls/ Cementitious Siding	1	Painted cementitious siding and wood trim are present on the exterior walls.	4	4	2010	21-Nov-17	MH	8	12	7	Repair siding and trim.  At the time of painting, replace sealant joints and wood trim as required.	Repair Allowance	3 - Future Renewal	Yes	Yes	No	No	160	\$8	SF	\$1,280	0%	15%	5%	\$2,000
Shawinigan Beach - Lift Station	Sewage Building	840	B Shell	CB20 Exterior Enclosure	B2010 Exterior Walls	B201001 Exterior Enclosure	Exterior Walls/ Cementitious Siding	1	Painted cementitious siding and wood trim are present on the exterior walls.	4	4	2010	21-Nov-17	MH	8	50	42	The cementitious siding is expected to last the life of the building.  Note: isolated sealant and wood trim replacement should be completed as part of the ongoing painting.	Replacement	3 - Future Renewal	Yes	Yes	No	No	160	\$35	SF	\$5,600	0%	5%	5%	\$7,000

Shawinigan Beach - Lift Station	Sewage Building	840	B Shell	CB20 Exterior Enclosure	B2010 Exterior Walls	B201001 Exterior Enclosure	Exterior Walls/ Soffit	1	Perforated metal soffit is present at the roof overhangs.	4	4	2010	21-Nov-17	MH	8	50	42	The perforated metal soffit is expected to last the life of the building. No capital expenses associated with this item are expected.	Replacement	3 - Future Renewal	Yes	Yes	No	No	40	\$20	SF	\$800	0%	10%	5%	\$1,000
Shawinigan Beach - Lift Station	Sewage Building	840	B Shell	B20 Enclosure	E2030 Exterior Doors	B203001 Solid Doors	Exterior Walls/ Door	1	A painted metal door is present on the building.	4	4	2010	21-Nov-17	MH	8	30	22	Replace door at the end of its service life.	Replacement	3 - Future Renewal	Yes	Yes	No	No	1	\$1,000	EA	\$1,000	0%	5%	5%	\$2,000
Shawinigan Beach - Lift Station	Sewage Building	840	B Shell	D30 Roofing	B3010 Roof Coverings	B301001 High Slope Roof Coverings	Roof/Sloped Roof Assembly	1	The roof is standing seam metal roof. A snow guard is present over the doors.  The roof drains via aluminum gutters to rain water leaders that drain into below grade piping.	4	4	2010	21-Nov-17	MH	8	40	32	Replace the metal roof at the end of its service life.  Ongoing maintenance of the roof should include review of all exposed fasteners and resealing of penetrations.	Replacement	3 - Future Renewal	No	Yes	No	No	50	\$30	SF	\$1,500	0%	5%	5%	\$2,000

Shawinigan Beach - Lift Station	Sewage Building	840	B Shell	D30 Roofing	B3010 Roof Coverings	B301001 High Slope Roof Coverings	Roof/Sloped Roof Assembly	1	The roof is standing seam metal roof. A snow guard is present over the doors.  The roof drains via aluminum gutters to rain water leaders that drain into below grade piping.	4	4	2010	21-Nov-17	MH	8	25	17	Replace gutters at the end of their service life.	Replacement	3 - Future Renewal	Yes	Yes	No	No	10	\$10	SF	\$100	0%	10%	5%	\$1,000
Shawinigan Beach - Lift Station	Sewage Building	840	C Interiors	D50 Electrical	D5020 Lighting and Branch Wiring	D502002 Lighting Equipment	Exterior Lighting Equipment		An exterior light is present on the building near the entrance.	4	4	2010	21-Nov-17	MH	8	20	12	Replace lights at the end of their service life.	Replacement	3 - Future Renewal	Yes	Yes	No	No	1	\$200	LS	\$200	0%	0%	5%	\$1,000

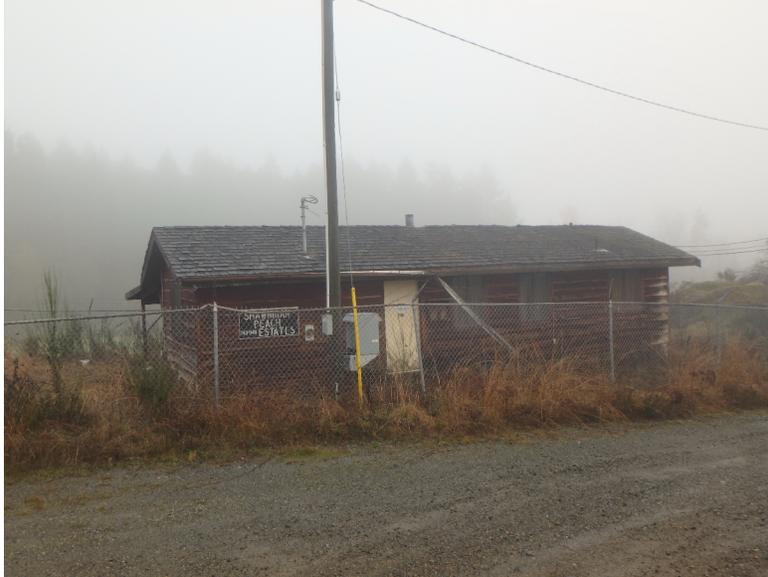
Photo 1

hawnigan Beach - Office Building - Functional Code 840

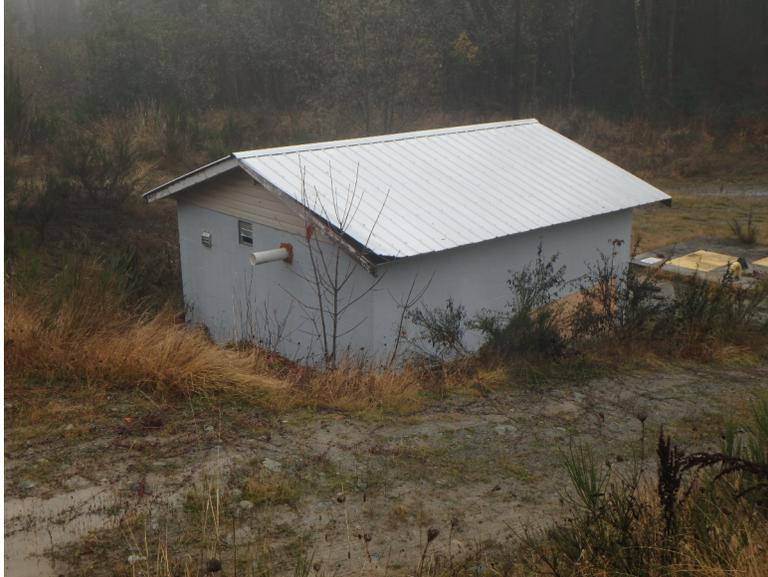
Photo 1

Shawnigan Beach - Sewage Treatment Plant - Functional Code 840

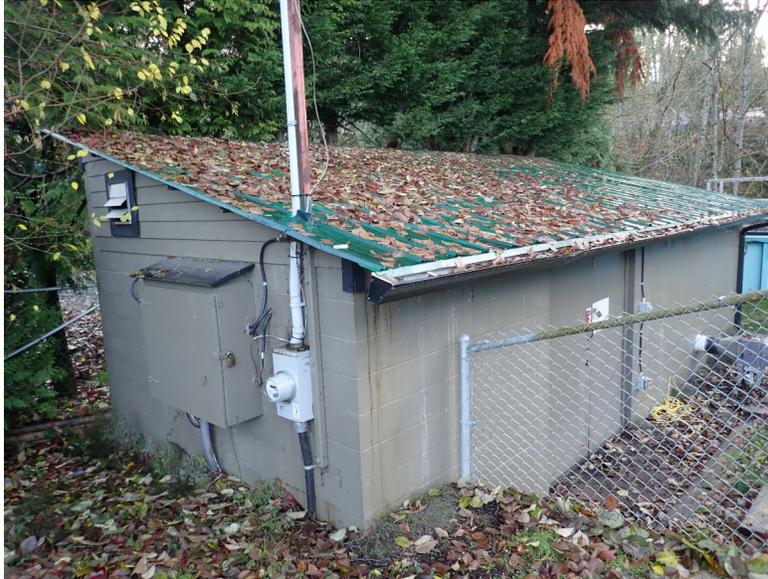
Photo 1

Kerry Village - Lift Station	Lift Station	850	B Shell	B10 Superstructure	B10 Superstructure	B10 Superstructure	Interior of Building/ General Superstructure		1	The superstructure is comprised of masonry blocks with a wood framed roof. Some efflorescence was noted on the interior; however, MH understands that no active leaks are present.  The masonry blocks have been painted.	4	4	2014	21-Nov-17	MH	4	12	8	Repaint masonry blocks.	Repair Allowance	3 - Future Renewal	Yes	Yes	Yes	No	1	\$2,000	EA	\$2,000	0%	10%	5%	\$3,000
Kerry Village - Lift Station	Lift Station	850	B Shell	B20 Exterior Enclosure	B2010 Exterior Walls	B201001 Exterior Enclosure	Exterior Walls/Wood Elements		1	Wood cladding and wood trim (included roof framing) is present through sections of the building. The wood cladding sections appear to be retrofit areas. Some deterioration was noted in these elements.	4	4	2014	21-Nov-17	MH	4	12	8	Repaint wood cladding, install flashing over exposed wood roof framing.	Replacement	3 - Future Renewal	Yes	Yes	No	No	1	\$1,500	EA	\$1,500	0%	10%	5%	\$2,000

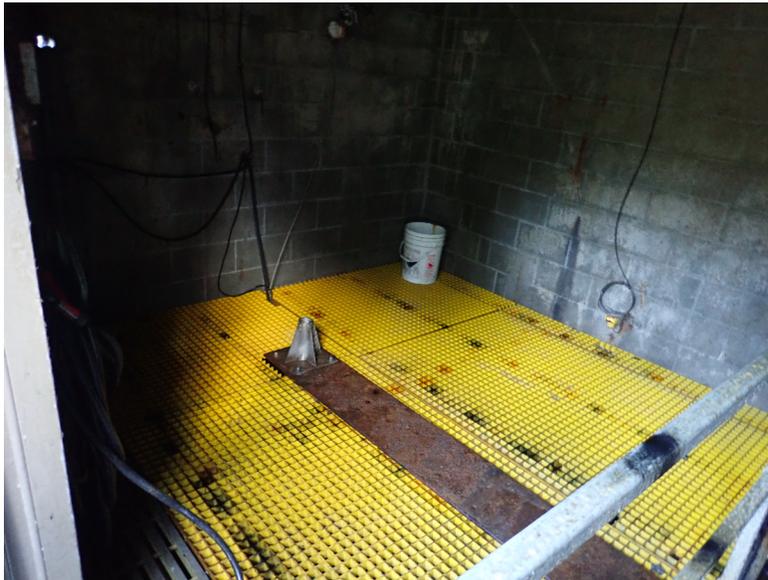
Photo 2

Kerry Village - Lift Station	Lift Station	850	B Shell	B20 Enclosure	B2030 Exterior Doors	B203001 Solid Doors	Exterior Walls/ Door		1	A painted metal door (double door) is present on the building.	4	4	2014	21-Nov-17	MH	4	30	26	Replace doors at the end of their service life.	Replacement	3 - Future Renewal	Yes	Yes	No	No	1	\$1,500	EA	\$1,500	0%	5%	5%	\$2,000
Kerry Village - Lift Station	Lift Station	850	B Shell	D30 Roofing	B3010 Roof Coverings	B301001 High Slope Roof Coverings	Roof/Metal Roof Assembly		1	The roof is sloped assembly which has been waterproofed with a metal roof assembly.  The roof is edge drained.	4	4	2014	21-Nov-17	MH	4	30	26	Replace metal roofing at the end of its service life.  Ongoing maintenance of the roof should include review of all penetrations when required.	Replacement	3 - Future Renewal	No	Yes	No	No	110	\$30	SF	\$3,300	0%	5%	5%	\$4,000
Kerry Village - Lift Station	Lift Station	850	C Interiors	D50 Electrical	D5020 Lighting and Branch Wiring	D502002 Lighting Equipment	Exterior Lighting Equipment			An exterior light is present on the building near the entrance.	4	4	2014	21-Nov-17	MH	4	20	16	Replace lights at the end of their service life.	Replacement	3 - Future Renewal	Yes	Yes	No	No	1	\$200	LS	\$200	0%	0%	5%	\$1,000

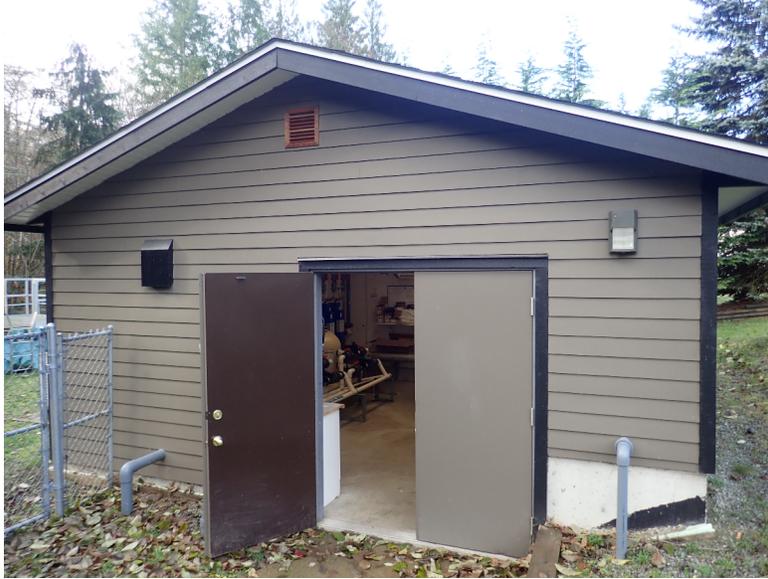
Photo 1

Kerry Village - Water Treatment Building	Water Treatment Building	850	B Shell	CB20 Exterior Enclosure	B2010 Exterior Walls	B201001 Exterior Enclosure	Exterior Walls/ Cementitious Siding	1	Painted cementitious siding and wood trim are present on the exterior walls.	4	4	2010	21-Nov-17	MH	8	12	7	Repair siding and trim.  At the time of painting, replace sealant joints and wood trim as required.	Repair Allowance	3- Future Renewal	Yes	Yes	No	No	550	\$7	SF	\$3,850	0%	15%	5%	\$5,000
Kerry Village - Water Treatment Building	Water Treatment Building	850	B Shell	CB20 Exterior Enclosure	B2010 Exterior Walls	B201001 Exterior Enclosure	Exterior Walls/ Cementitious Siding	1	Painted cementitious siding and wood trim are present on the exterior walls.	5	5	2010	21-Nov-17	MH	8	50	42	The cementitious siding is expected to last the life of the building.  Note: isolated sealant and wood trim replacement should be completed as part of the ongoing painting.	Replacement	3- Future Renewal	Yes	Yes	No	No	550	\$35	SF	\$19,250	0%	5%	5%	\$22,000

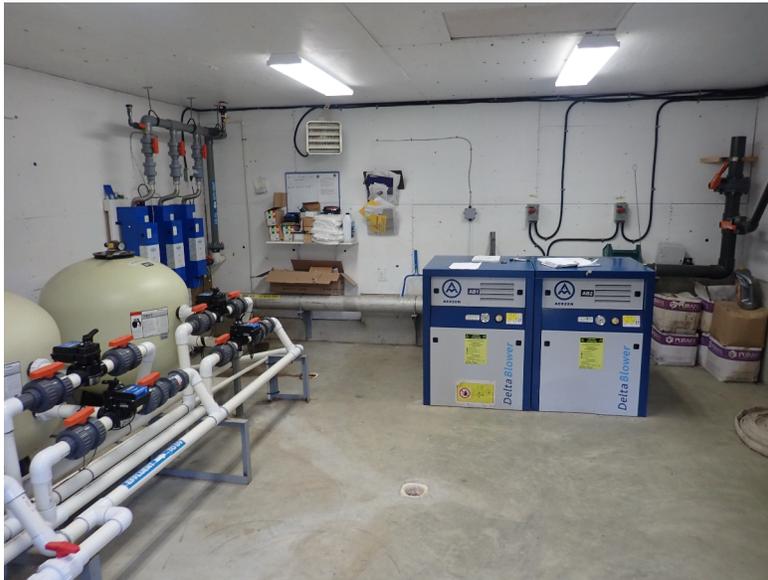
Photo 2

Kerry Village - Water Treatment Building	Water Treatment Building	850	B Shell	D30 Roofing	B3010 Roof Coverings	B301001 High Slope Roof Coverings	Roof/Sloped Roof Assembly	1	The roof is a sloped assembly with asphalt shingles installed.  The roof drains via aluminum gutters to rain water leaders that drain into below grade piping.	5	5	2010	21-Nov-17	MH	8	25	17	Replace gutters at the end of their service life.	Replacement	3- Future Renewal	Yes	Yes	No	No	60	\$10	SF	\$600	0%	10%	5%	\$1,000
Kerry Village - Water Treatment Building	Water Treatment Building	850	C Interiors	C30 Interior Finishes	C3010 Wall Finishes	C301003 Gypsum Wallboard Finishes	Interior/Interior Finishes	2	The interior gypsum and plywood walls and ceilings are painted.	5	5	2010	21-Nov-17	MH	8	20	12	Repaint interiors as required.  Note: a long service life has been included to reflect to building usage.	Repair Allowance	3- Future Renewal	Yes	Yes	No	No	1	\$2,500	LS	\$2,500	0%	0%	5%	\$3,000
