LOWER COWICHAN / KOKSILAH RIVER INTEGRATED FLOOD MANAGEMENT PLAN

FINAL REPORT

SEPTEMBER 2009

nhc northwest
hydraulic
consultants

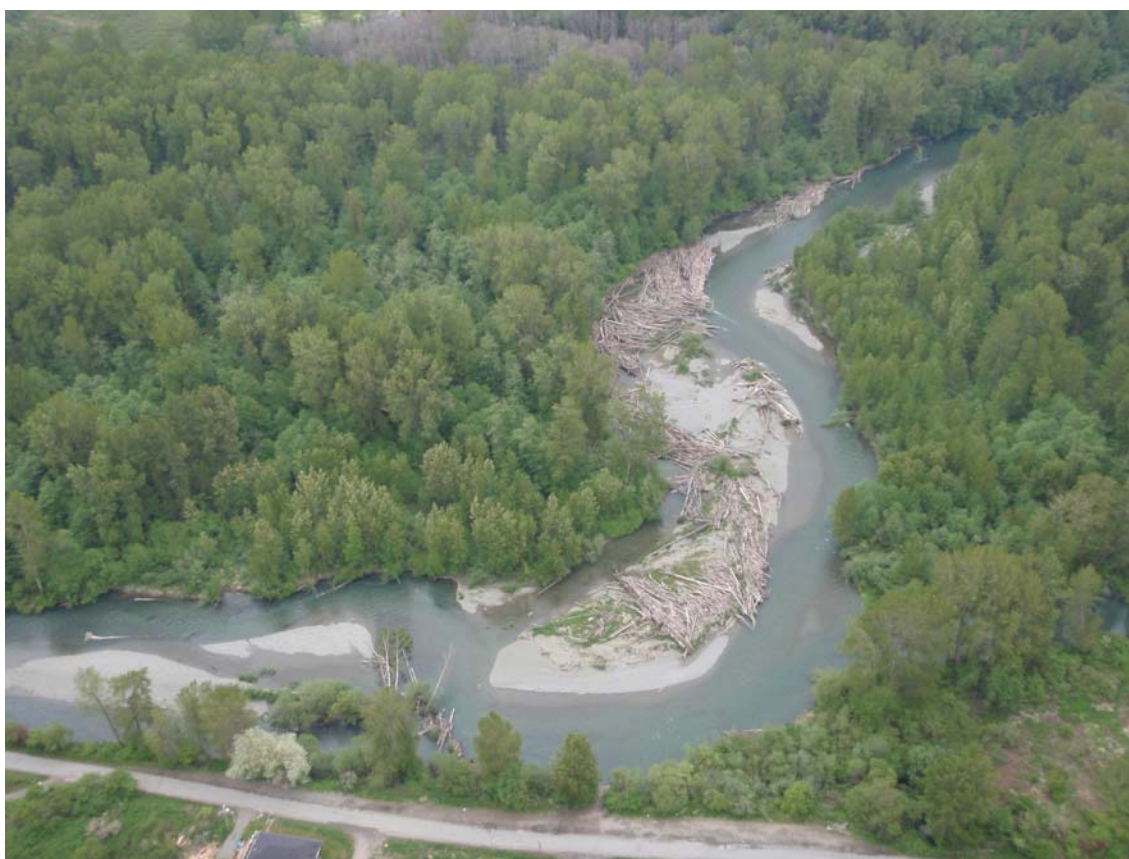
Photo 2.1: Aerial view of the Cowichan River mainstem illustrating mid channel bars at km 4.3 and 4.5 where gravel and debris accumulate and intact riparian habitat extends over both left and right banks with Quamichan Road in the foreground (May 08).

Intact riparian habitat provides important features that support biological diversity, structure and function on a floodplain (Photo 2.1). They also provide important migration corridors as well as important nesting and foraging habitat for wildlife species (black tailed deer, black bears, furbearers), and numerous species of waterfowl, shorebirds, songbirds and raptors. For example, mature cottonwood trees within riparian habitat along the Cowichan River provide critical roosting habitat for bald eagles during the fall season as well as important nesting habitat during the late winter and spring.

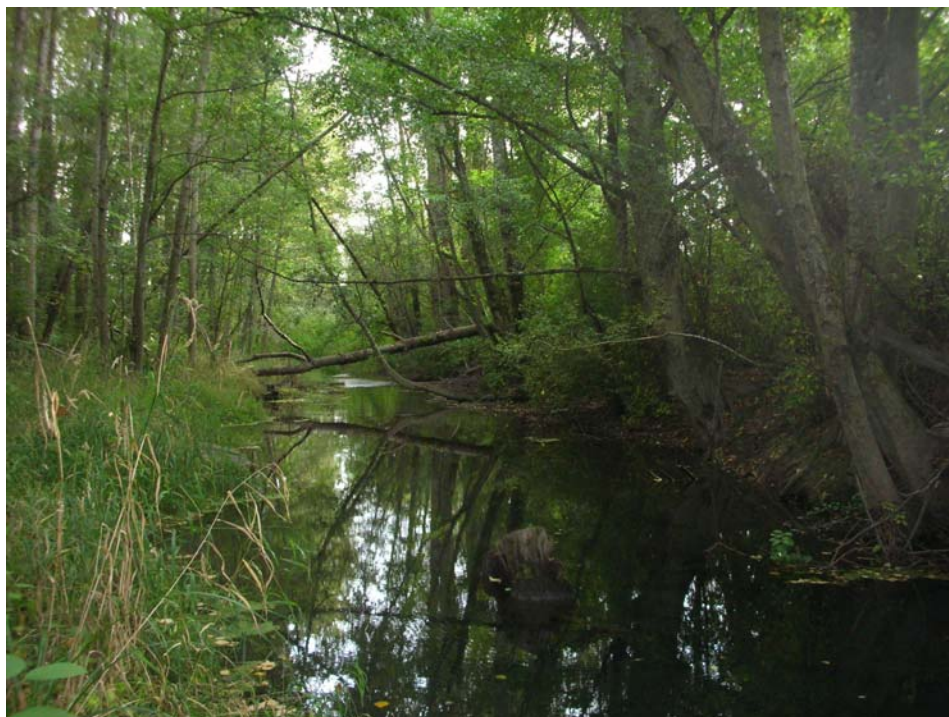
Photo 2.3: Downstream view of the Hatchery side-channel illustrating high value summer rearing habitat, intact riparian canopy with a bankfull width of 10 m and channel gradient of approx 0.5% (June 08).

Off-channel habitat consists of a matrix of side-channels, backwatered channels, off-channel ponds and sloughs which provide high quality fish habitat. Off-channel fish habitat typically provides a high quality refuge area during peak flows as well as stable overwintering habitat when the mainstem is subject to high flow periods. During summer low flows, off-channel fish habitat offers refuge to juveniles that migrate into the well-vegetated and groundwater fed off-channel habitat (Photo 2.2 to Photo 2.5, and Figure 2.10).

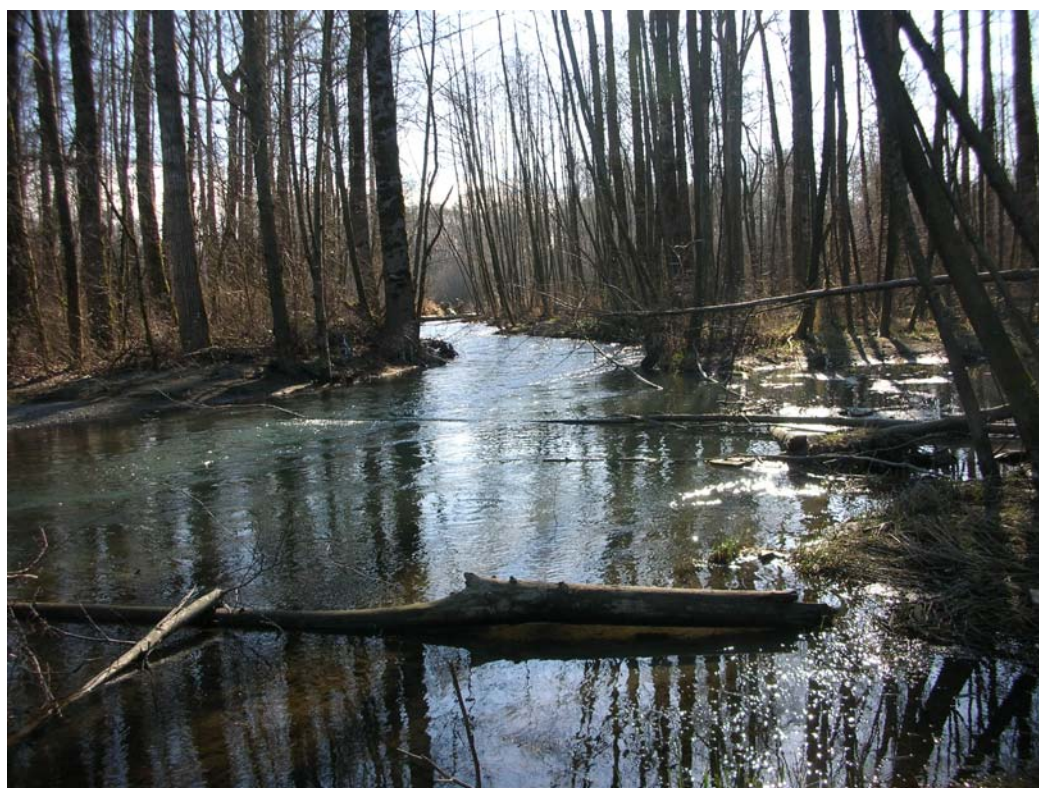
Photo 2.5: Overbank flooding at right bank near km 5.1 and flooding into Fish Gut alley at discharge of 33 m³/s. (February 17 09).

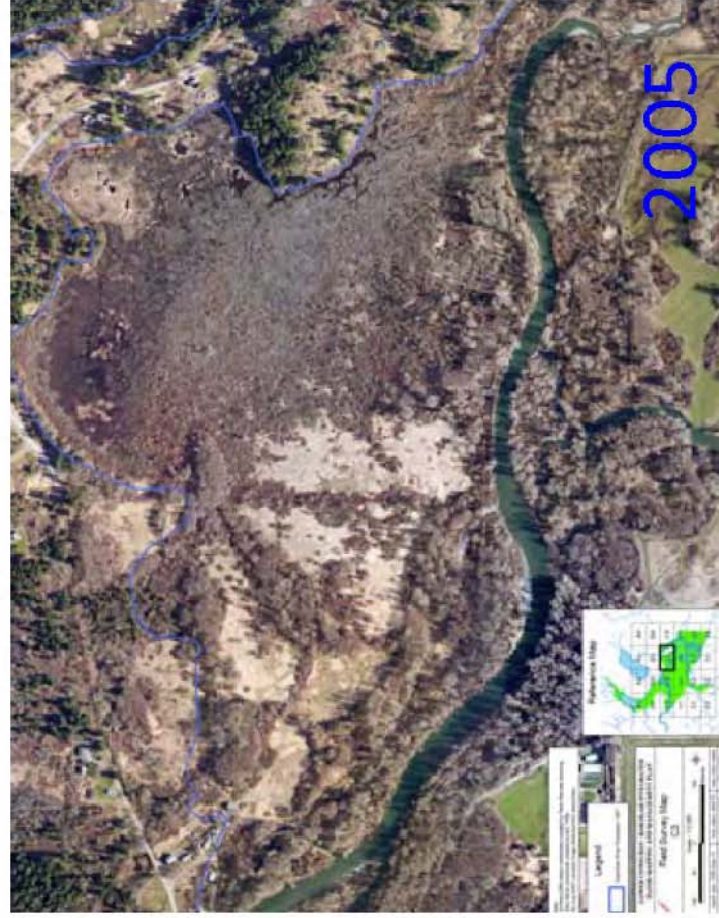
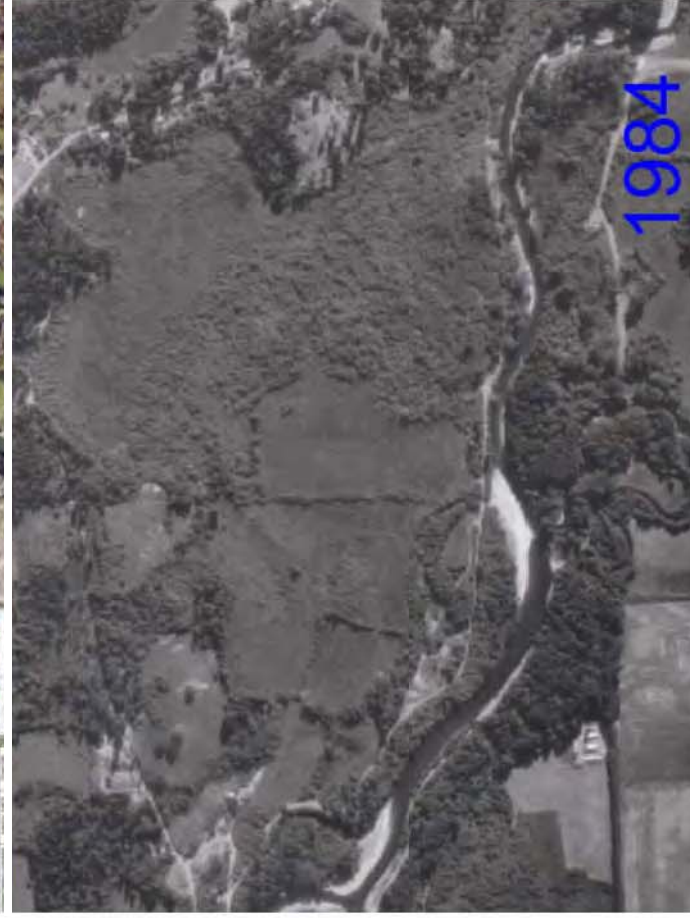
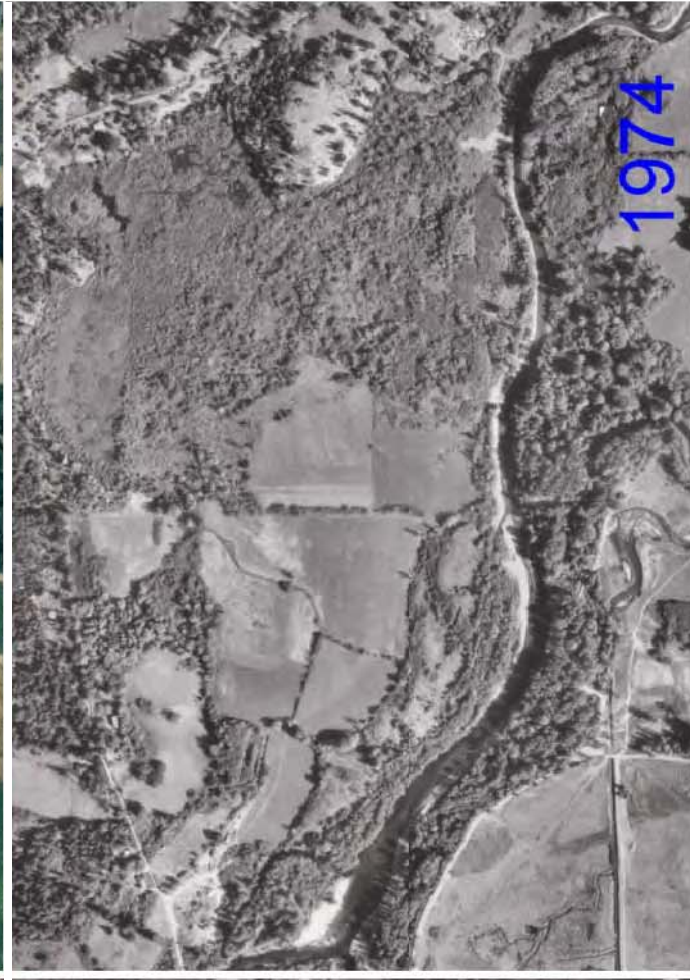
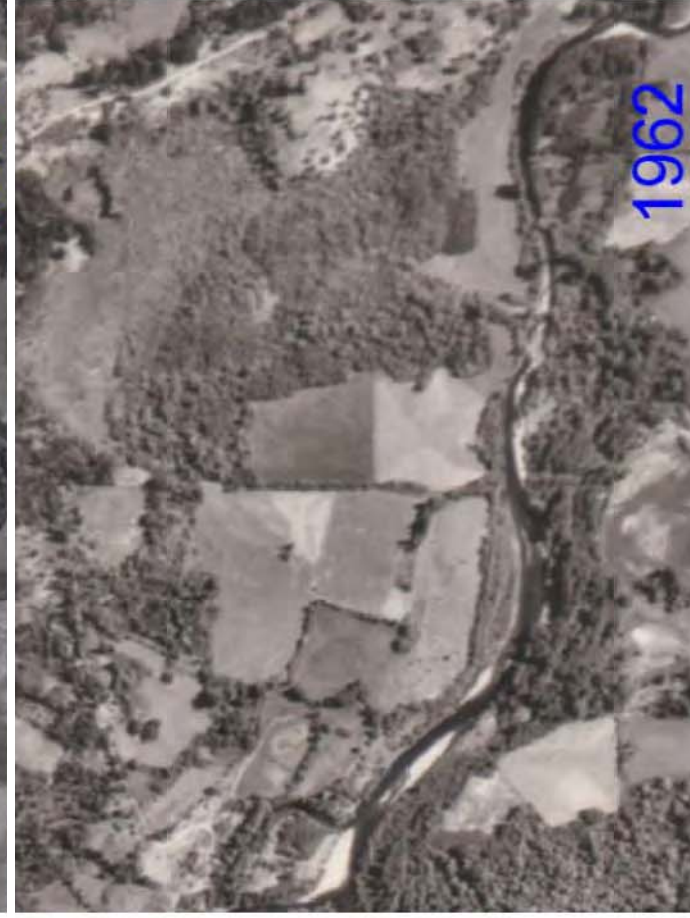
Based on reconnaissance level field sampling completed in 2008, soil and vegetation characteristics within Priest's Marsh are consistent with wetland ecosystems. In the early 1900s, farm settlement in the Priest's marsh area resulted in changes in landcover and drainage within the wetland (Figure 2.12). Priest's Marsh was historically dominated by facultative hydrophytes in the vegetation community and received seasonal inundation from

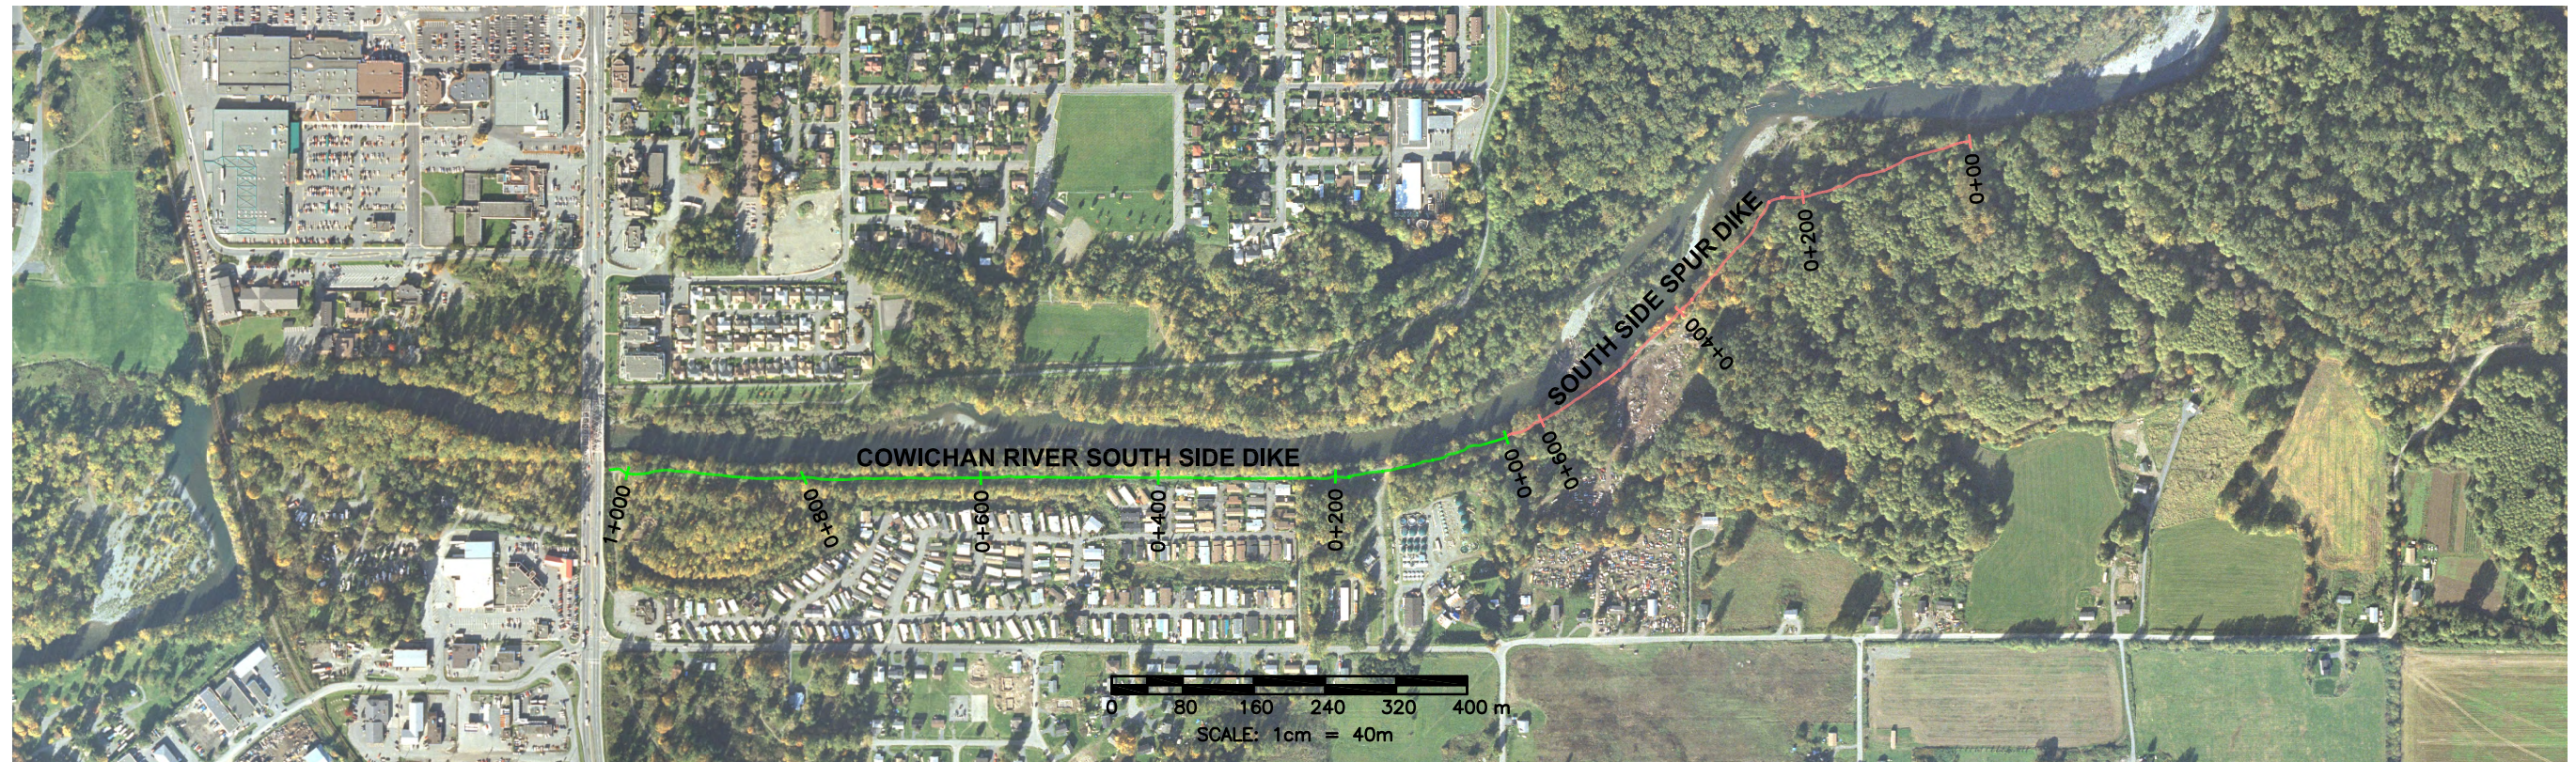
SOUTH SIDE SPUR DIKE

RETURN PERIOD	COWICHAN RIVER AT DUNCAN (08HA011)	KOKSILAH RIVER AT COWICHAN (08HA003)
YEARS	(m ³ /s)	(m ³ /s)
25	572	390
50	620	410
100	660	430
200	700	450

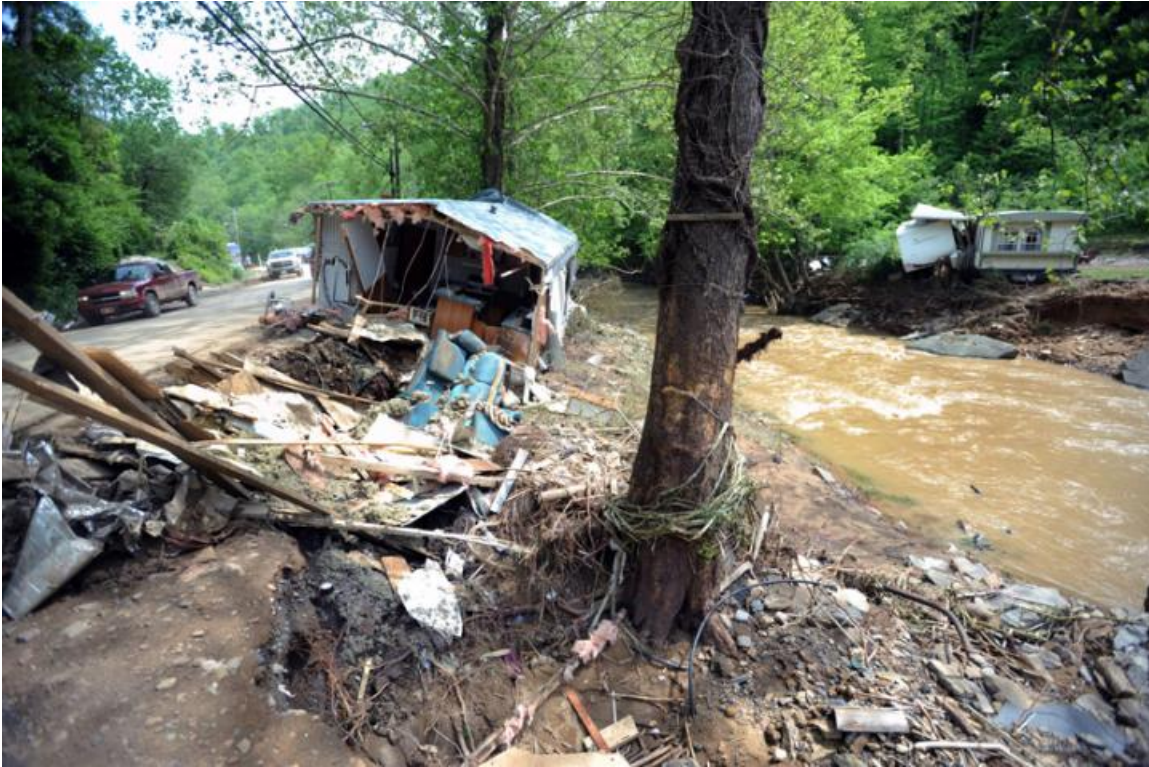
Photo 6.1: Flood damage to mobile home

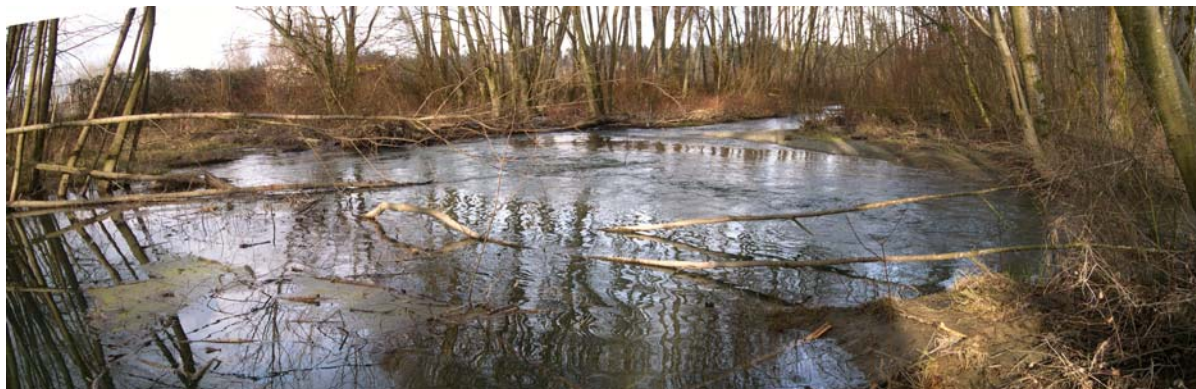
Proposed upgrades to the JUB Sewage Lagoon dike will increase freeboard around the overall 1.1 km perimeter giving rise to an estimated 5 m horizontal displacement beyond the existing structure. As an added measure of flood protection 670 m x 5 m of rock armouring is proposed along the toe of the upgraded dike as shown in Figure 8.1. An estimated 6,700 m² of sensitive aquatic and riparian habitat associated with lower Fish Gut Alley channel will be altered (Photo 8.1).

Photo 8.1: Downstream view of lower Fish Gut Alley side-channel

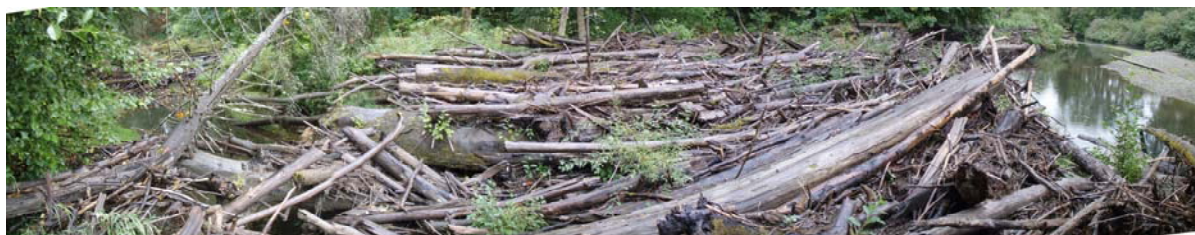
Photo 8.2: Downstream view of LWD jam obstructing side-channel intake at km 2+080 LB

Large woody debris jams on the Koksilah River have partially blocked the entrance to some side-channels potentially limiting fish production due to impaired flow and fish access as well as reduced water quality (Photo 8.2). Impaired flow to side-channels identified in this section also reduces the overall capacity of the channel, potentially increasing flood levels in the mainstem. Opportunity exists to modify existing jams by partial removal and construction of ballasted intake features.

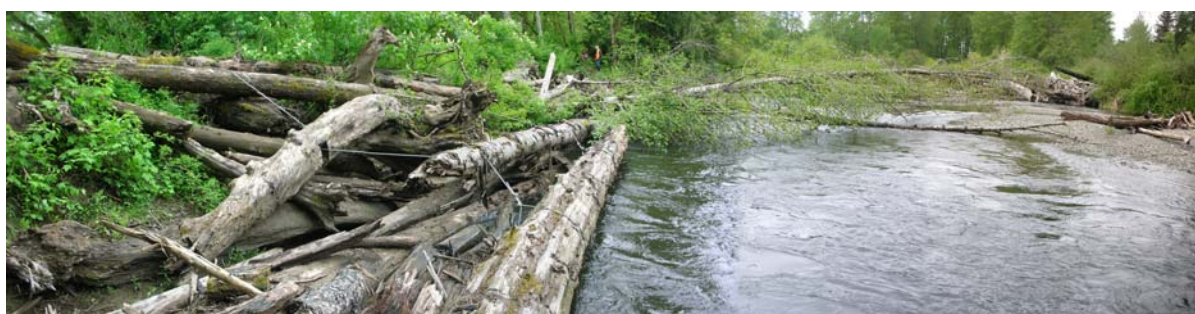
Photo 8.3 : Upstream view of log jam on Koksilah River at km 3+290

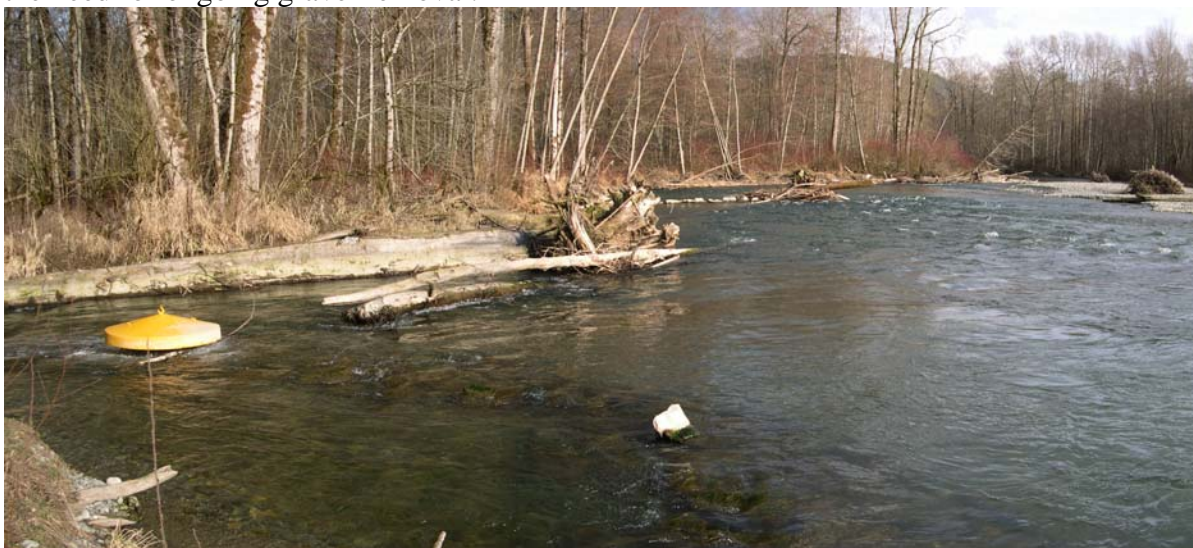
Photo 8.4: Downstream view of lower Fish Gut Alley side-channel intake showing avulsing mainstem flow and proposed installation of ballasted LWD intake feature.

- The aggrading gravel bar opposite the JUB outfall and accessible from the south side dike, where mainstem flow is avulsing into the lower Fish Gut Alley side-channel (Photo 8.4 and Figure 8.4)
- The large aggrading point bar upstream of the railway bridge and accessible from the north bank (Figure 8.3).

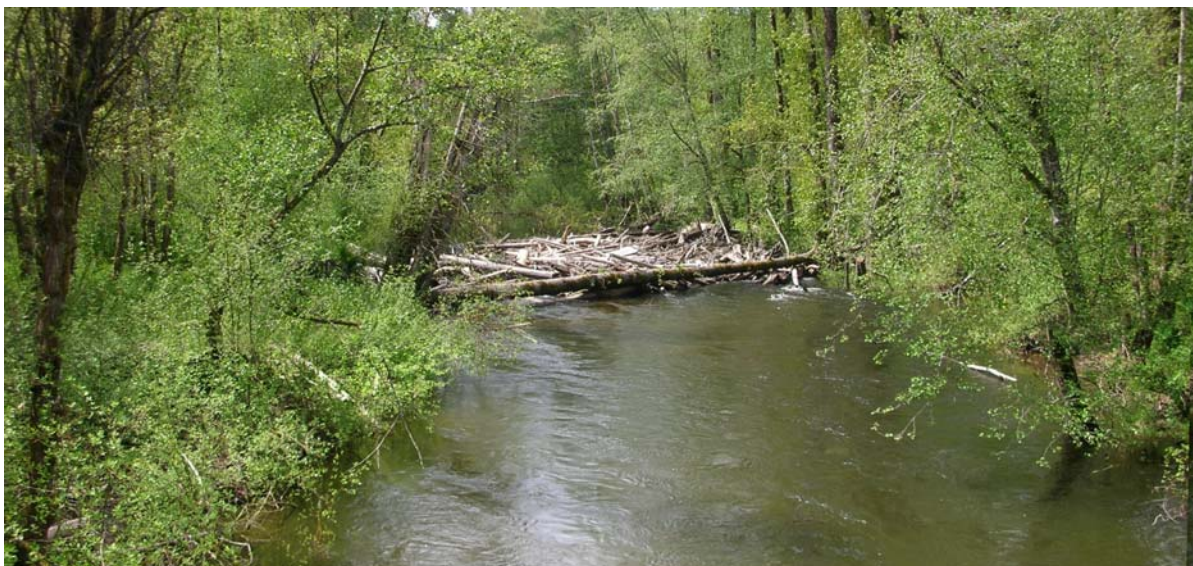
The goal of this strategy is to proactively remove or stabilize debris jams of concern before threats to infrastructure occur. A channel spanning debris jam located on Koksilah River at km 3+290 should be further assessed to determine flood risk to the Koksilah Dike, residential property and the E&N Railway crossing located downstream (Figure 8.8 and Photo 8.5).

Photo 8.5: Upstream view of log jam on Koksilah River at km 3+290

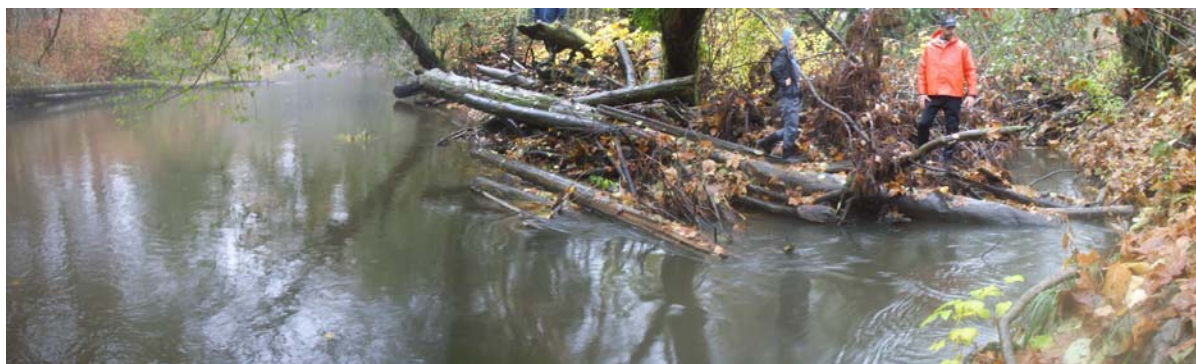
Photo 8.6: Downstream view of LWD jam partially obstructing side-channel intake at km 1+380 LB

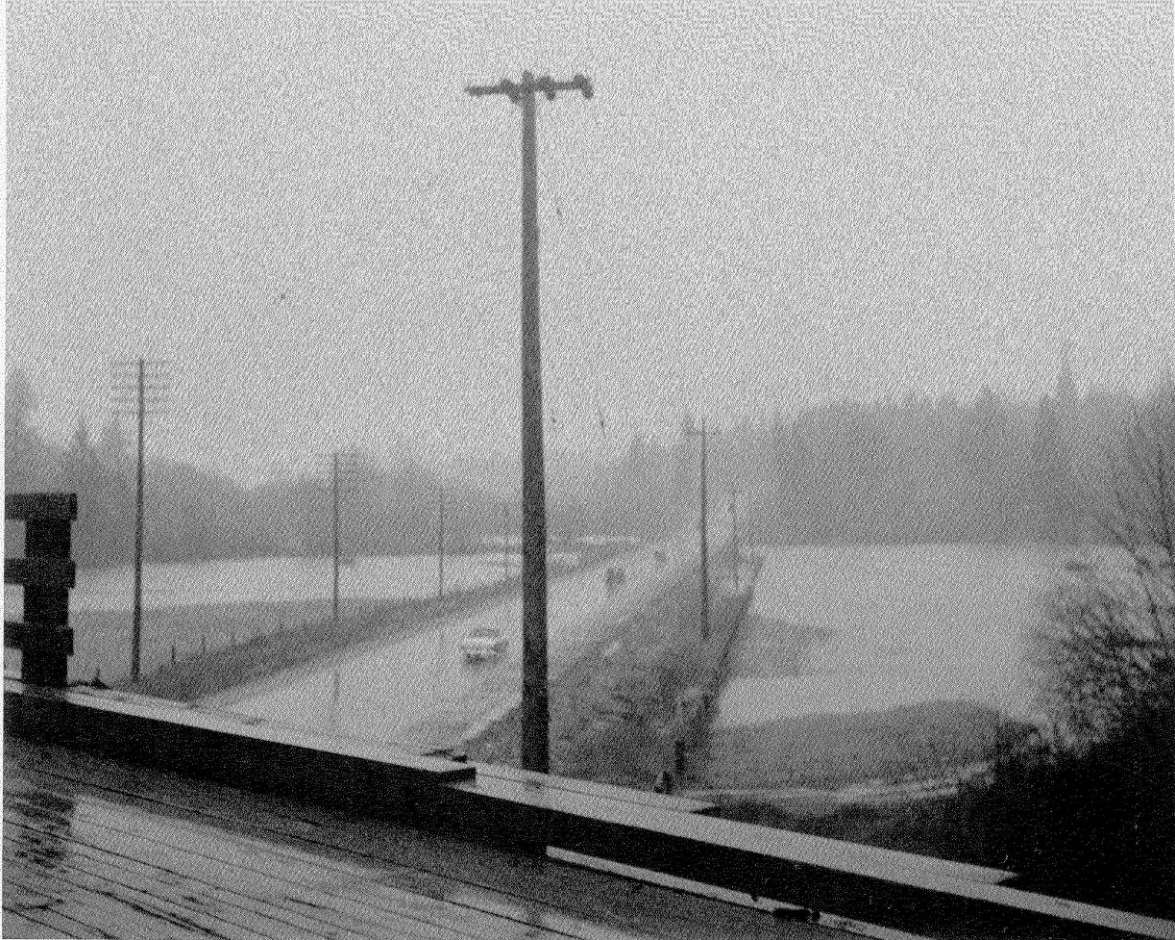
Koksilah River flooding near Highway 1. Photograph taken from the old Trestle crossing, looking southeast towards the Koksilah River.

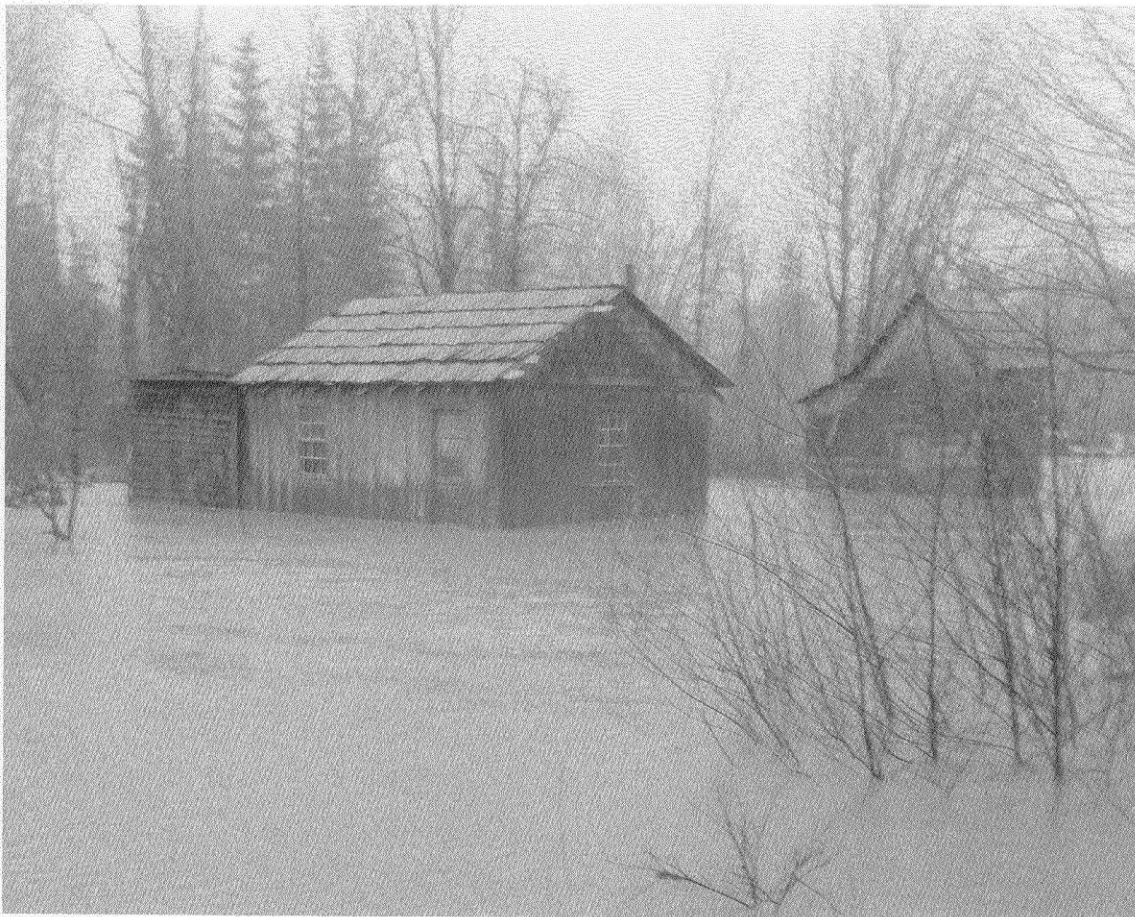
Flooding from Koksilah River on Cowichan Tribes land.

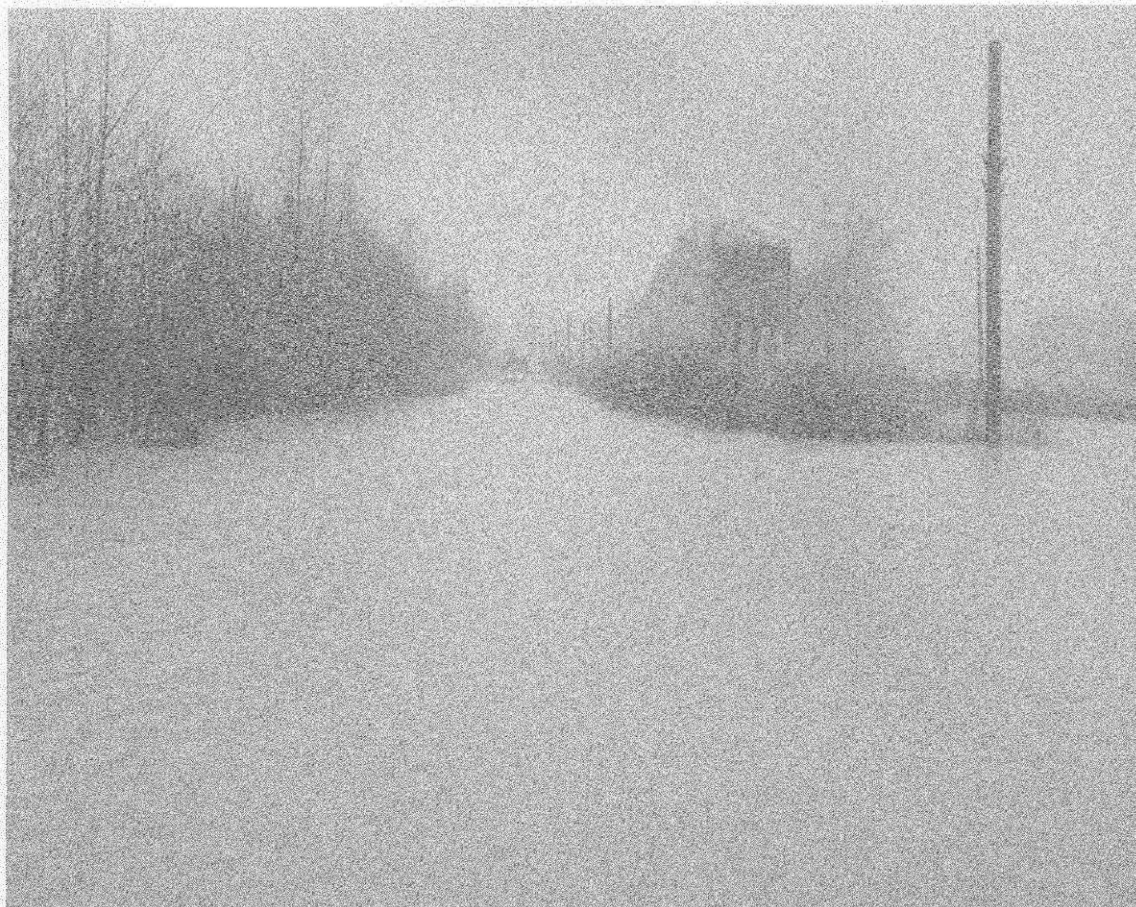
Flooding on Cowichan Tribes land.

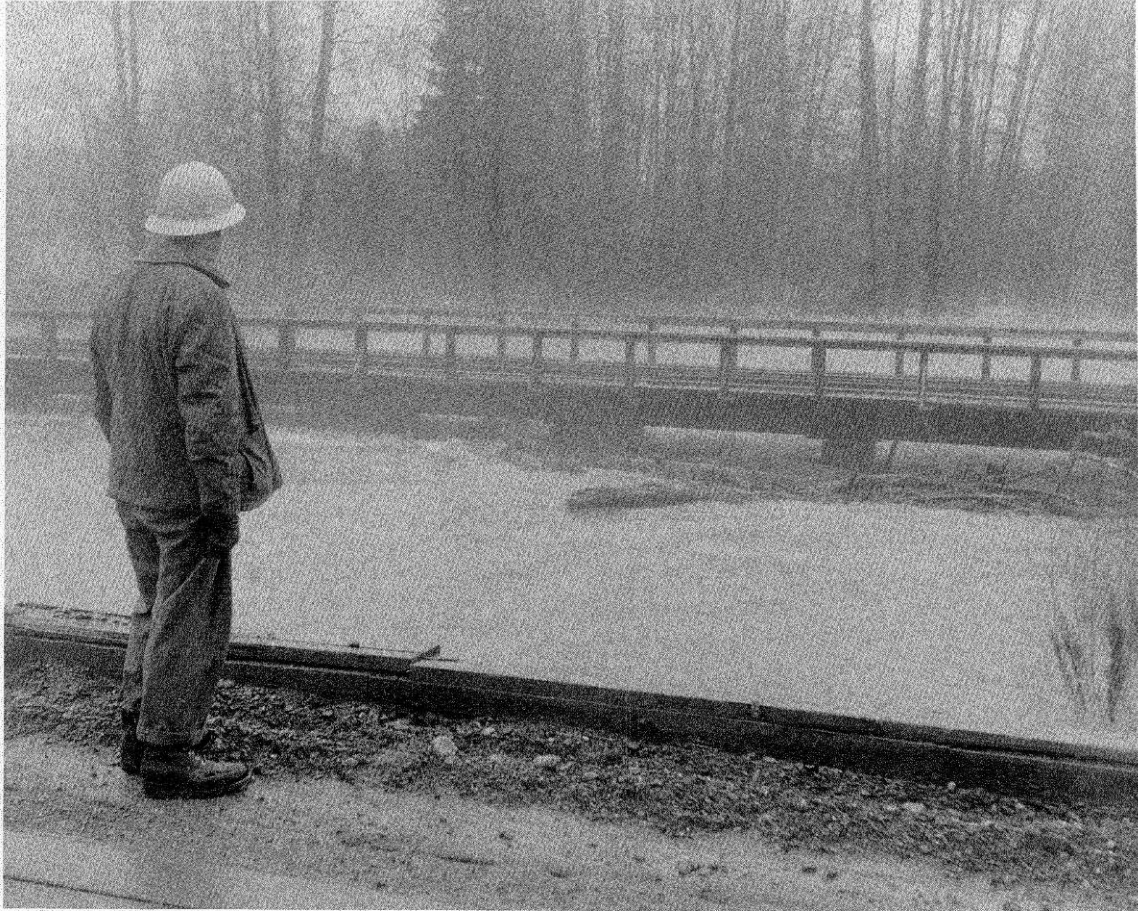
Log jam forming at upstream end of bridge.

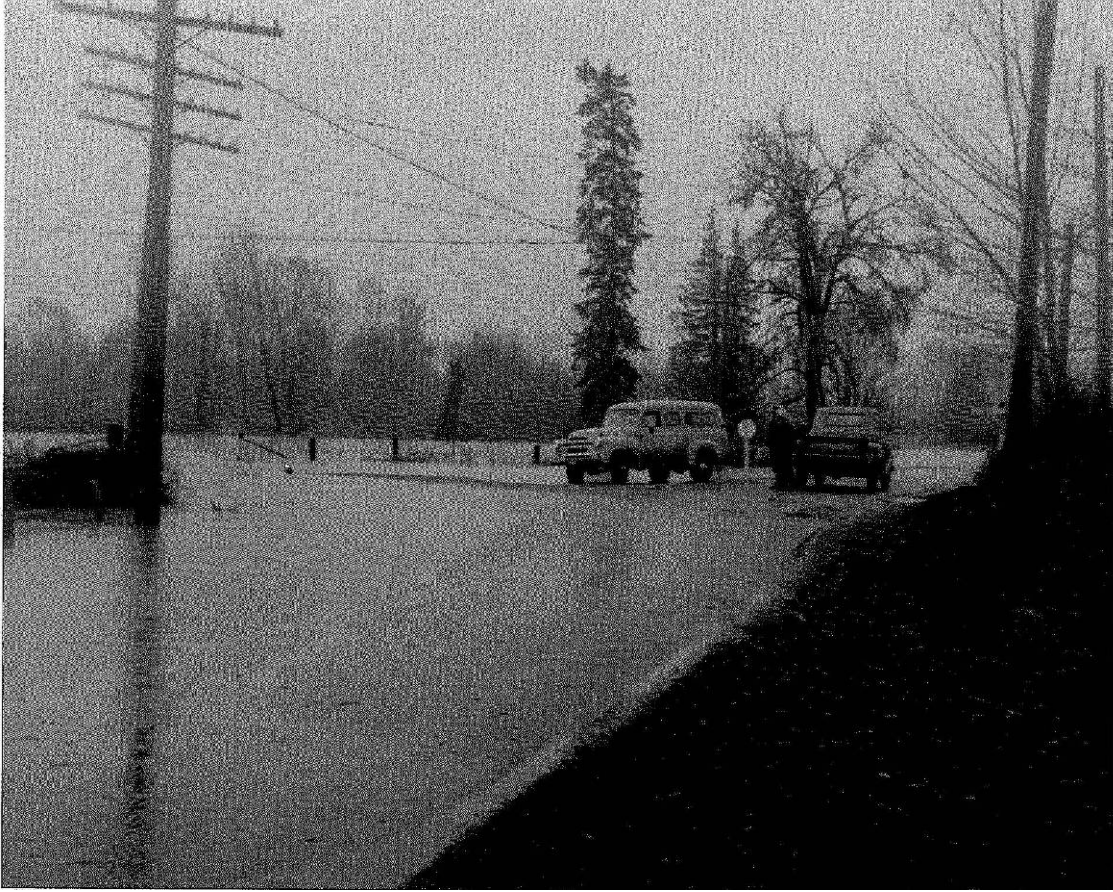
Flood waters on Cowichan Bay Road near the Lawn Tennis Club.

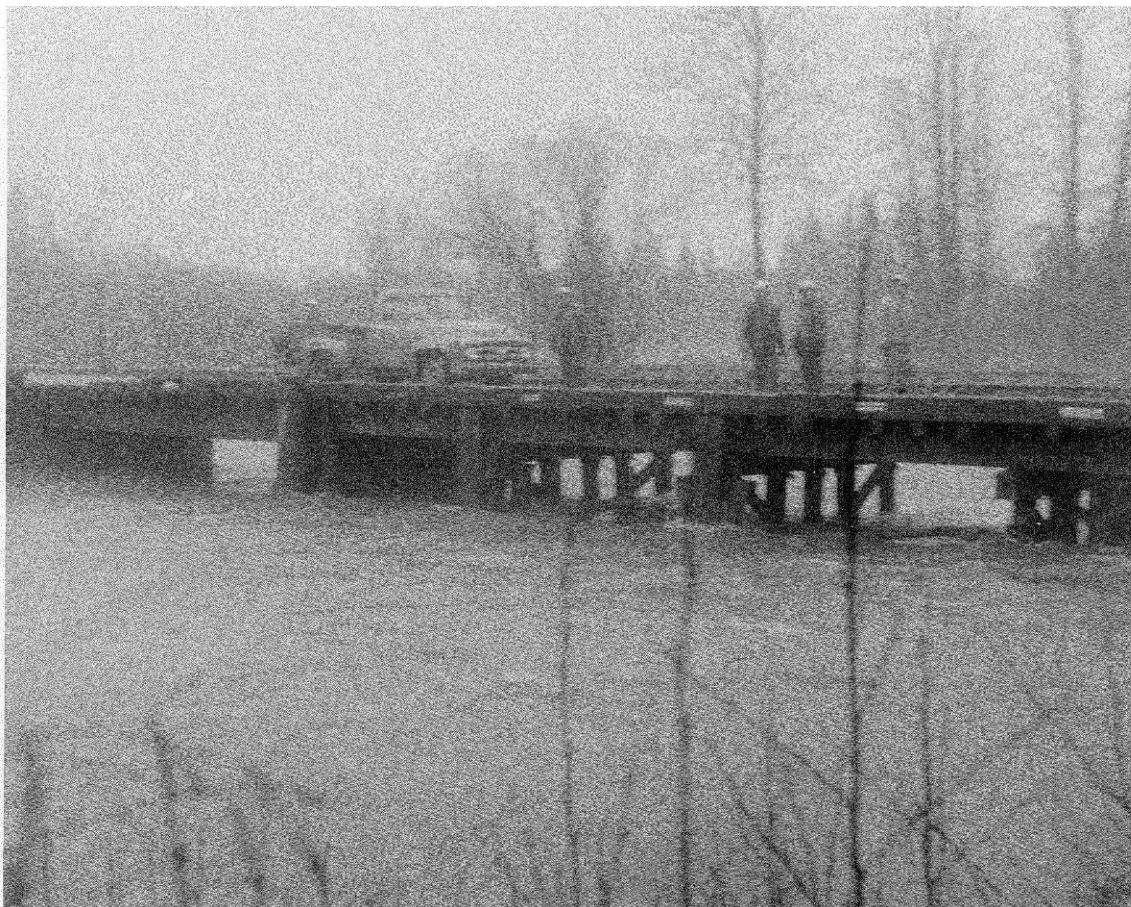
Log jam starting to form at upstream side of bridge.

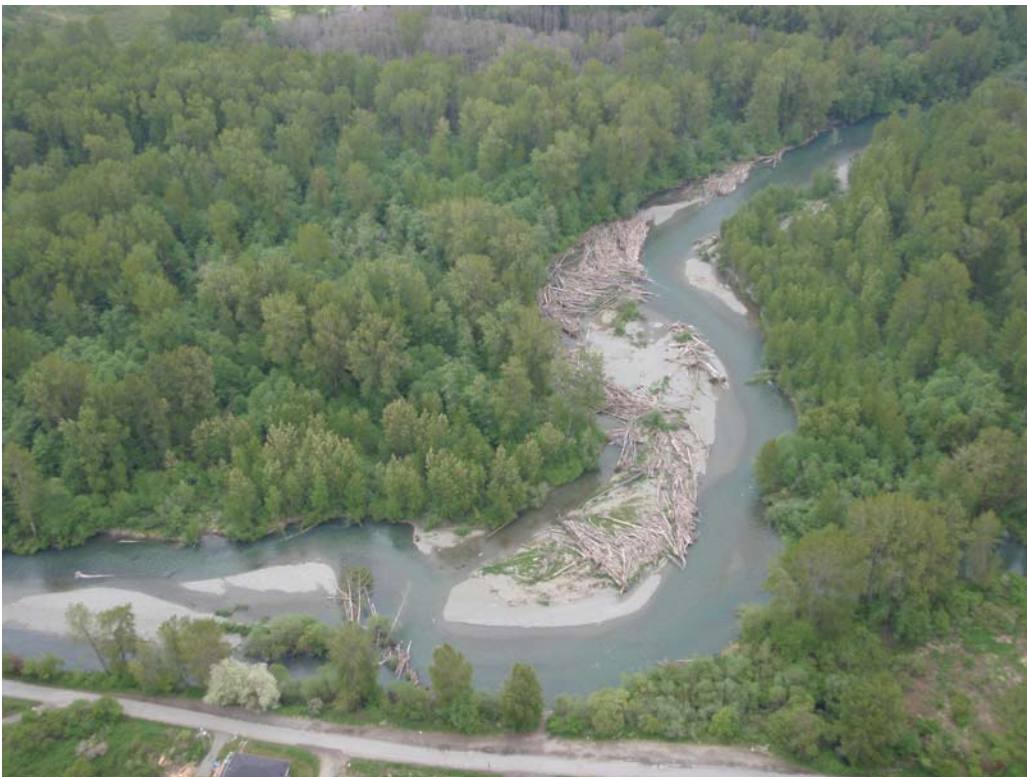
Photo A.1: Aerial view of the Cowichan River mainstem illustrating mid channel bars at km 4.3 and 4.5 where gravel and debris accumulate and intact riparian habitat extends over both left and right banks with Quamichan Road in the foreground (May 08).

Riparian areas are distinct and provide critical habitat components for wildlife. Intact riparian habitat provides important features that support biological diversity, structure and function on a floodplain (Photo A.1). They also provide important migration corridors as well as important nesting and foraging habitat for wildlife species (black tailed deer, black bears, furbearers), and numerous species of waterfowl, shorebirds, songbirds and raptors. For example, mature cottonwood trees within riparian habitat along the Cowichan River provide critical roosting habitat for bald eagles during the fall season as well as important nesting habitat during the late winter and spring.

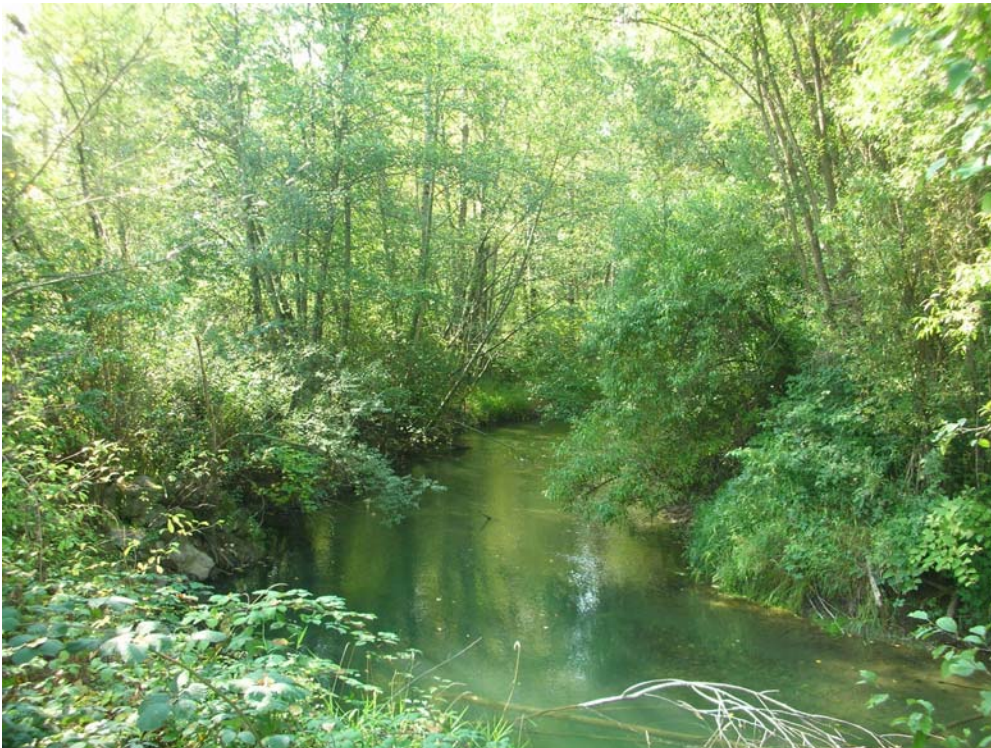
Photo A.2. Upstream view of Major Jimmy's side-channel where year round flows support high quality spawning and rearing habitat (June 08).

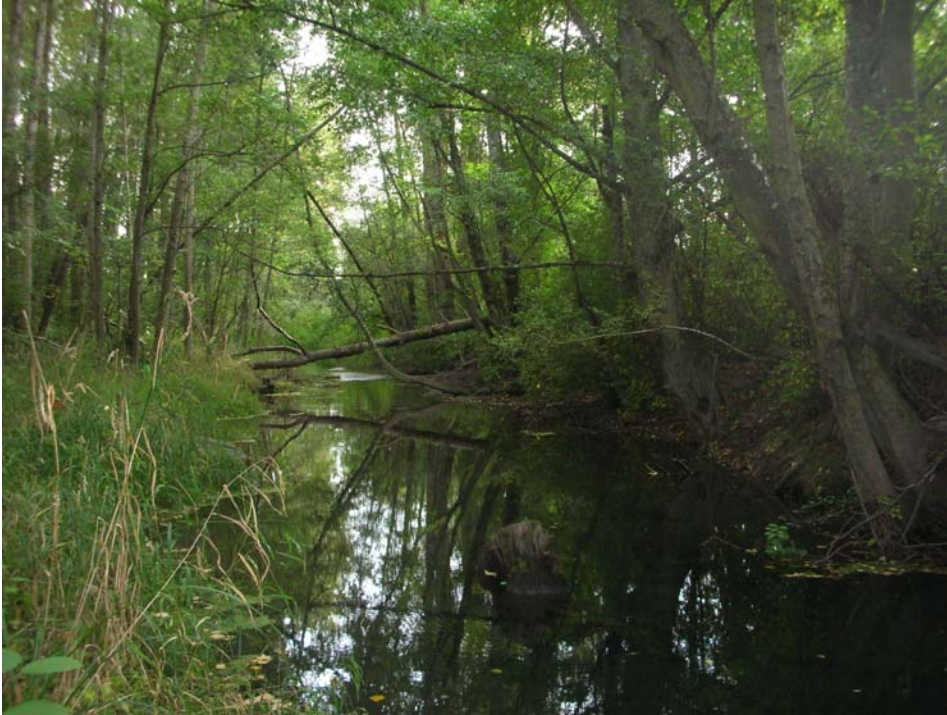
Photo A.3: Downstream view of the Hatchery side-channel illustrating high value summer rearing habitat, intact riparian canopy with a bankfull width of 10 m and channel gradient of approx 0.5% (June 08).

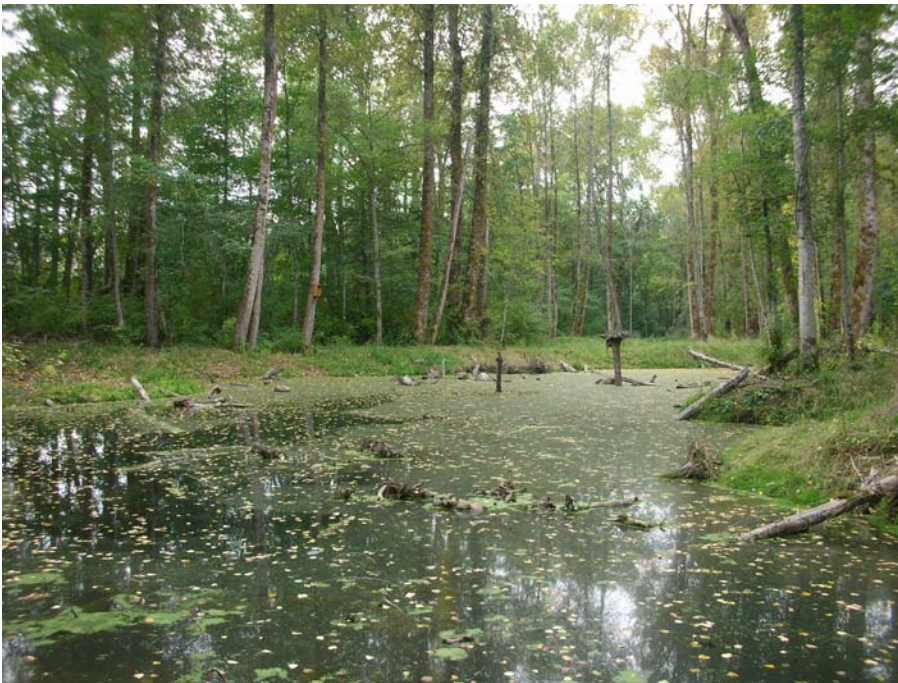
Photo A.4: Lateral view of one of the Five Fingers rearing ponds illustrating stable, high quality year round rearing habitat, with enhanced LWD cover as well as wildlife habitat enhancement including bird and bat nesting boxes (June 08).

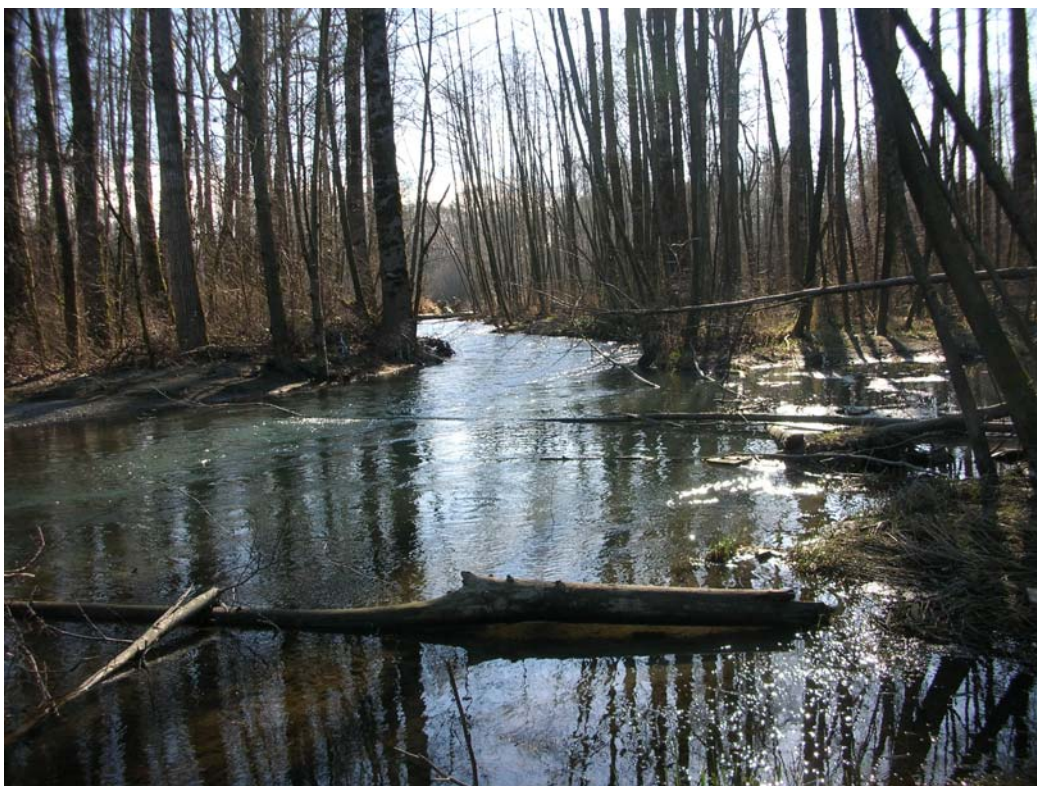
Photo A.5: Overbank flooding at right bank near km 5.1 and flooding into Fish gut alley at discharge of 33 m³/s. (February 17 09).

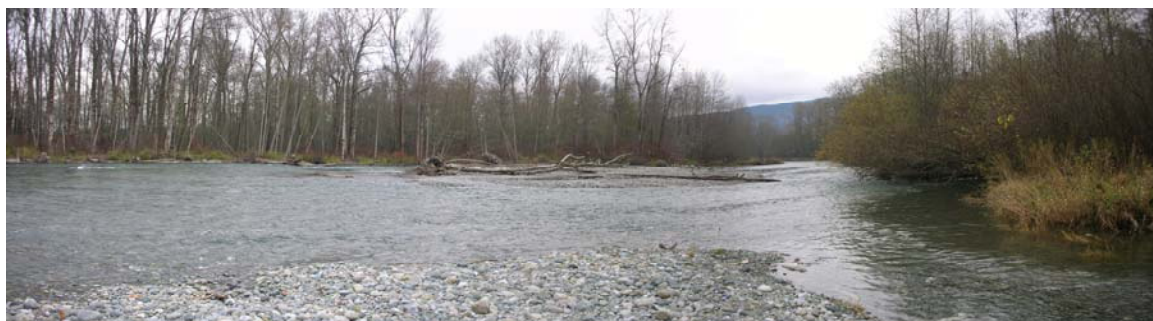
Photo A.6. Lateral view of the mainstem Cowichan River at km 5.1 illustrating high quality spawning habitat that continues to support chum and coho spawners. The mature and intact riparian habitat is dominated by Black Cottonwood and provides high quality wildlife habitat. This site is also a proposed gravel removal site as part of the flood maintenance program. Approximately 1800 m³ of gravel was removed in June 2007 as part of emergency works to the JUB outfall (Nov 2008).
