LOWER COWICHAN / KOKSILAH RIVER INTEGRATED FLOOD MANAGEMENT PLAN

FINAL REPORT

SEPTEMBER 2009

nhc northwest
hydraulic
consultants

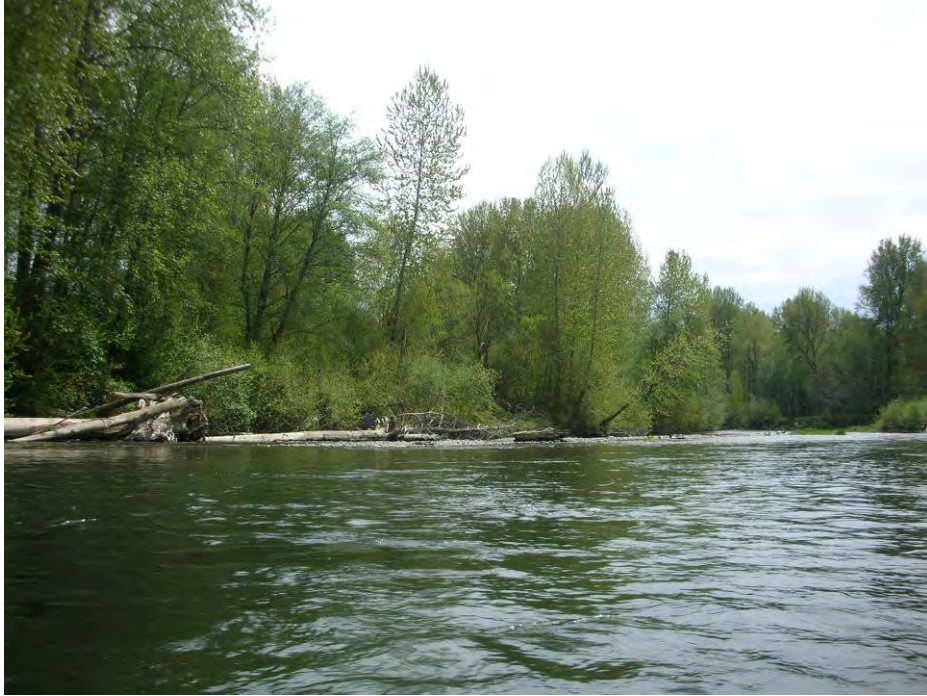
Photo B.1: Downstream view of high value shoreline habitat at Cowichan River km 3.7 where functional LWD structures adjacent to mature riparian vegetation are created high value instream habitat (May 5, 08).

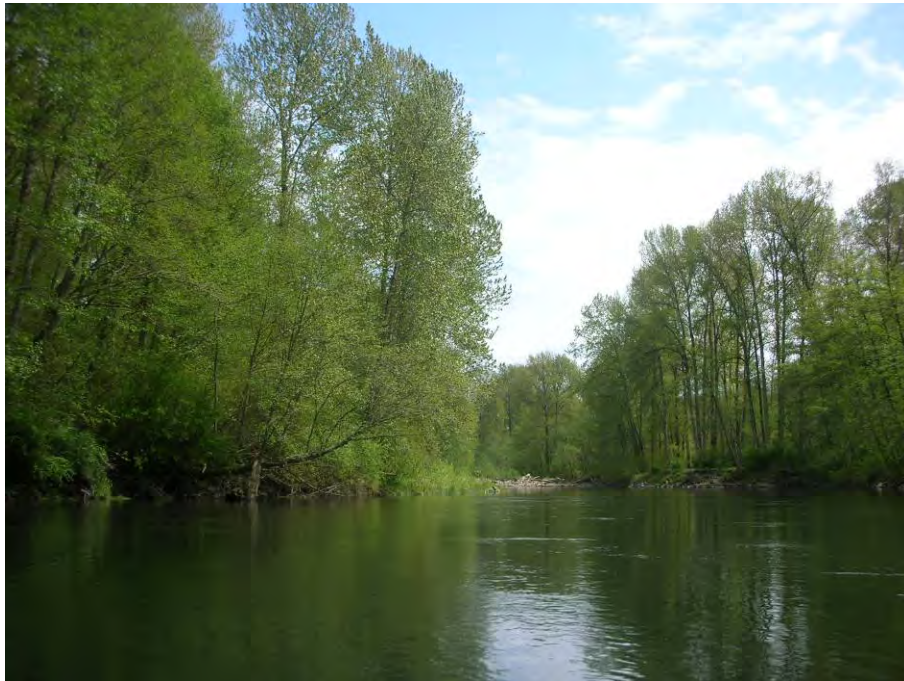
Photo B.2: Downstream view in the North Branch at km 1.7 illustrating mature riparian habitat and natural shoreline features that are providing high quality, stable instream habitat (May 5, 08).

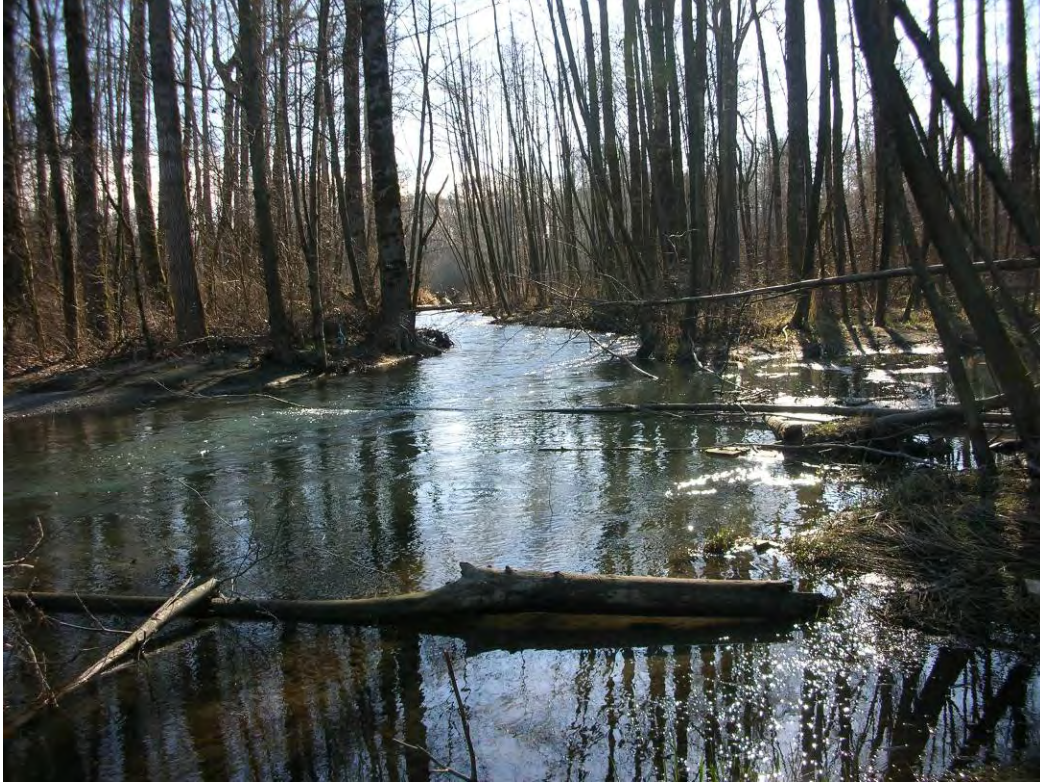
Photo B.3: Overbank flooding (right bank) at km 5.1 over floodplain and into Fish Gut Alley at discharge of 33 m³/s. (February 17 09).

- Off-channel areas are inundated by numerous high flow channels during mainstem discharges of 94 m³/s (Photo B.3).
- High value forage habitat is provided on exposed mid-channel bars for birds including bald eagle, high densities of red crested mergansers, marine diving ducks, seagulls (Photo B.4).

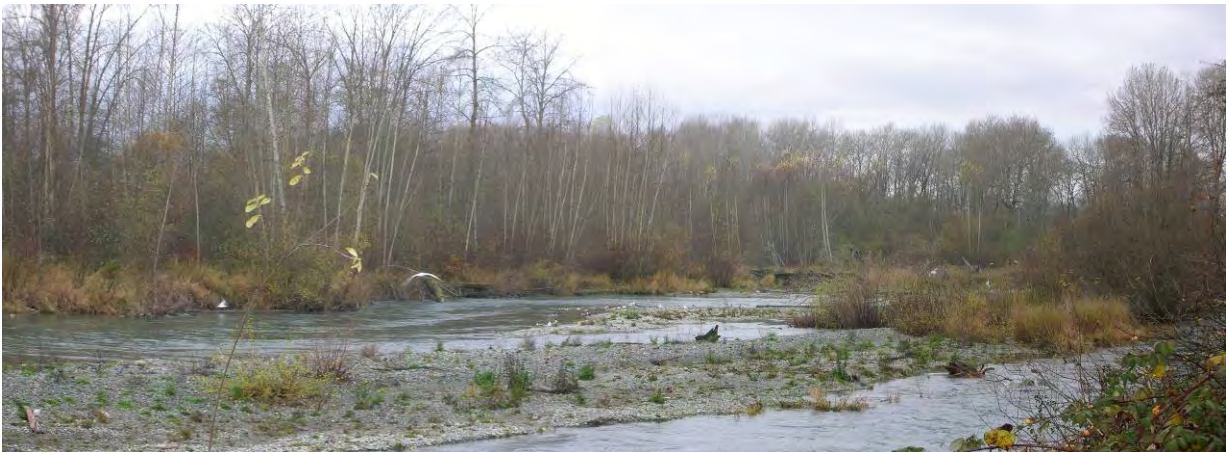
Photo B.4: Upstream view of mid-channel bar in the Cowichan mainstem at km 4.2 providing good quality foraging habitat for bald eagles, diving ducks and seabirds (Nov 2008).

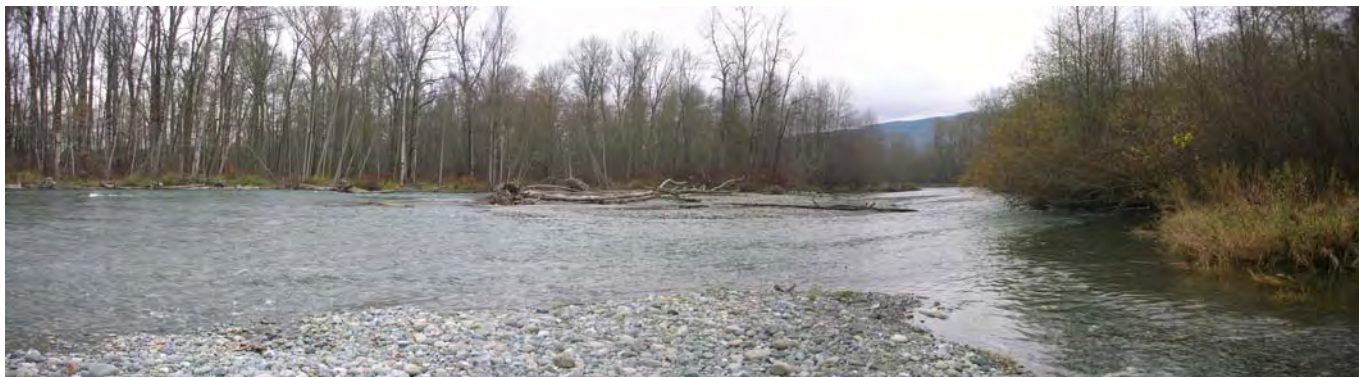
Photo B.5. Lateral view of the mainstem Cowichan River at km 5.1 illustrating high quality spawning habitat that continues to support chum and coho spawners. The mature and intact riparian habitat is dominated by Black Cottonwood and provides high quality wildlife habitat. This site is also a proposed gravel removal site as part of the flood maintenance program. Approximately 1800 m³ of gravel was removed in June 2007 as part of emergency works to the JUB outfall (Nov 2008).

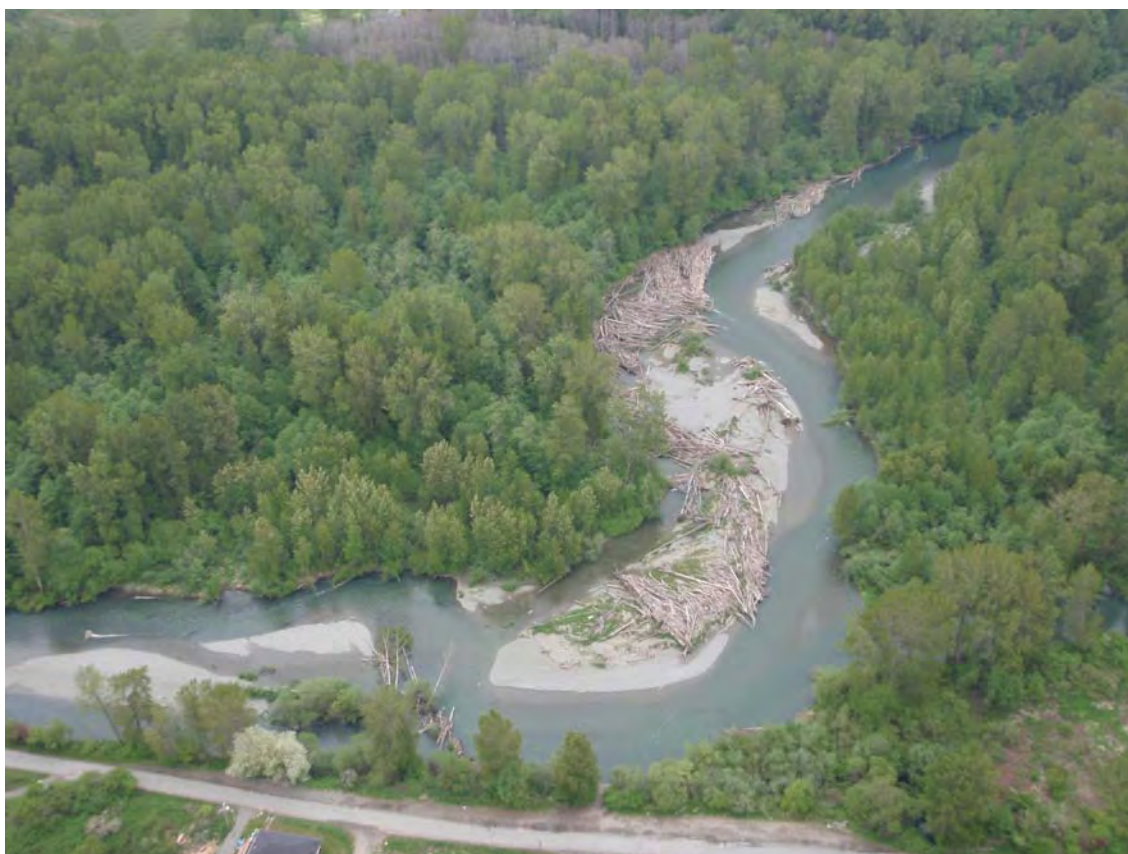
Photo B.6. Aerial view of the Cowichan River mainstem illustrating mid channel bars at km 4.3 and 4.5 where gravel and debris accumulate and intact riparian habitat extends over both left and right banks with Quamichan Road in the foreground (May 08).

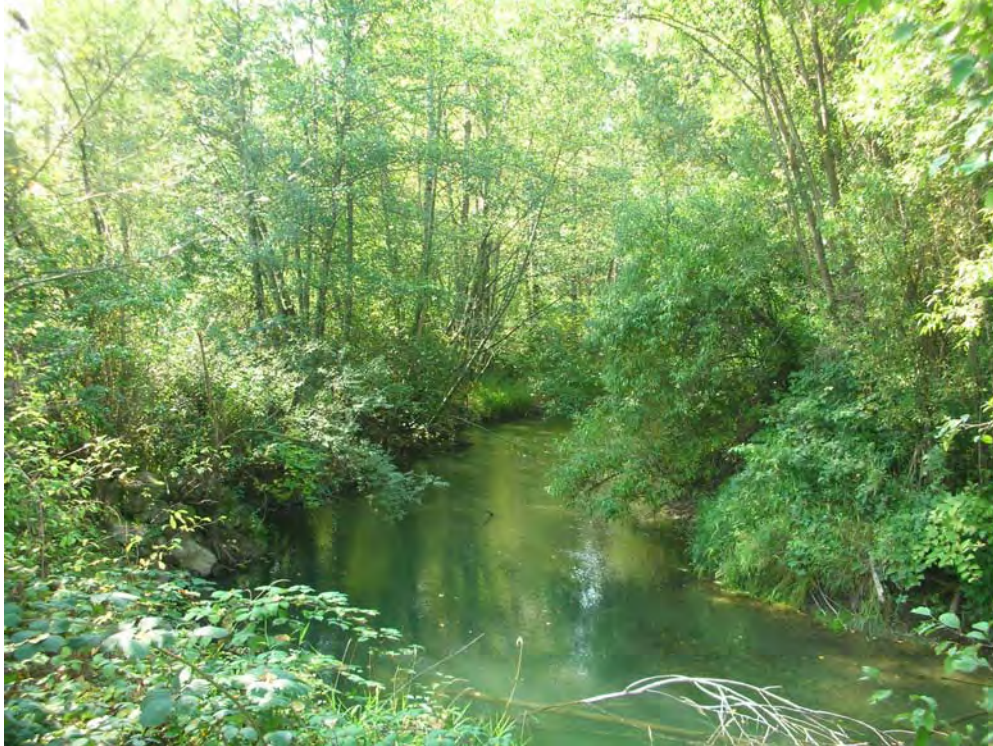
Photo B.7. Upstream view of Major Jimmy's side-channel where year round flows support high quality spawning and rearing habitat (June 08).

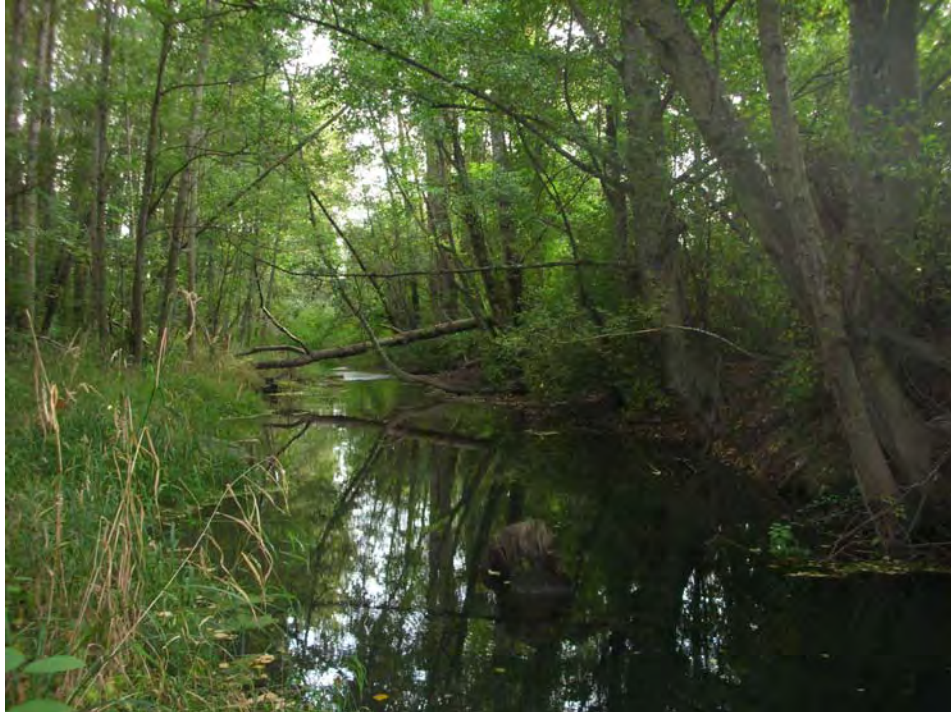
Photo B.8. Downstream view of the Hatchery side-channel illustrating high value summer rearing habitat, intact riparian canopy with a bankfull width of 10 m and channel gradient of approx 0.5% (June 08).

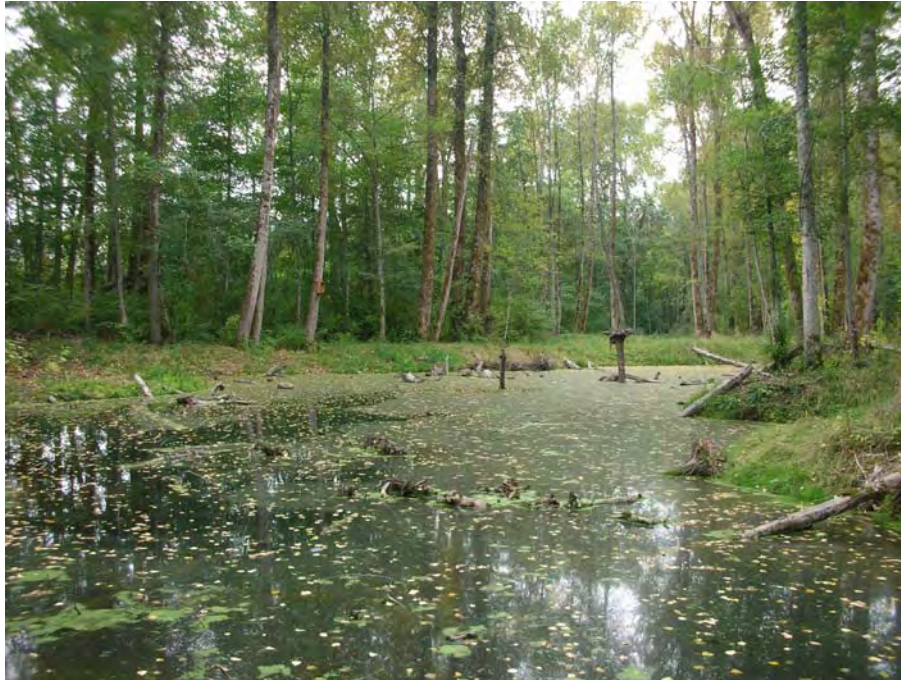
Photo B.9. Lateral view of one of the Five Fingers rearing ponds illustrating stable, high quality year round rearing habitat, with enhanced LWD cover as well as wildlife habitat enhancement including bird and bat nesting boxes (June 08).

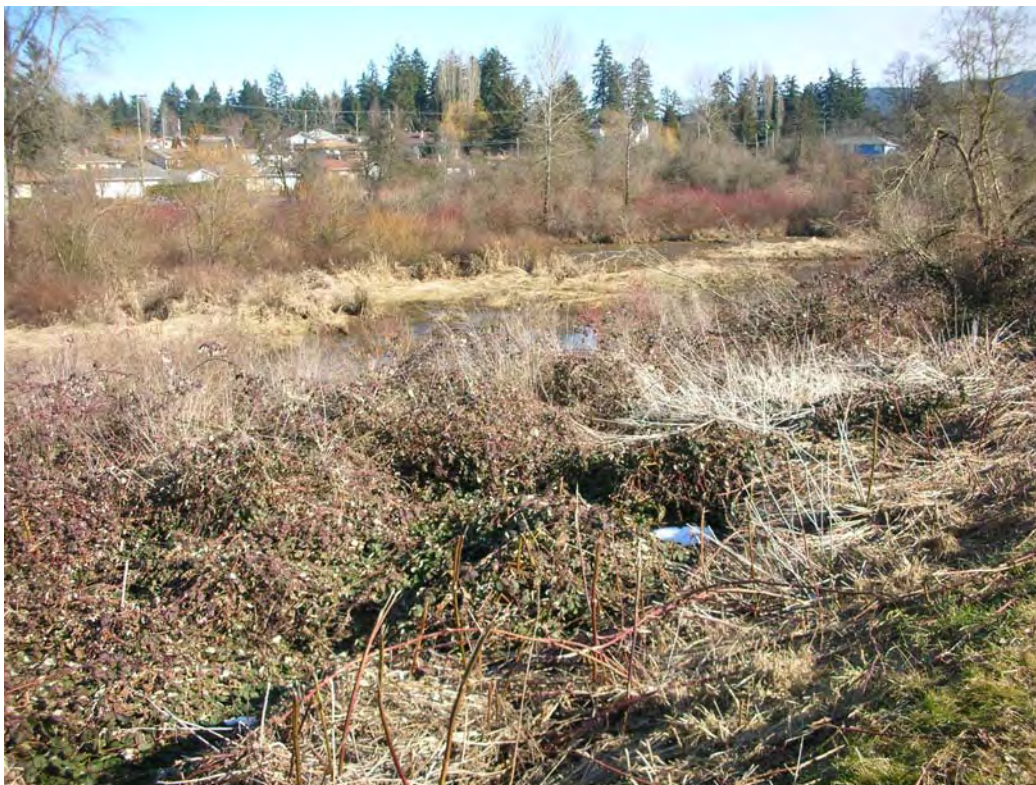
Photo B.10. Lateral view of wetland habitat at Km 0.6 RB of the Somenos mainstem adjacent to the JUB outfall dike Section 2 (Feb 09).

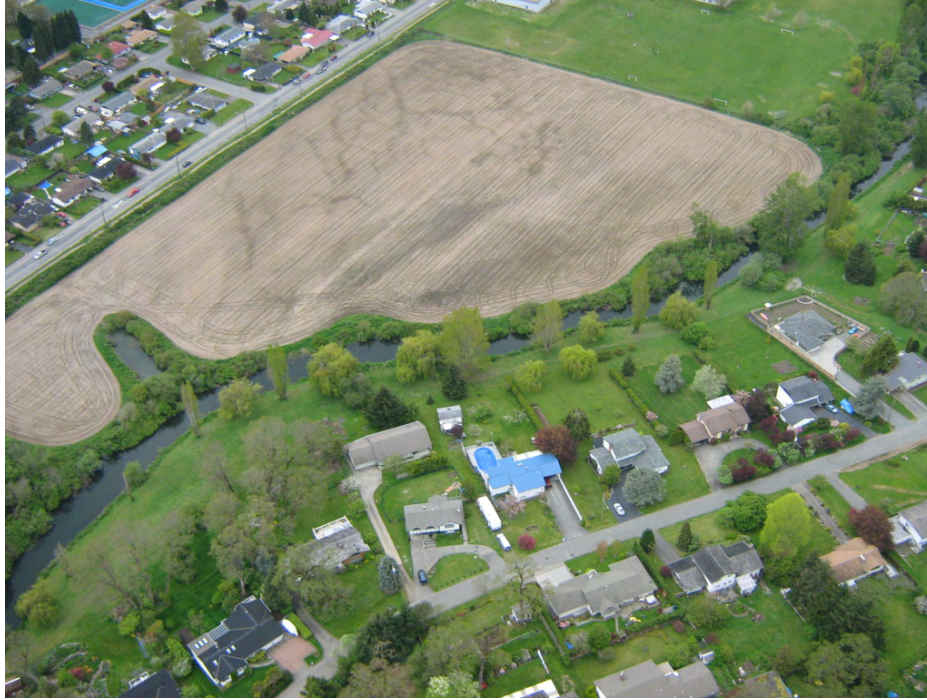
Photo B.11. Aerial view of the Somenos mainstem illustrating an latered riparian habitat along both sides for the channel at km 1.7. The cultivated field is SEI polygon V1509* (May 15, 08).

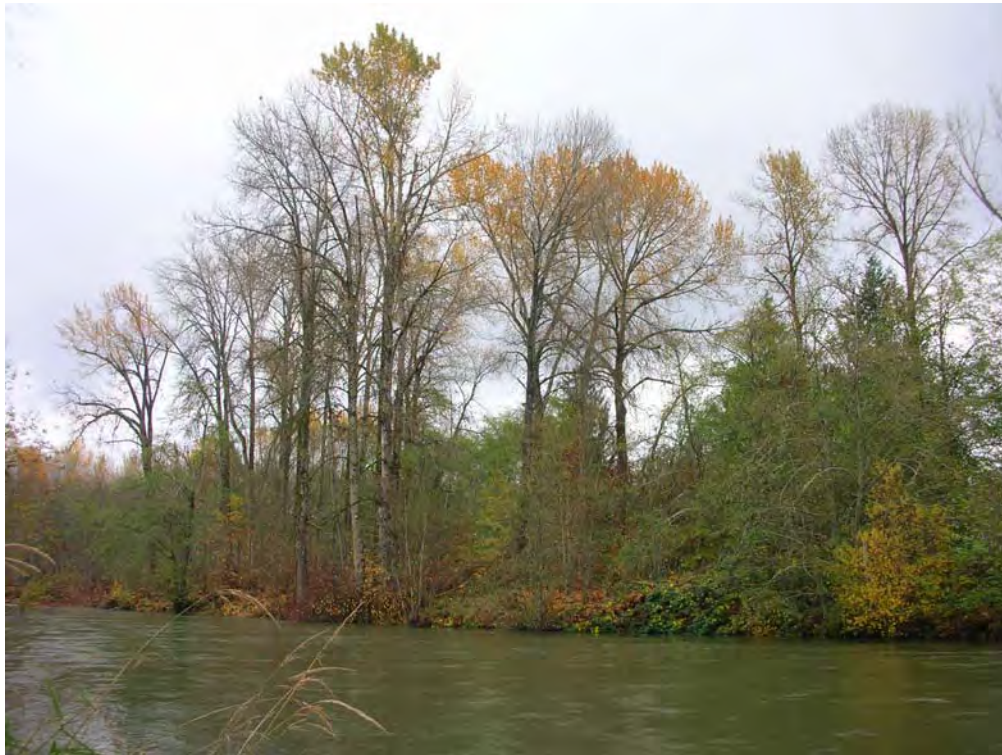
Photo B.12. Lateral view of south side dike at km 5.7 adjacent to the right bank shoreline where proposed dike maintenance will require removal of vegetation along both sideslopes. Riparian vegetation is currently providing overhanging cover, refuge and food supply to salmonids. Dike maintenance activities will require consultation with FOC and likely require details of the proposed maintenance along with a compensation plan and monitoring plan (Nov 2008).

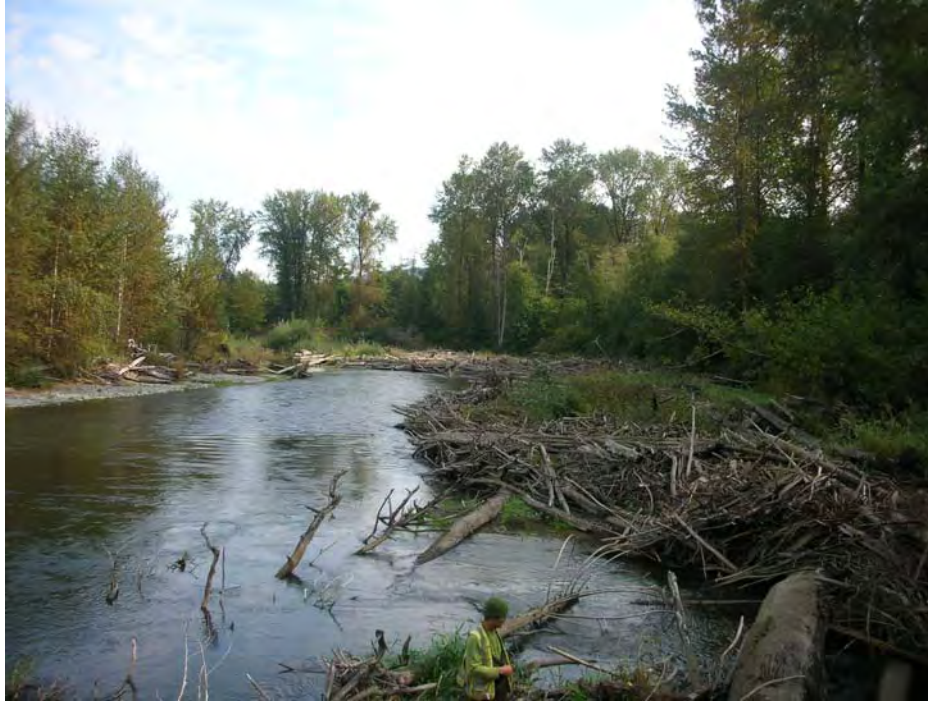
Photo B.13. Downstream view of excessive woody debris that has altered natural shoreline values in the lower Cowichan mainstem between km 4.5 and 4.75 (September 2008).

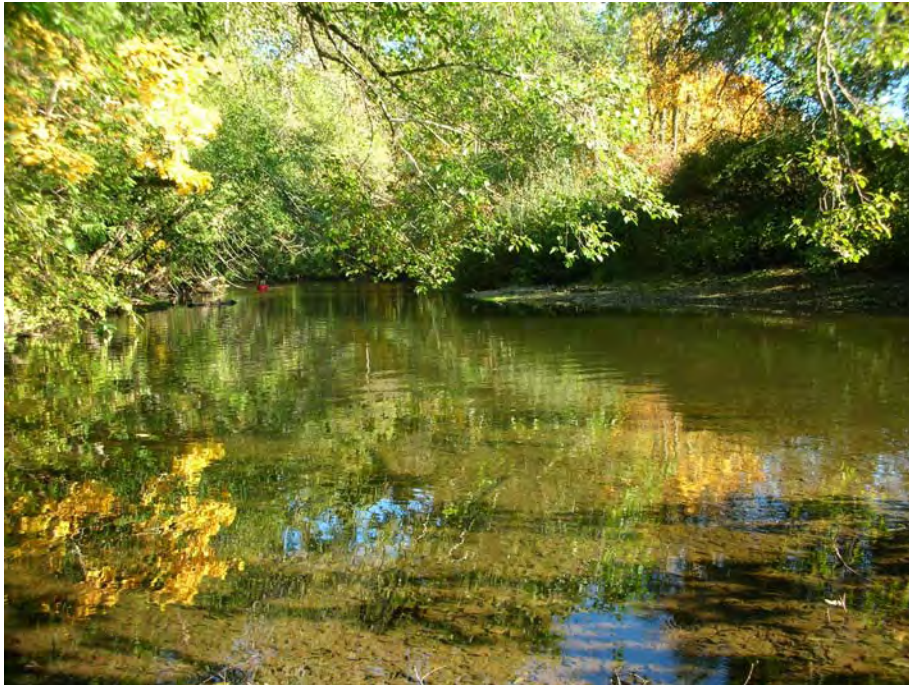
Photo B.15. Downstream view of the mainstem Koksilah illustrating shallow water conditions, with minimal instream or overhead cover for migrating spawners or juvenile salmonids (Oct 22 2008).

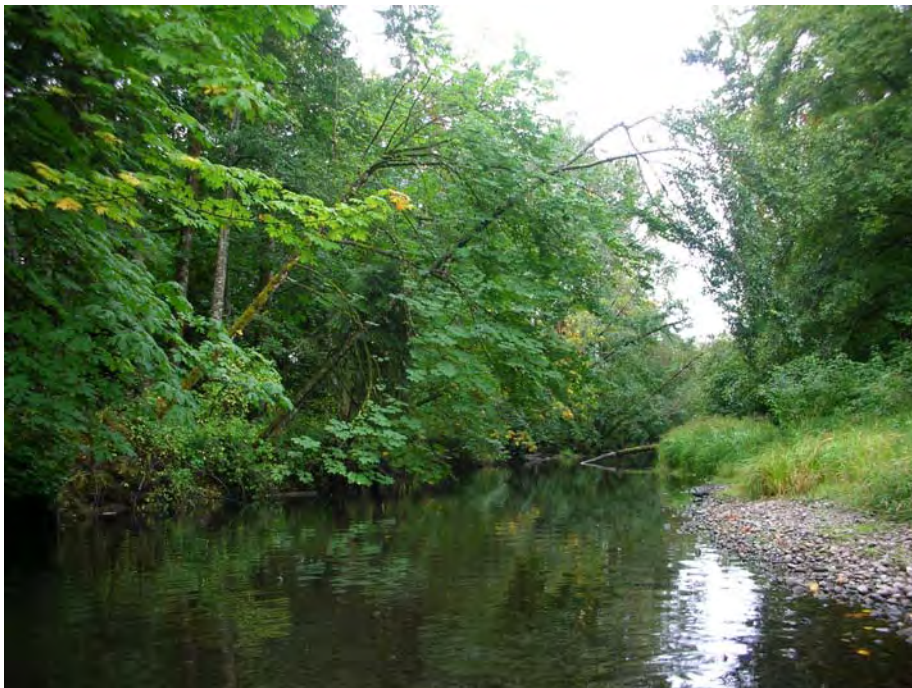
Photo B.16. Upstream view of the mainstem Koksilah where the right bank is actively eroding and immature riparian trees are collapsing into the channel (September 2009).

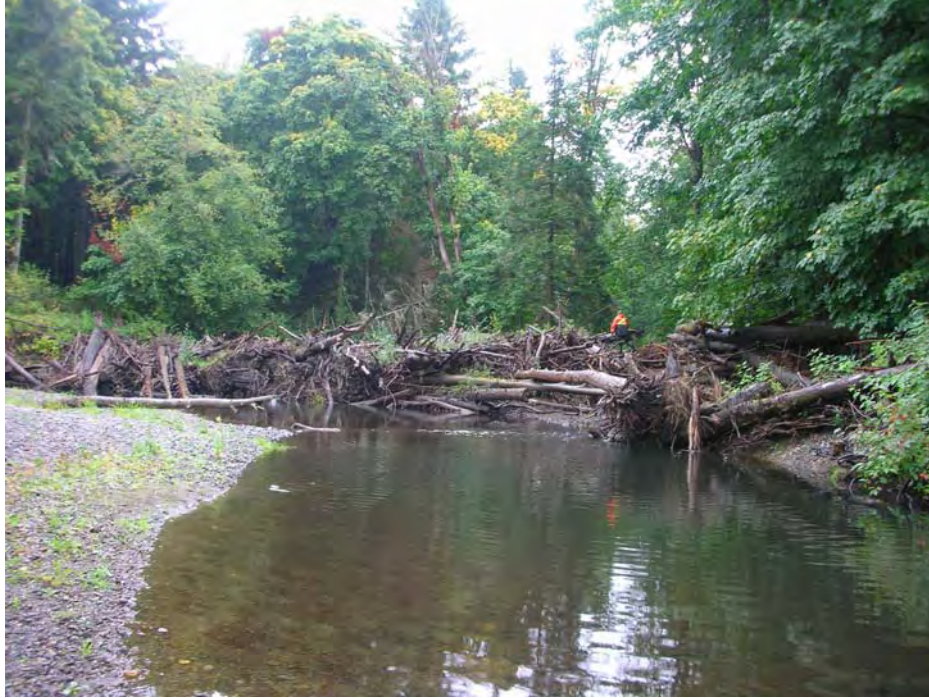
Photo B.17. Upstream view of the LB debris jam restricting fish passage and flows in the Koksilah mainstem at approximately km 2.1 (Sept 08).
