2020 Corporate Strategic Asset Management Plan

Appendix E Condition Assessment Framework Part 3 - Public Safety

A – 12
Sahtlam Fire Hall

**Cowichan Valley Regional District
Facility Condition Assessment and Capital Plan
Sahtlam Fire Hall, 4384 Cowichan Lake Road, Duncan, BC V9L 6J7**

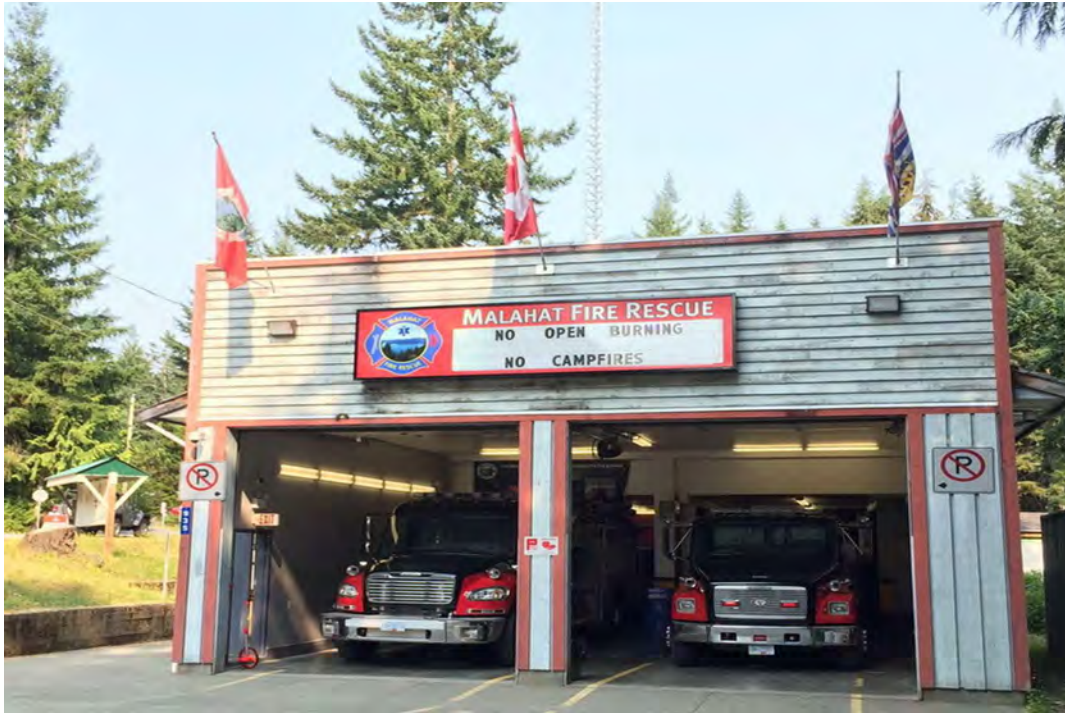
Photo 01

Refer to Photo 01.

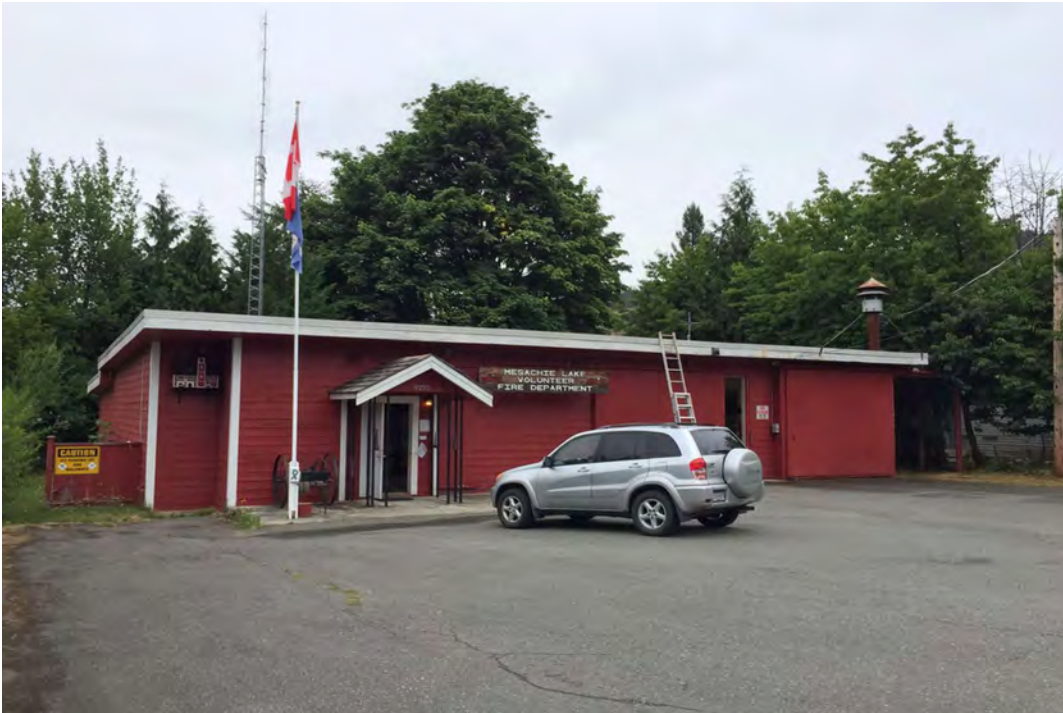
Refer to Photo 01 for an overview of the building.

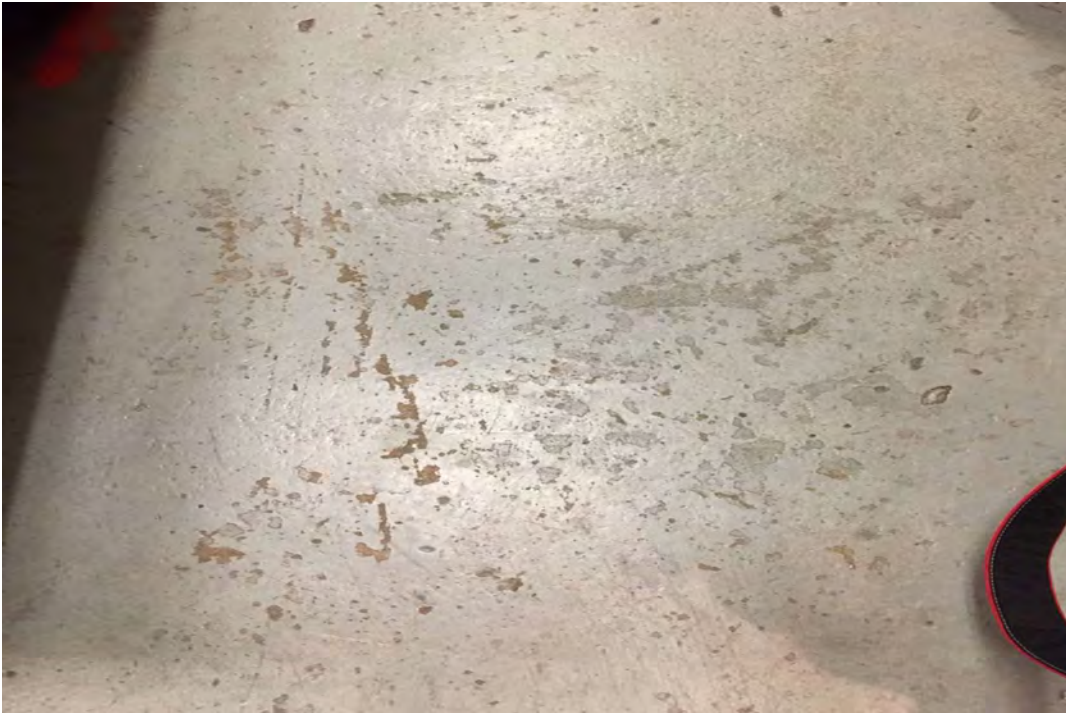
Photo 03

2	Mesachie Lake Fire Hall		9295 Carlton Rd, Mesachie Lake, BC	A Substructure	A10 Foundations	A1030 Slab on Grade	A103001 Standard Slab on Grade	Throughout Interior of Building At-Grade/ Slab-on-Grade	03	The floor is concrete slab-on-grade, with the lounge section of the building wood framed over crawspace. No evidence of major settlement or heaving was reported or observed. There was no access to the crawspace.	4	5	1975	21-Jul-17	MH	42	75	33	The concrete slab-on-grade is expected to remain serviceable for the life of the building, with isolated repairs, if needed. Maintain crawspace ventilation at the grilles through the foundation walls. This item falls outside the ten year plan, costs associated with this item have not been carried into the cash flow tables.	Not Applicable	Not Applicable	Yes	Yes	Yes	No								
3	Mesachie Lake Fire Hall		9295 Carlton Rd, Mesachie Lake, BC	A Substructure	A10 Foundations	A1030 Slab on Grade	A103006 Foundation Drainage	Underground/ Perimeter Drains	x	Perimeter drain pipes are assumed to be installed at the footing level. No issues related to foundation drainage were noted by facility staff. No information was available regarding the scoping of the system to review for continuity.		4	1975	21-Jul-17	MH	42	5	2	Periodic camera inspection and isolated repairs as required.	Study	Not Applicable	No	N/A	No	N/A	1	\$2,000	LS	\$2,000	0%	0%	5%	\$3,000
